CONSTRUCTION HISTORY AND PRESERVATION**Conservation principles and structural performance of Modern heritage:
the church of San Giovanni in Bosco in Bologna***Giorgia Predari, Angelo Massafra*

CONSERVATION PRINCIPLES AND STRUCTURAL PERFORMANCE OF MODERN HERITAGE: THE CHURCH OF SAN GIOVANNI IN BOSCO IN BOLOGNA

Giorgia Predari, Angelo Massafra

Abstract

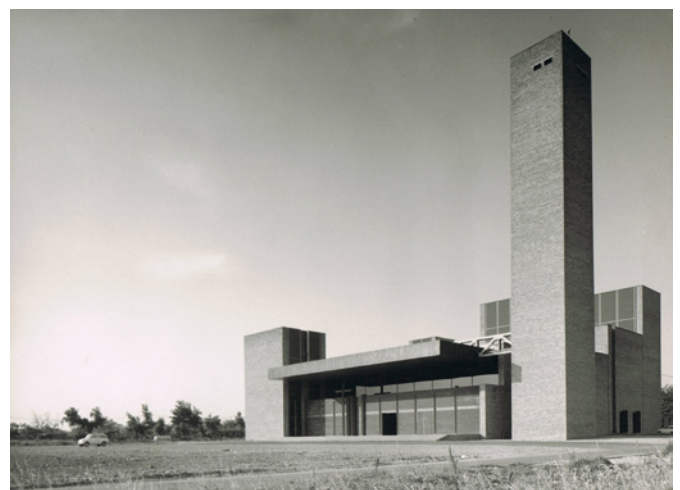
Fig. 4. The church during the last phases of the construction works.

In January 1964, Cardinal Lercaro laid the first stone, and the structure began to reach the ground level in June 1965. First of all, the bell tower around 38 meters high was built, providing support for the roof’s large reticular structures. Then, the pillars and basement walls were erected, and the massive external walls were finally built. The laying of the metal roof trusses began in 1966; then, the works were completed in 1968 (Fig. 4) [8].

The secondary framework is also made of steel lattice beams of the Monier type. They are realized by L-shaped coupled profiles for both the chords and the diagonal members; the vertical members are rectangular section profiles. The upper chord is inclined towards the main façade truss to give a slope to the pitches; the horizontal bracing systems are anchored to it. The connection between the main framework and the secondary one allows a part of the latter to overhang above the churchyard (Fig. 4).

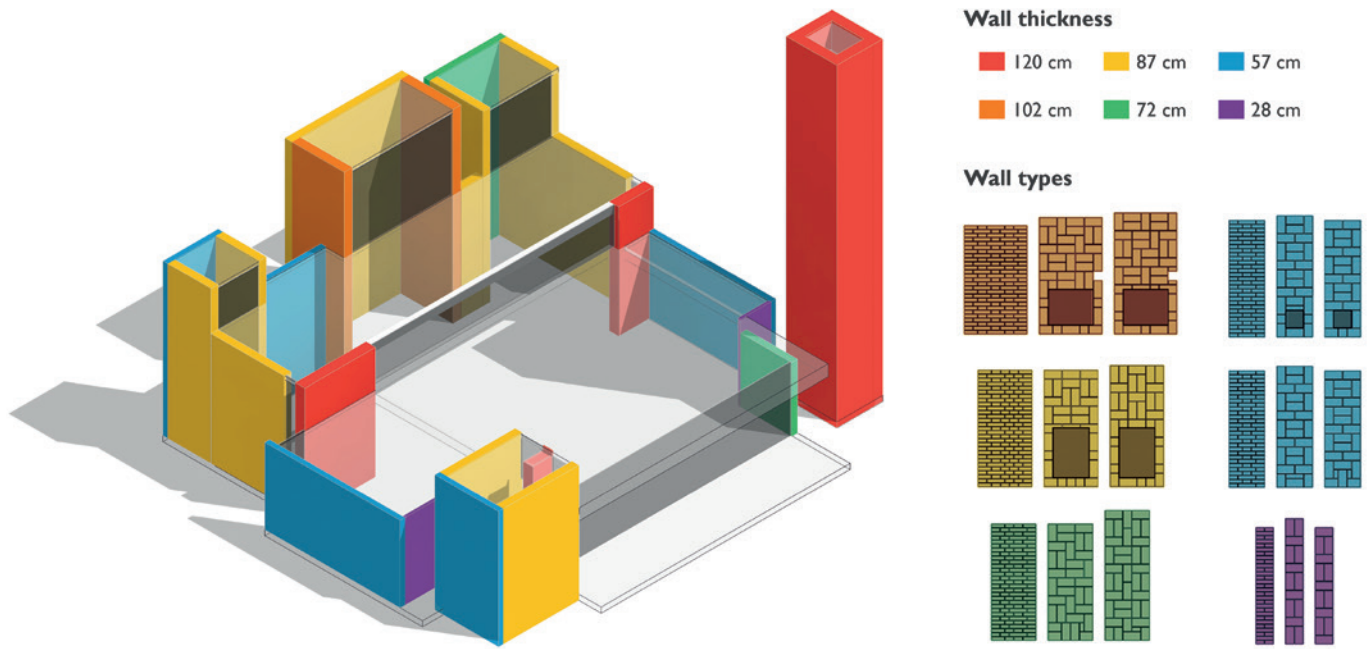
Fig. 5. Identification of wall types.

A specific study on the wall thicknesses identified different stratigraphic solutions concerning the respective

heights (Fig. 5). All the bricks have the typical dimensions of the Bolognese brick, which is 13.5×28.0×5.5 cm, with holes in a percentage lower than 45%, as can be deduced from the site photographs. The wall texture refers to the cross-bond type formed by alternating bricks arranged as headers and stretchers.
