Review

The Importance of Rock Mass Damage in the Kinematics of Landslides

Davide Donati ^{1,*}

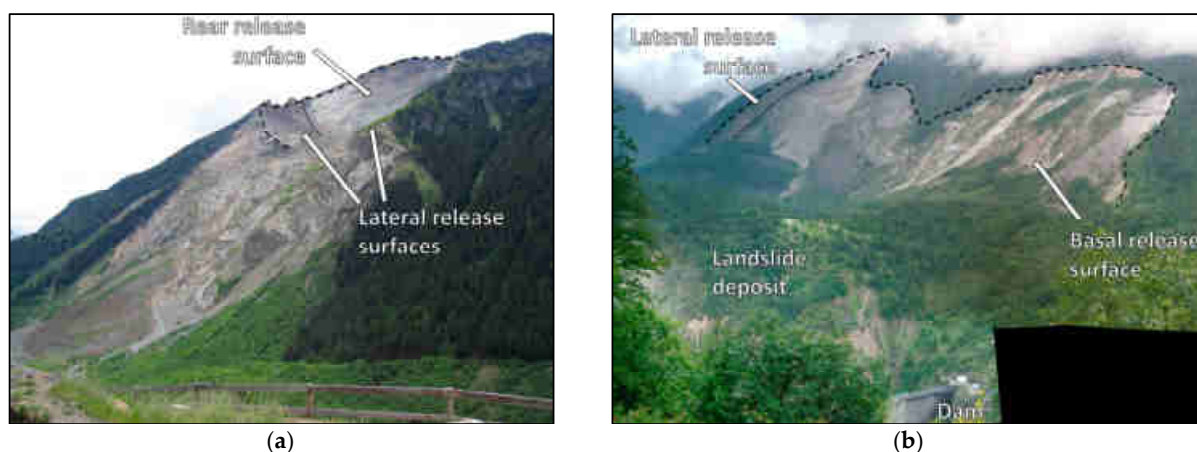
Figure 3. (a) Photograph of the Val Pola landslide from the valley (public domain). Note the rear and lateral release surfaces that formed a wedge-shaped landslide body. The maximum width of the headscarp is approximately 750 m. (b) Photograph of the Vajont Slide from the opposite valley slope. The outcropping bedrock scar forms the high-angle part of the basal release surface. The low-angle part is covered by the deposit. The Col Tramontin Fault forms the lateral release surface (left-hand side of the panorama). In the foreground, the Vajont Dam is visible. The width of the scar is approximately 2000 m.

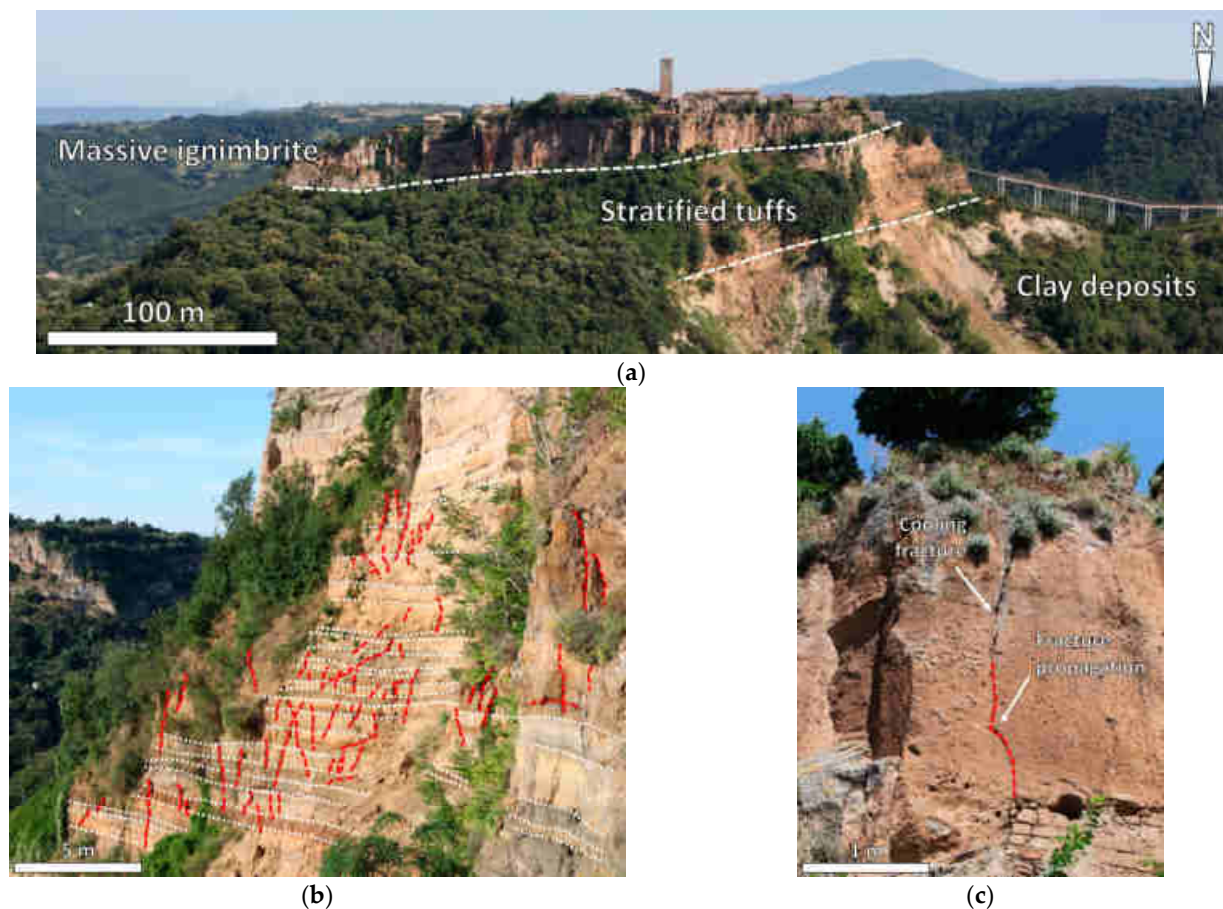
Figure 10. Rock mass and slope damage at Civita di Bagnoregio: (a) View of the volcanic plateau. Note the varying behavior of the materials that characterize the area, particularly the landslide developing in the clayey deposit. White, dashed lines mark the boundaries between the different materials. (b) Slope damage features (dashed red curves) affecting the stratified tuff, inducing a decrease in the overall rock mass quality that, in turn, affects the failure and deformation behavior of the slope. (c) Brittle damage, in the form of a fracture propagation from the tip of a cooling fracture, in the massive ignimbrite.

The San Leo landslide occurred in a litho-geomorphological environment that can be described as resistant-over-recessive (ROR, [144]), in which a strong material (namely, limestones and sandstones forming the San Leo plateau) stratigraphically overlies a softer material (i.e., clay shales) [142]. In such cases, the behavior and deformability of the soft, basal material can significantly impact the deformation behavior (damage) and stability of the more competent layer. Indeed, Spreafico et al. [143] suggested that the accumulation of brittle damage and, ultimately, the failure of the San Leo landslide were partly driven by weathering and softening in the underlying clay-rich materials. The northern Apennines in Italy display several sites with similar geomorphological and lithological characteristics, such as the San Marino Plateau (San Marino), the Pietra di Bismantova Plateau [145], and the Sasso Simone and Simoncello. ROR succession can also occur in significantly different lithologies. The Civita di Bagnoregio Plateau (Italy) consists exclusively of pyroclastic rocks (Figure 10), with thinly stratified tuffs in the lower part, and a massive ignimbrite in the upper part of the plateau, overlying a clay deposit [146]. In this slope, the softening, swelling, and deformations within the basal clayey material cause damage to develop in the overlying volcanic rocks (Figure 10a,b), with the characteristics of the slope damage features varying significantly across the plateau [59]. The stratified tuffs, characterized by a low GSI, display a ubiquitous, rock-mass-controlled accumulation of slope damage that results in roto-translational, soil-like failures. Conversely, within the massive ignimbrite, characterized by high GSI values, brittle slope damage features develop (i.e., fracturing in intact material and propagation of sub-vertical cooling cracks; Figure 10c).

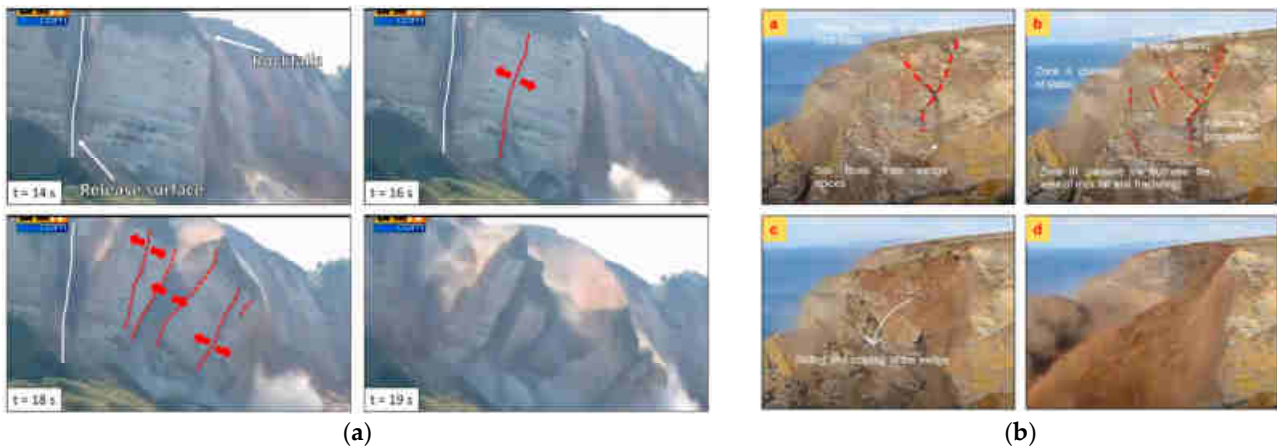
Figure 11. Examples of type 4 slope damage: (a) Frames extracted from an online video of the toppling failure of a sea cliff in France (from <https://www.youtube.com/watch?v=gvSe27Ht-NY>, accessed on 2 December 2022). The white line shows the existing release surface at the rear of the unstable block. Red, dashed lines mark fractures that opened during the displacement of the landslide, which did not affect the detachment or the kinematics of the landslide. At $t = 16$ s, note the rockfalls preceding the detachment of the block, enhancing its kinematic freedom. (b) Frame video analysis showing the development of slope damage during the displacement of a landslide that affected the Hell’s Mouth cliff (Cornwall, UK, from [159]).

Type 4 slope damage includes features that develop after the detachment and during the displacement of the landslide. Therefore, type 4 slope damage produces no significant effect on the pre-failure stability of the slope or the kinematics of the slope, but it plays an important role in landslide runout distance and the post-failure behavior of the landslide body and deposit. The fragmentation and comminution of the landslide body and/or the debris are examples of type 4 slope damage, which can be referred to as “post failure landslide damage”. Figure 11a shows frames extracted from an online video showing type 4 damage features that develop during the failure of landslides. Features such as ridges, scarps, and ripples that can be observed in the landslide deposit (e.g., [10,148,158]) can also be considered examples of type 4 slope damage. The surface slope damage observed at the

Downie Slide and described in [28] developed during the post-glacial displacement of the landslide, and can therefore also be considered an example of type 4 slope damage.

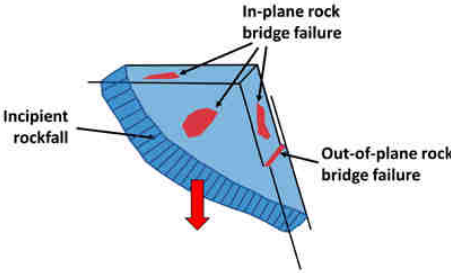
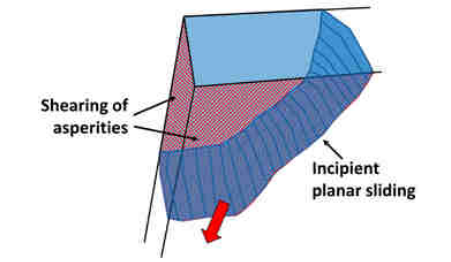
Table 3. Summary of the proposed subdivision of slope damage type, based on the effects on slope stability and kinematics.

Slope Damage Type	Conceptual Examples	Effects on Slope Stability and Kinematics
Type 1	<p data-bbox="453 1357 791 1388">Incipient rockfall (overhanging)</p>

<p data-bbox="890 1608 1445 1749">Slope damage accumulation promotes instability by reducing shear and tensile strength along rupture surface through shearing of asperities and brittle fracturing of in-plane and out-of-plane rock bridges. Limited effect on failure or deformation kinematics.</p>
	<p data-bbox="453 1682 791 1713">Sliding block (non-overhanging)</p>
