Recovering a lost seismic disaster. The destruction of El Castillejo and the discovery of the earliest historic earthquake affecting the Granada region (Spain)

This paper discusses recent archaeological fieldwork conducted at El Castillejo, a medieval Islamic settlement in Los Guájares, Granada, southern Spain. Results from combined archaeological excavation and archaeoseismological assessment of standing structures suggest that the site was affected by a destructive earthquake during its occupation. Radio-carbon samples and OSL analysis point to a seismic event in the period CE 1224–1266. The earthquake occurred within an area marked by a ‘seismological gap’ in terms of historic seismicity and the causative fault has been tentatively identified in the Nigüelas-Padul Fault System which lies north of the settlement. This event is not recorded by national or European seismic catalogues and represents the oldest historic earthquake in the Granada area. Our work stresses the significant impact that targeted archaeological investigations can generate in our understanding of the local historic seismicity, thus providing clear implications for seismic disaster prevention and reduction.

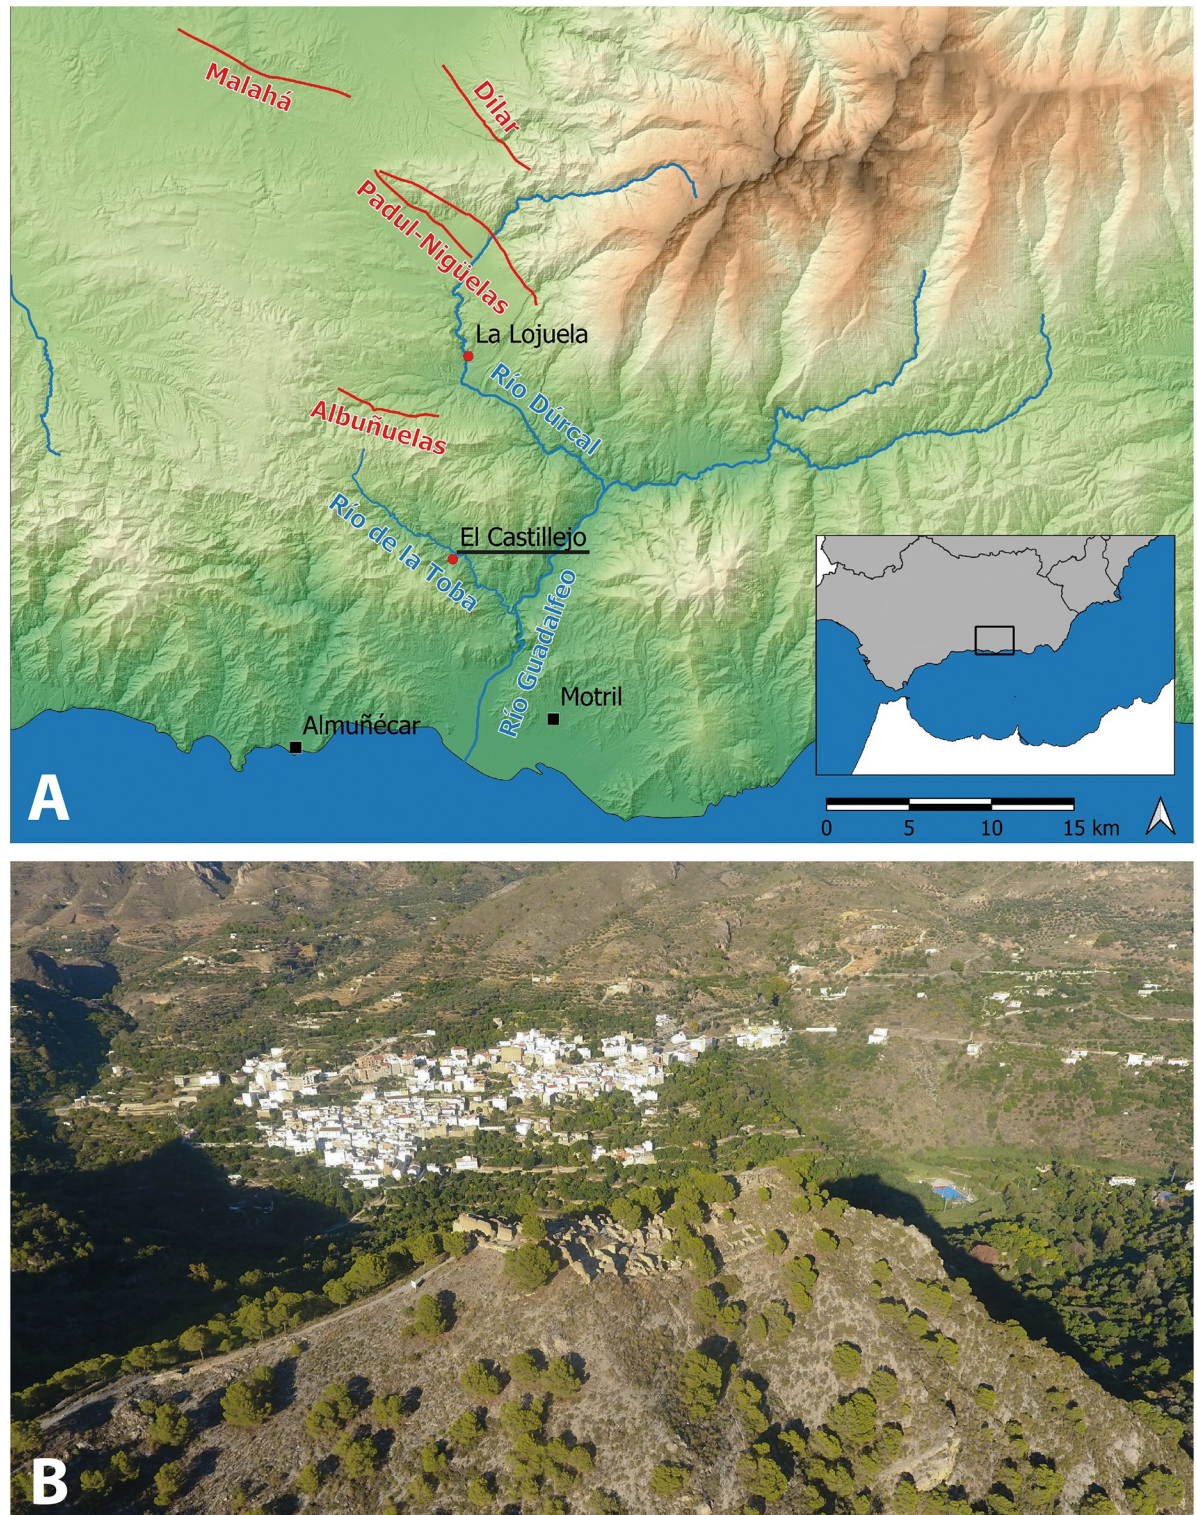
Fig 1. A: Geographical location of El Castillejo (map generated by the authors using QGIS 3.26; Basemap: MDS05 2020 CC-BY 4.0 ign.es; seismic faults from the QAFI database [17]); B: Drone view of the archaeological site from SW. The village of Guájár Faragüt lies in the background. Photograph by P. Forlin.

The site of El Castillejo in the Las Guájaras sierra overlooks the Toba valley in the southernmost sector of the central Betic Cordilleras in southern Spain [14, 15] (Fig 1A). This part of Andalusia is among the most seismically-active areas in Europe and characterised by high energy destructive earthquakes [16–18]. A diffuse plate boundary at the collision zone of the Eurasian and Nubian plates induces mainly shallow earthquakes with a maximum horizontal stress (S_{Hmax}) orientated NW-SE. This stress regime developed after the collision and formation of the Betic Cordilleras in the late Miocene, together with an extension running NE-SW and Neogene basin formation [19–21]. These intra-montane basins are fault-bound and seismically evidenced by frequent micro-earthquake activity [18, 22]. The last major seismic event in the Granada area was the Arenas del Rey earthquake in 1884, which affected 14,000 km² and destroyed a number of settlements, claiming nearly 1,000 lives [23–25]. However, the seismic historic record is rather limited for this region and no earthquakes are recorded before the 15th century [26, 27].

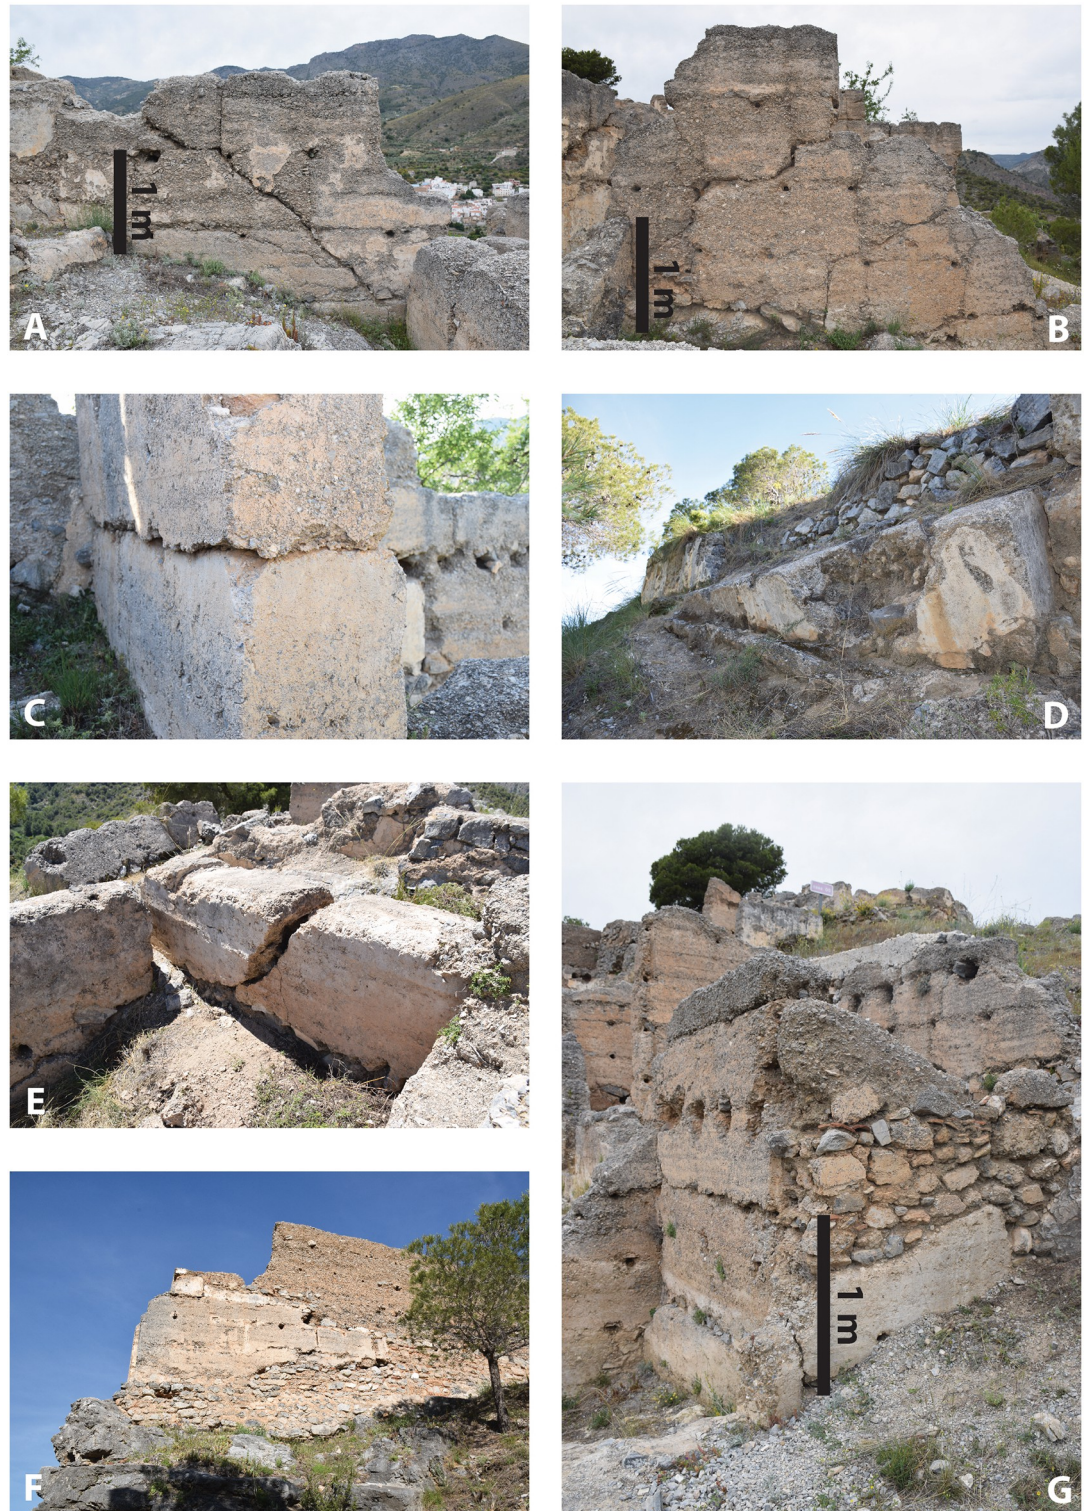
Fig 2. Examples of seismic damage and restoration observed at El Castillojo: A-B: shear cracks in Building 4; C: horizontally-shifted block of rammed earth in Building 3; D: tilted block of the outer wall; E: broken and displaced wall in Building 30; F: post-earthquake restoration of the western gatehouse and G: Building 10. Photographs by P. Forlin.

- **Penetrative fractures.** Horizontal, vertical and shear cracks had passed right through the full width of the rammed earth walls (usually around 45 cm) producing symmetrical fractures on either side. Fractures like these were clustered in the western half of the village where the majority of the standing structures are still preserved today (buildings 0, 2, 3, 4, 5, 6, 7, 8, 10, and 40; see examples in Fig 2A and 2B).

- **Displaced or shifted blocks of walling.** Displacements in which blocks of rammed earth become vertically misaligned were identified in buildings 2, 3 and 4 in the north-east part of the site and measure between 5 and 10 cm (Fig 2C).

- **Tilted walls.** Tilting was observed at the bases of four (partially collapsed) walls in buildings 4, 9 and 10 as well as at the base of the northern outer wall of the settlement (Fig 2D).

- **Fractured and misaligned walls.** Lateral seismic impacts can fracture and then misalign a structure horizontally. This effect was identified in building 30 and possibly along the aqueduct outside the village (examples in Fig 2E).

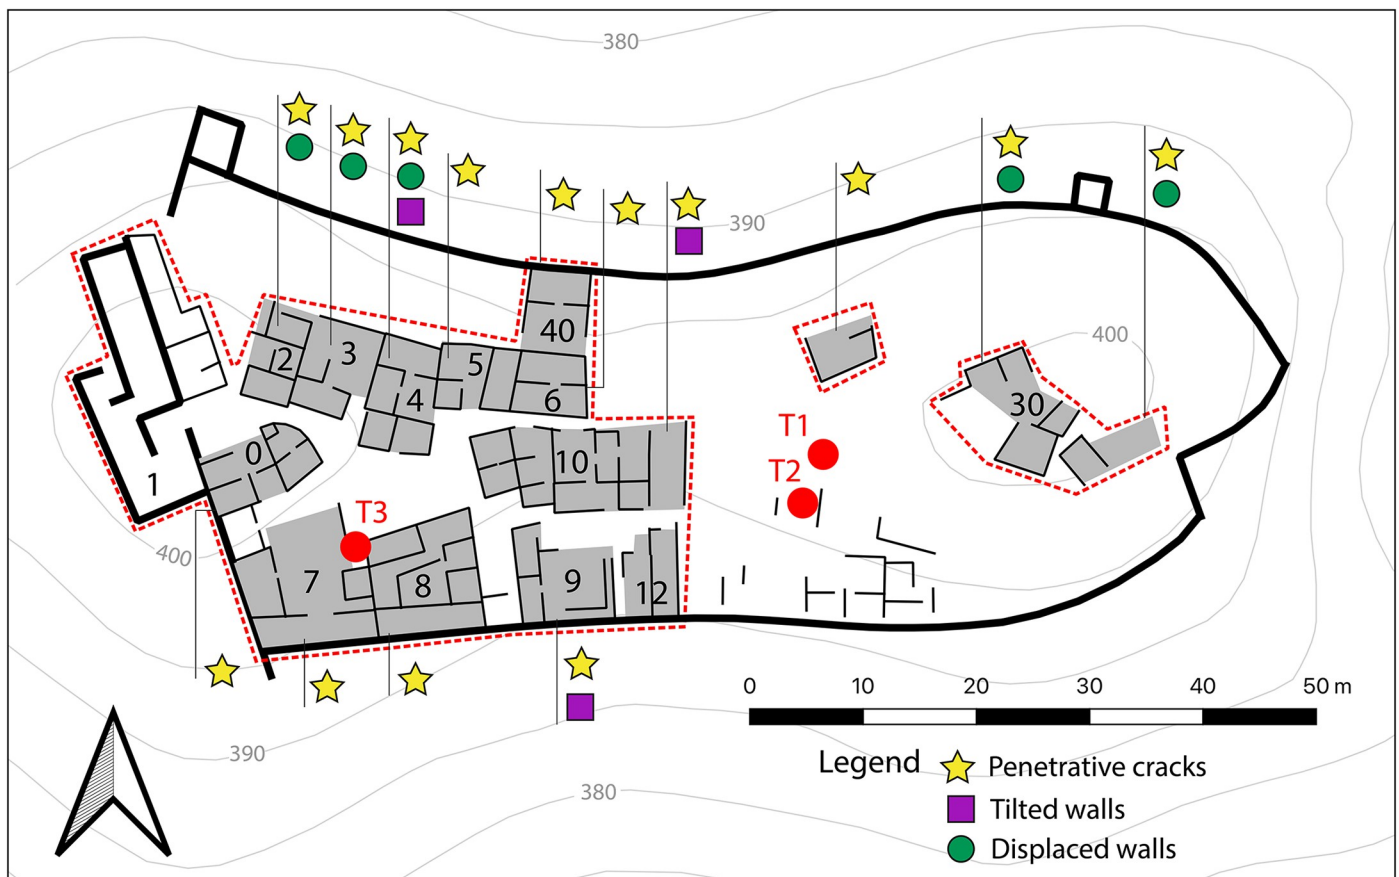
Fig 3. The distribution of structural deformation and damage grouped by buildings (see key for the types of damage). The dot red lines indicate previously excavated areas. Trenches discussed here are shown as red circles (map generated by P. Forlin using QGis 3.26).

Fig 3 is a map of all the structural damage detected at El Castillejo. Notably, structural damage is exclusively observed on first phase structures and absent on second phase structures which, as we have already noted, also reused construction materials from older damaged buildings (see for instance Fig 2F and 2G). In itself, this strongly suggests that a destructive event

Four trenches were excavated, of which three are discussed below (Fig 3 for location).

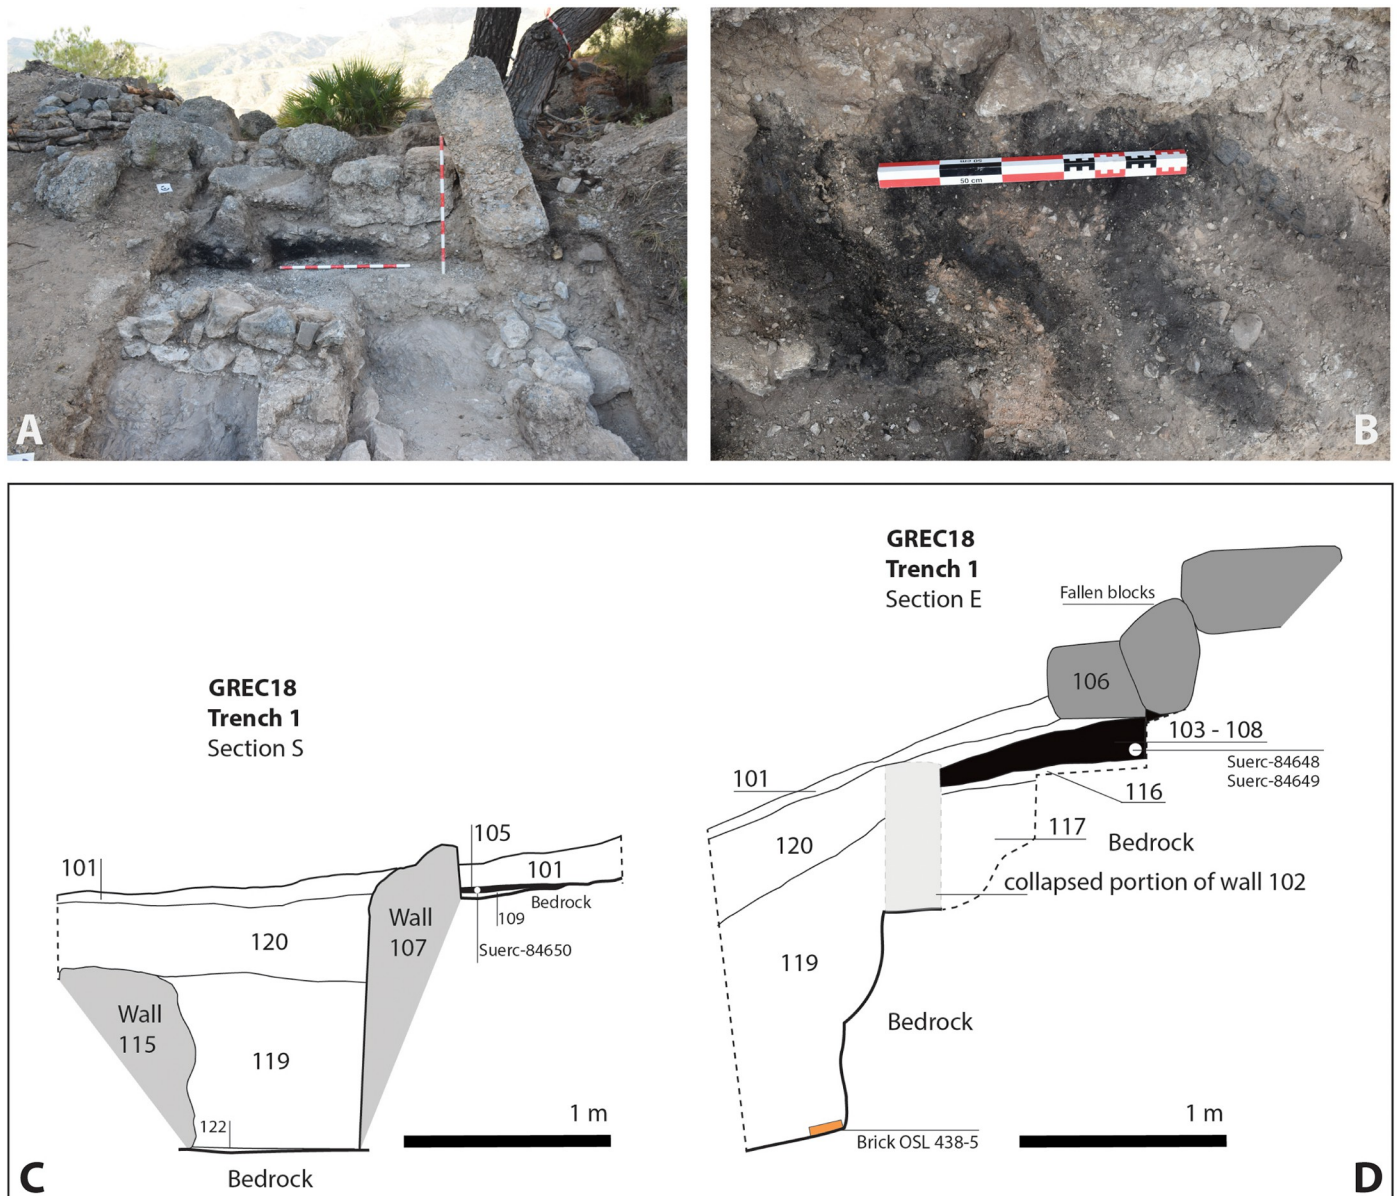
Fig 4. A: Trench 1 under excavation. Note the burning layers 103–108 sealed by debris and rubble 106 and 120; B: Close-up of the in situ carbonised beams; C: Stratigraphic section S; D: Stratigraphic section E.

Trench 1 (2x3m) was located at the centre of the site where a tilted wall and a number of rammed earth blocks were visible at the surface (Fig 4). The excavation identified the eastern limit of a building (tilted wall 115, aligned N-S) with an internal room (probably a patio) delimited by two perpendicular walls, 102 (E-W) and 107 (N-S). Parallel N-S walls 107 and 115 probably define a narrow corridor, wall 107 having chevrons incised on its eastern plaster face. Wall 102 served as a retaining wall for a terraced area which had been levelled with gravel and schist clasts (117). Taken together, these features correspond to the construction and occupation of a building which had been terraced into the hillside by modifying the original profile of the bedrock (118). The occupation surfaces of this (probably domestic) building consisted of a coarse gravel layer 116 (sitting on 117 north of wall 102) and two plaster floors. These sat directly on the bedrock in the southwestern (109) and southeastern quadrants (122) of the trench.

In-situ layers of burning (103 and 108) were discovered both north and south of the wall delimiting the possible internal patio. Four parallel beams had burnt *in situ* and, within the internal room, the burning layer (105) was intermixed with roof tiles, quantities of nails, worked iron and copper artefacts possibly derived from a wooden box or chest. These areas of *in situ* burning, along with the internal walls 102 and 107, were all found to be sealed by substantial blocks of fallen wall (106) and smaller fragments of loose, decayed rammed earth (101, 110, 119, 120). Given that this clay lump debris was reddened through contact with the burnt timbers, it can be inferred that the fire and the collapse of the building were a single contemporary event. The soil horizon above (101) indicates that this part of the site was subsequently abandoned.

3.4.3. OSL dating. OSL dating results are reported in Table 2. One brick (sample 438–5) recovered from the surface sealed by layer 119 in Trench 1 (Fig 4) produced an OSL date of CE

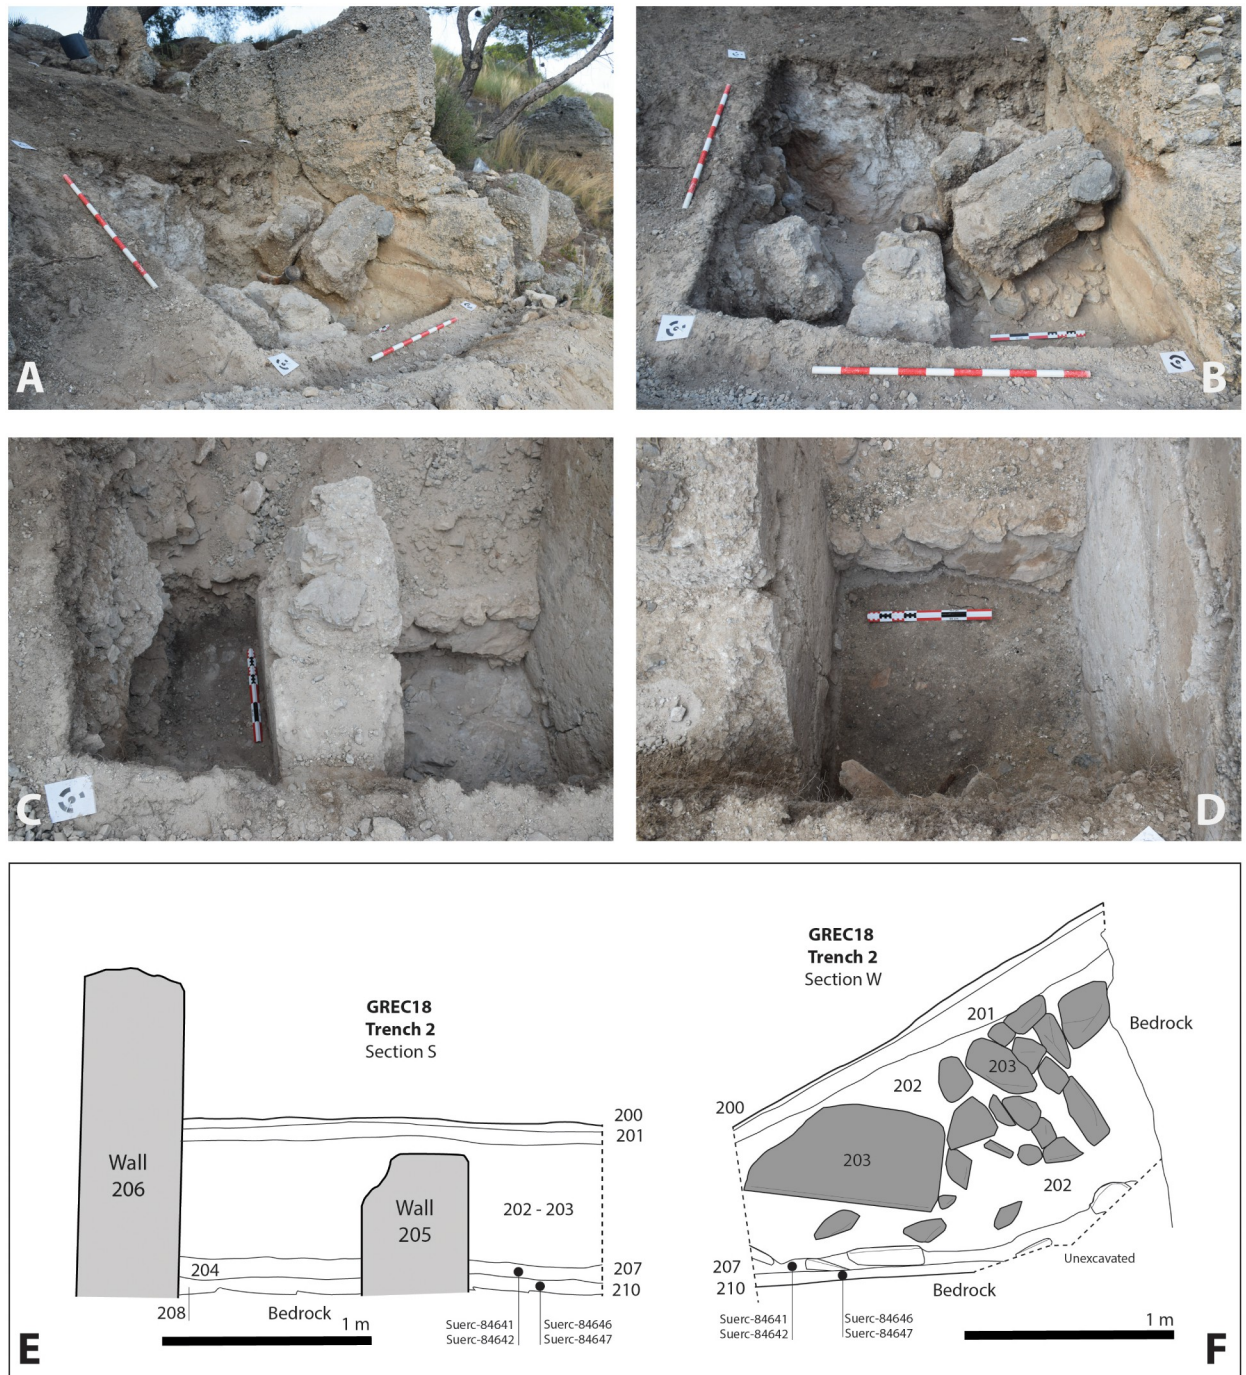
Fig 5. A: Trench 2 under excavation looking NE. Note wall 206 showing penetrative fractures associated with fallen blocks of rammed earth; B: Close up of debris and fallen blocks 202 and 203; C: the occupation surface 208 looking north; D: the occupation surface 210 looking north; E: Stratigraphic section S; F: Stratigraphic section W.

Trench 2 (2x2m) flanked an almost completely buried standing wall about 8 m downhill to the south (Fig 5). The earliest occupation here also corresponded with the construction and occupation of a rammed earth building. The building's external N-S wall (206) was the eastern limit of the trench, but an internal N-S wall (205) was also identified, together with an internal mortar floor (211) which had been laid onto a stepped surface running uphill towards Trench 1. The internal wall (205) divided two compacted occupation surfaces (208 to the east; 210 to the west) with pottery sherds lying directly on the bedrock (209).

A rapid onset event had also led to the collapse of this building. Occupation surfaces 208 and 210 were sealed by broken slabs of rammed earth (204/207), interpreted as the remains of smashed walling. Both 204 and 207 contained *in-situ* broken pottery and broken roof tile. The interior of the building was completely infilled by large blocks of rammed earth mixed at higher levels with a thick layer of decayed and loose rammed earth (202). Voids between the fallen blocks of walling had allowed finer crumbs of sediment to percolate downwards, probably derived from the decay of the rammed earth at higher levels which had filtered down through empty spaces over time. Finally, a colluvium of loose and degraded rammed earth (201) and topsoil (200) covered this part of the site and represents the subsequent abandonment of the area.

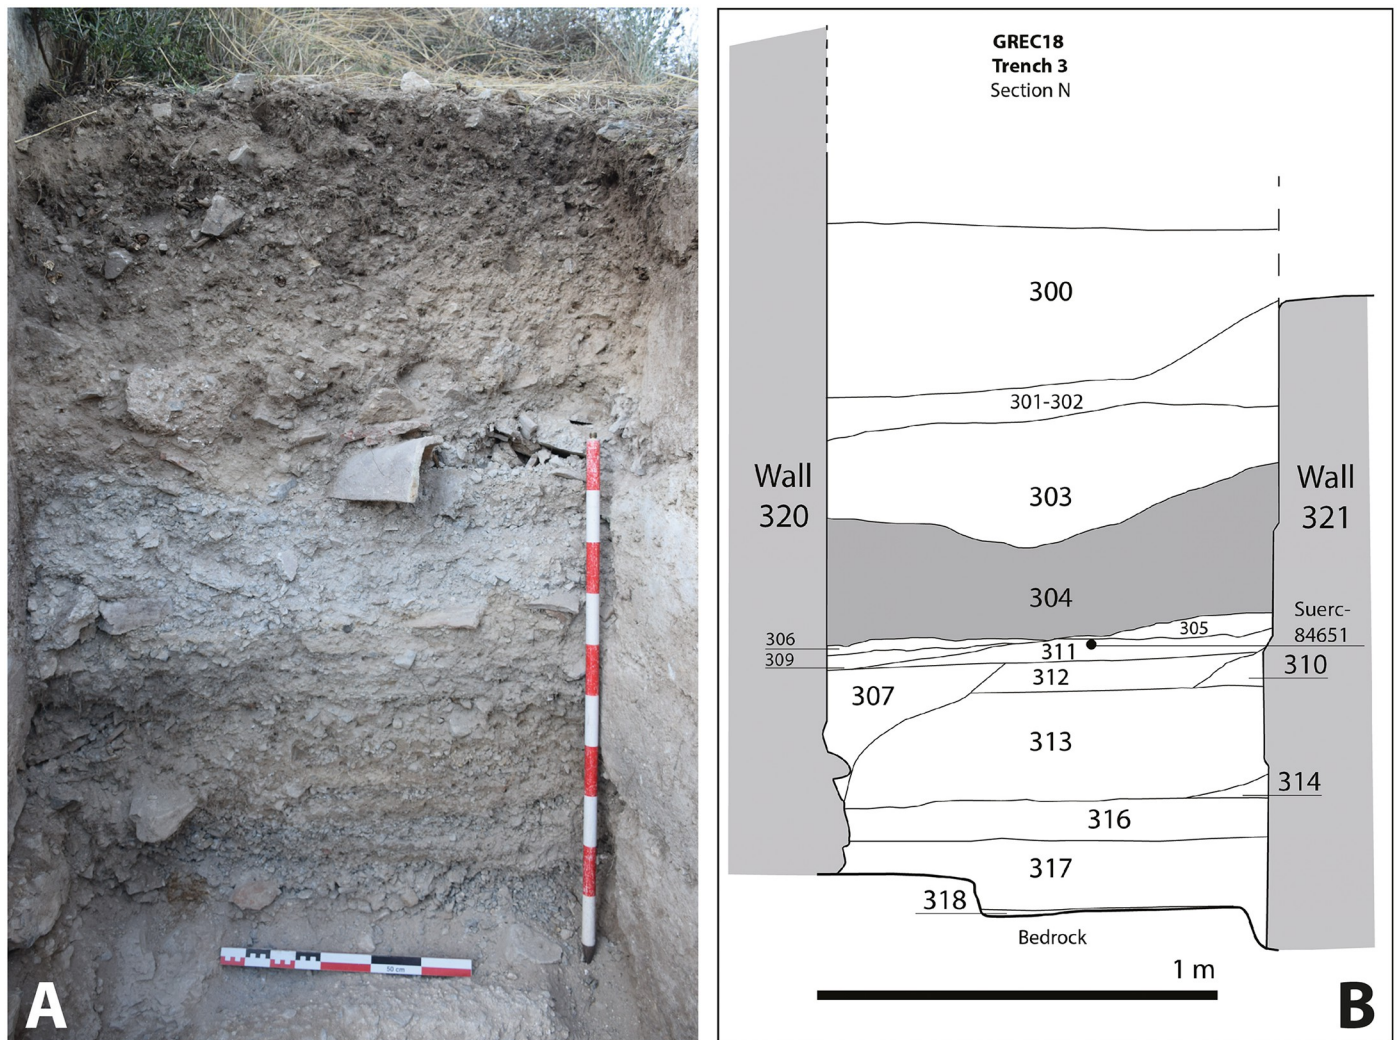
Fig 6. A: Trench 3 looking N; B: Stratigraphic section. 304 corresponds with the rammed earth block and loose horizon.

Trench 3 corresponded to an exposed section in the external space flanked by building 7 to the west and building 8 to the east (Fig 6; see Fig 3 for location). The section shows an original plaster floor at the base which was later re-surfaced with schist gravel (318). In this case, a thick deposition of laminated sediments lay above the gravel surface (316, 313). These were interpreted as gravitational run-off deposits in an area which had not been maintained. A small triangular wedge of degraded *tapia* (314), possibly due to the erosion (weathering) of wall 321, was recorded in 313. At the top of this sequence, a possible stasis in the formation process of the laminated sequence is represented by 312 and 311, two dark organic layers which might be occupation surfaces. In a further phase, the eastern wall of building 7 (320) was built. The upper part of the sequence described above is cut by its foundation trench 308 and filled by 307. A possible occupation surface (305 = 306) developed in association with this wall.

Surface 305–306 was completely covered by a thick layer of debris including substantial rammed earth blocks and loose, decayed rammed earth (304). Layer 303 above contained a cluster of large fragments of roof tile and some rammed earth rubble with a developing soil horizon in the upper part of the section. The abandonment of this site's sector is indicated by a thick layer of colluvium (302, lower part; 301, upper part) and topsoil (300).

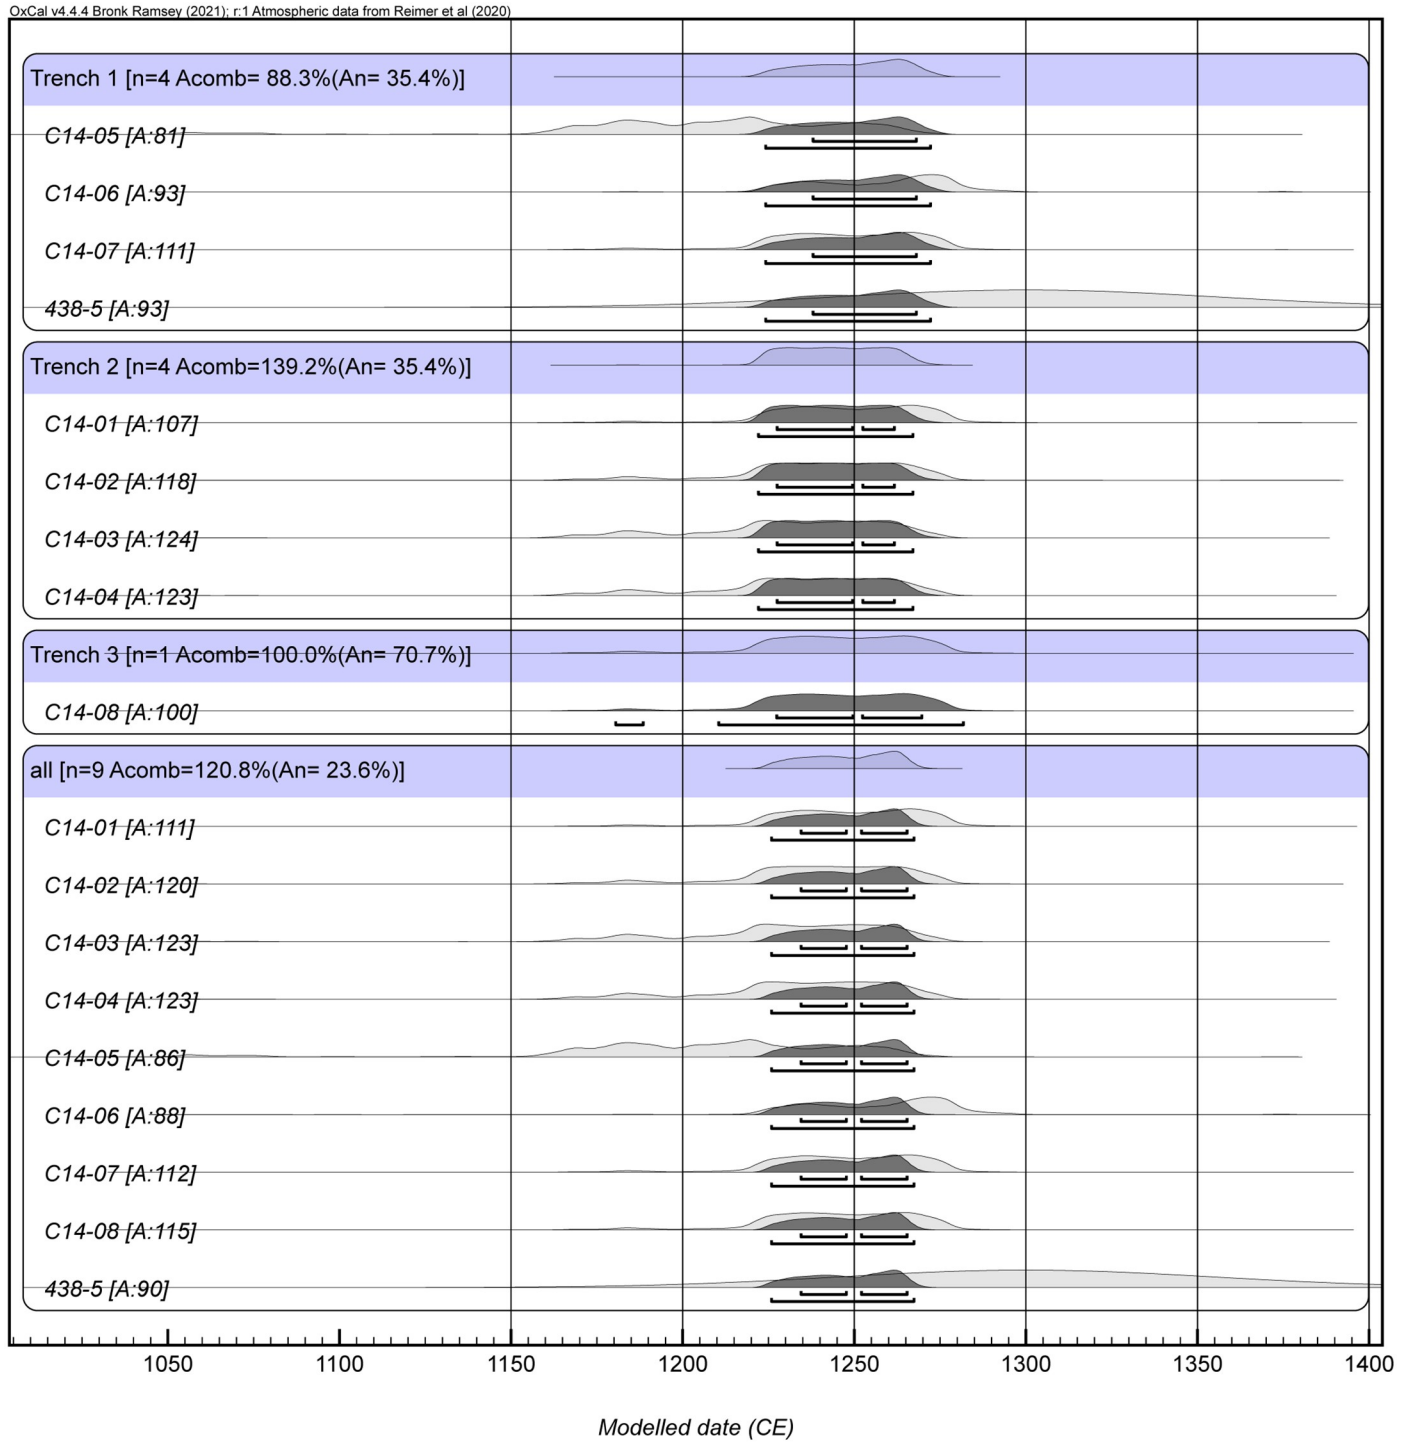
Fig 7. Plot of the radiocarbon dates obtained from the analysed samples (image by G. Capuzzo).

(see sections in Figs 4–6 for the stratigraphic position of the selected samples). This organic material, which was found on the occupation surfaces, had either been charred in the fire which followed the destructive event (in Trench 1: contexts 105 and 108) or had been deposited immediately beforehand (Trench 2: contexts 207 and 210; Trench 3: context 3011). The individual dates obtained consistently point to an event in the 13th century CE. As they relate to the same stratigraphic event, they can be combined to produce a more precise calendar age estimate. All calculations were performed in OxCal 4.4.4 and using IntCal20. Dates were combined separately for each trench and as a single dataset (Table 1; Fig 7). The results show no differences between the trenches and indicate a date for the earthquake within a time interval of ca. 40 years between CE 1224–1266 at 95.4% probability. Radiocarbon dating extracted from the sealed surfaces thereby provides an entirely consistent chronology for the destruction of the site.

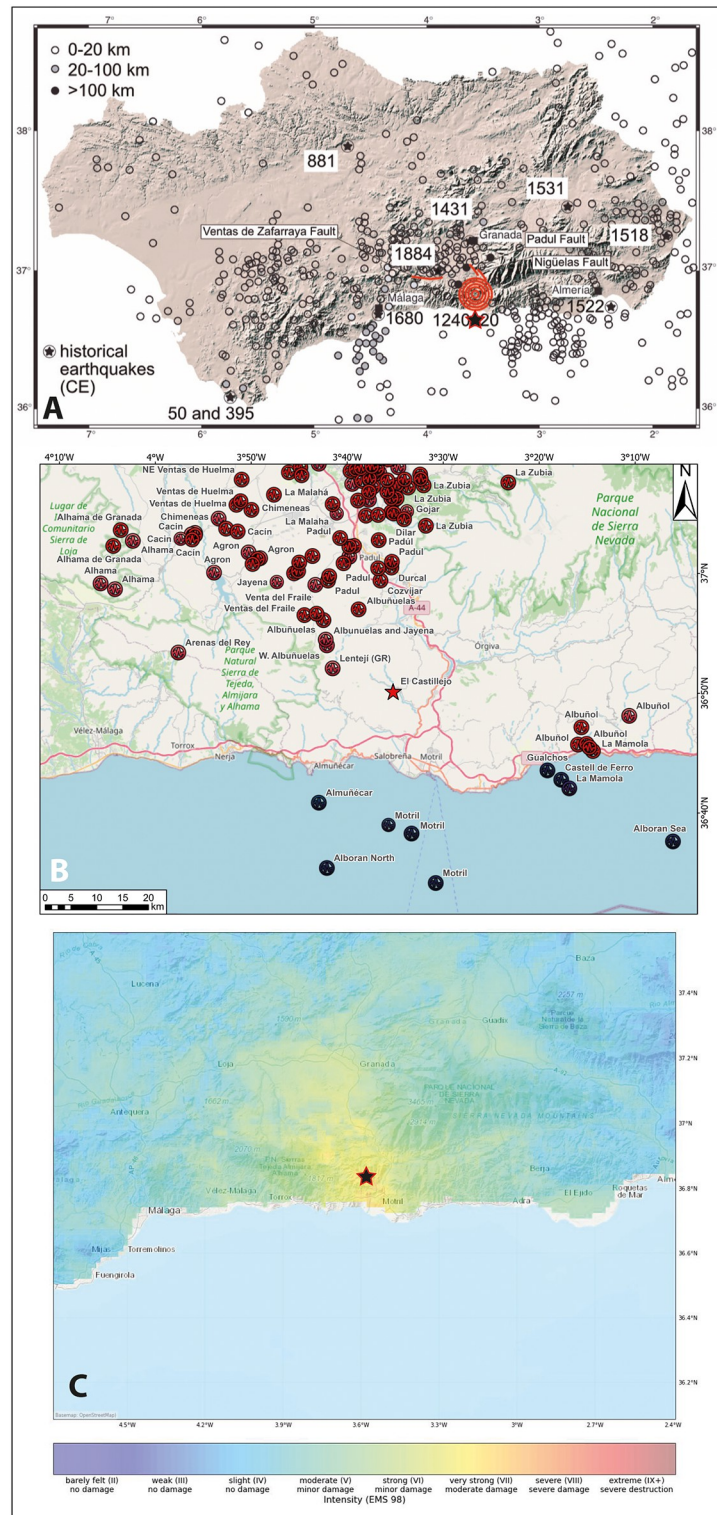
Fig 8. A: Seismicity in Andalusia, the red area shows the archaeological site at El Castillejo, the red lines are possible active faults in the vicinity (generated by K. Reicherter using QGIS 3.26; Basemap: MDT200 2015 CC-BY 4.0 ign.es; historical earthquakes from [23], faults from the QAFI database [17]) B: recent earthquakes around El Castillejo (star) (K. Reicherter’s own compilation; Basemap Open Street Map); C: Palaeo-shake map modelled for the missing El Castillejo earthquake, based on M6 and 10 km hypocentral depth [35] (generated using the ShakeMap map code by Jens Skapski; Basemap Open Street Map [<http://usgs.github.io/shakemap/index.html>]).

The broad collision zone of the Eurasian and Nubian tectonic plates in southern Spain and especially Andalusia accommodates a NW-SE convergence of up to c.5 mm/year [64]. El Castillejo lies in the metamorphic Internal Zone of the Betic Cordilleras (see summary in Weijermars [65]), mainly consisting of marbles and schists which are mostly stable for construction purposes. Recent seismicity concentrates to the north in the Miocene post-orogenic Granada Basin and its bounding normal faults and to the west of El Castillejo along the boundary of the Internal and External Zones of the Betics [66, 67]. This is where seismicity has been documented historically, for example on 24 April 1431 at Atarfe near Granada or on 25 December 1884 in Zafarraya/Arenas del Rey [22, 68]. Both these earthquakes reached macroseismic intensities of VIII-IX (EMS), corresponding to magnitudes M_S of 6.5 ± 0.2 . Other reported historical events are smaller, the Albolote earthquake April 19 1956 and the Jayena earthquake June 24, 1984 reached M_5 (EMS V-VII; [69]), at the threshold of causing physical damage in urban environments and sparsely settled areas. We suggest that three active tectonic faults are capable of generating the damage observed at El Castillejo [17]. The first candidate is the Ventas de Zafarraya Fault which has ruptured three times in the last c. 9,000 years with earthquakes significantly higher than M_6 , the last occasion being in 1884. With a length of c.15 km, this fault could be responsible for earthquakes up to $M_{6.7} \pm 0.3$. However, the penultimate event occurred c.2,315 \pm 30 years BP [23]. A second candidate is the Nigüelas (7 km long) and Padul Faults (8 km long; Gil et al. [70]), both of which could generate earthquakes of magnitude $M_{6.0-6.3} \pm 0.3$ [16]. If both of these faults were to rupture at the same time, which is possible [70], an earthquake of magnitude $M_{6.2} \pm 0.5$ is likely. Other possible faults in the area and within the Granada depression are the Dílar Fault, which parallels the Padul Fault, but if this fault is mapped correctly, it seems too short to generate a $M_{6.5}$ earthquake, and the longer La Mahalá Fault (15 km long), where a surface rupture displaced c. 887 \pm 48 years BP old deposits. Given that both have identical strikes, one hypothesis is that the La Mahalá Fault may connect to the Padul Fault and so form a much longer fault [71]. A fourth fault (the Albuñelas Fault) was excluded as it is too short (6.5 km max.) and no earthquake activity is noted in the QAFI database [17].

While El Castillejo lies in what might be described as a ‘seismic gap’ within the wider region of the Granada Basin and Internal Betic Cordilleras [22] (Fig 8C), it also sits in something of an historical ‘black hole’. Geographically, its location on the western outreaches of the Sierra de Tejada is remote and isolated. When the Christian kingdom of Castile occupied the Guadalquivir valley, conquering Córdoba (1236), Jaén (1246) and Sevilla (1248) during the 13th century, El Castillejo remained under the authority of a new Islamic dynasty, the Nasrids, whose emirate in Granada would endure until 1492. The paucity of written records for this period is due both to the less systematic conservation of documentary sources under the Nasrids [73] and later archival catastrophes perpetuated by the new Christian rulers: thousands of Arabic manuscripts were publicly destroyed in the Plaza Bib-Rambla in Granada at the end of the 15th century and many accounts of earthquakes and other natural disasters were presumably lost at that time [74, 75]. By contrast, from a region under Christian authority, letters of financial support survive in the Alicante area in the aftermath of the CE 1258 Onteniente earthquake [23, 76]. For geographical, geopolitical and historical reasons any written testimony of the El Castillejo earthquake was probably lost, if indeed it was ever produced in the first place.
