# Characterization of the Fels Landslide (Alaska) Using Combined Terrestrial, Aerial, and Satellite Remote Sensing Data

Davide Donati <sup>1,2,\*</sup> , Doug Stead <sup>2</sup>, Bernhard Rabus <sup>3</sup>, Jeanine Engelbrecht <sup>4,5</sup>, John J. Clague <sup>2</sup> , Stephen D. Newman <sup>6</sup> and Mirko Francioni <sup>7</sup>

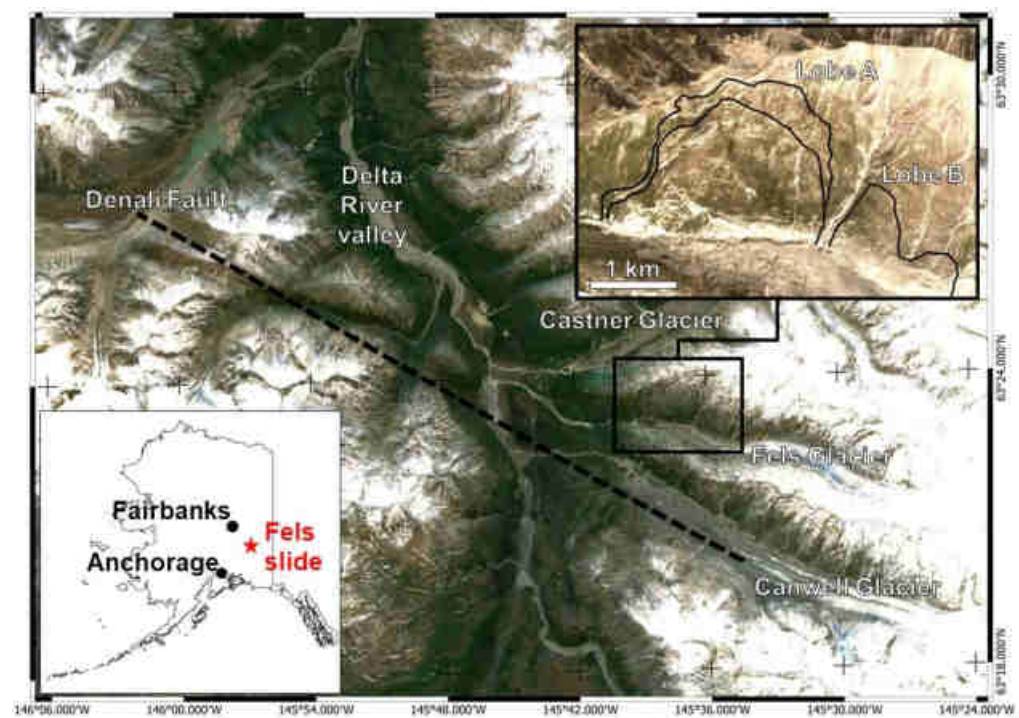
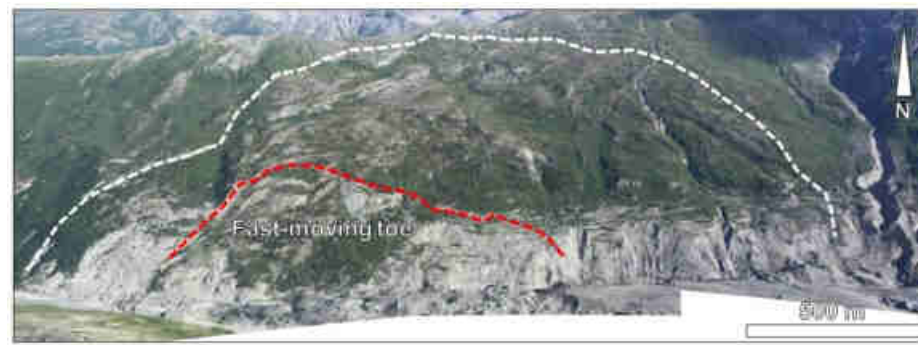
**Figure 1.** Overview of the Fels landslide. (a) Satellite view of the intersection of the Delta River and Castner, Fels, and Canwell valleys (Copernicus–Sentinel 2 imagery). The black dashed line marks the trace of the Denali Fault. The insets show the location of the Fels landslide in Alaska and a satellite view of the landslide area [41]. Black curved lines in the upper right inset delineate the areas of “Lobe A” (i.e., the Fels landslide) and “Lobe B” where deformation has also been detected. The upper part of Lobe A, characterized by significantly lower deformation rates, is also outlined. (b) Frontal view of the landslide from the crest of the ridge on the south side of Fels Glacier valley. The white dashed line marks the boundary of the inferred unstable area, and the red dotted line delineates the upslope boundary of its fast-moving toe. Note the absence of a well-defined landslide headscarp.

The Denali Fault is an active, right-lateral strike-slip fault that follows the Canwell Glacier valley south of the Fels Glacier valley (Figure 1a). An  $M_W$  7.9 earthquake occurred on this fault on 3 November 2002, accompanied by up to 5.3 m of right-lateral slip, as estimated within nearby Delta River valley [36,37], and hundreds of rock avalanches, rockslides, rotational slides, and debris avalanches within the epicentral area [38,39]. The area of the landslide was also affected by ground shaking during the 1964  $M_W$  9.2 Good Friday earthquake, which had a source beneath Prince Williams Sound about 320 km to the WSW. In this case, the ground motions were considerably attenuated over a large distance from the earthquake source [40].

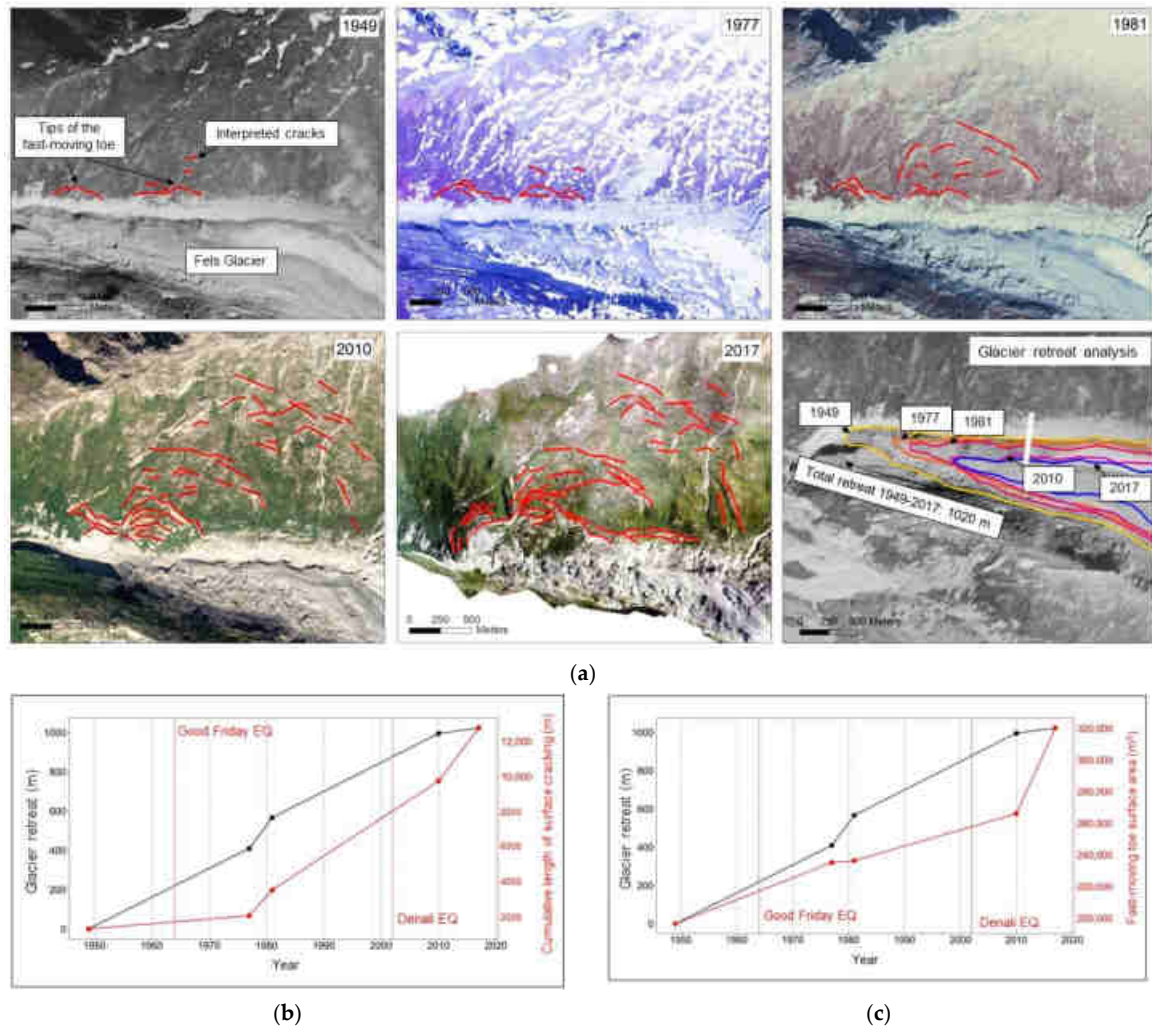
**Figure 3.** Summary of historical analysis of Fels Glacier and the deforming slope bordering its toe. (a) Progressive growth of surface slope damage features (solid red lines) mapped on historical air photographs. The tab in the lower left corner provides a summary of the progressive retreat of the toe of Fels Glacier based on historical air photographs. The elevation of the slope–ice interface was sampled at the location of the white line. (b,c) Plots showing changes in, respectively, cumulative crack length and surface area of the fast-moving landslide toe and glacier ice surface elevation over time.

The analysis of historical air photographs and satellite imagery revealed a significant increase in the cumulative length of surface cracks over time (Table 1). Surface cracks were visible near the toe of the slope in the 1949 air photograph, indicating that the landslide

has been active since before 1949 (Figure 3a). Between 1949 and 1977, cumulative surface cracking in the landslide area increased from about 1300 m to 2100 m, from which an average increase of surface cracking length of 75 m/year was derived. The cumulative length of the surface cracking increased to 3550 m by 1981, 9750 m by 2010, and 12,760 m by 2017 (Figure 3a,b), corresponding to increases in surface crack length of 890 m/year, 340 m/year, and 1800 m/year for the time windows 1977–1981, 1981–2010, and 2010–2017, respectively (Figure 3b).

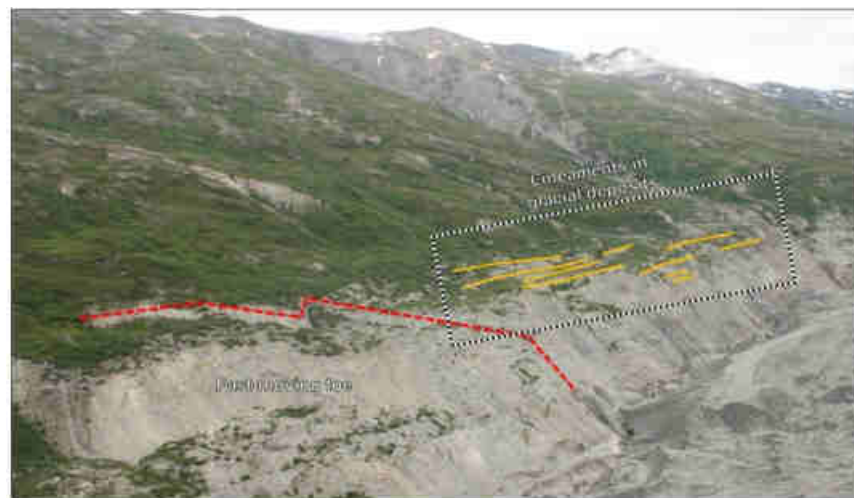
**Figure 5.** Results of lineament analysis. (a) Lineament map showing the mapped features, which are color-coded based on orientation. The dotted black lines delineate the approximate upslope boundary of the landslide and, below it, the internal boundary, below which higher displacement rates are observed. The red dashed line marks the boundary of the fast-moving toe. Trend III lineaments on the east part of the lower slope are likely controlled by surface deformation of Little Ice Age glacial deposits. The change in orientation of the valley axis is also highlighted by the dash-dotted black line. (b) Oblique view of the trend III lineaments in glacial deposits on the lower slope, which are independent of geological structures.

Persistent linear features (i.e., length > 500 m) on the failing slope reflect a significant structural control on their location and orientation. A NE-SW-oriented, sub-vertical scarp with a length of about 800 m and a height of about 10 m crosses the slope between 1240 and 1400 m a.s.l. (II in Figure 4). Just west of this feature is another structurally controlled geomorphic step (III in Figure 4) with a similar orientation and length but a significantly lower dip angle, possibly due to erosion at the crest and deposition at the base of the slope. It likely is older than the sub-vertical scarp, below which a two- to three-fold increase in deformation rates in the SAR ST dataset is observed (see Section 4.3). The trend of these features is similar to that of the prominent gully on the east side of the landslide (IV in Figure 4), suggesting that the gully's location may also be controlled by bedrock discontinuities. The Fels Glacier flows in an ESE-WNW direction past the landslide area. However, to the east, outside the landslide area but near the gully, the glacier flows in a SE-NW direction, about 20° different from the downvalley flow direction. This change in the orientation of the valley axis is likely controlled by geological structure (Figure 5a).

Lineaments were placed on the GIS thematic maps to further highlight the potential correlation between geomorphic features and structural geology. Rosette diagrams illustrating the mapped lineament orientations define three major trends (Figure 5a), which are referred to as trends I, II, and III based on the relative number of lineaments mapped. Trend I includes lineaments with a SW-NE orientation, parallel to the geomorphic steps (II and III in Figure 4) and the gully that marks the east boundary of the landslide (IV in Figure 4). Trend II comprises lineaments oriented in an NNW-SSE direction parallel to the east landslide boundary. Trend III comprises lineaments with an ENE-WSW orientation, which is sub-parallel to the orientation of the Denali Fault and the rear boundary of the landslide area. The orientation of the valley axis east of the gully also correlates with trend III and aligns with the rear boundary of the wedge-shaped, fast-moving toe, further supporting the control exerted by the geological structure on the evolution of the valley and landslide (Figure 5a). However, on the east part of the lower slope, features similar in orientation to trend III occur in glacial deposits. Lineaments in this area represent lateral moraines rather than geological structures. Similar results were reported by [32], who identified three prominent lineament trends oriented NNE-SSW, NE-SW, and E-W, in good agreement with trends I, II, and III of our study.

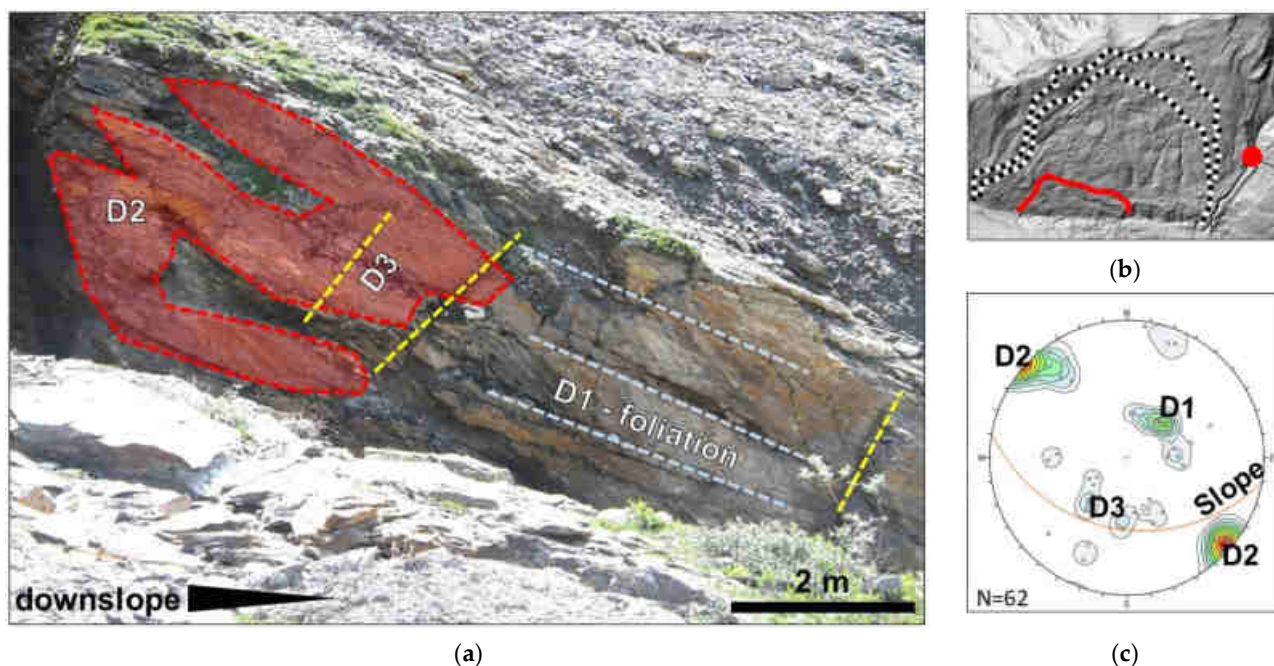
**Figure 7.** Outcrop-scale analysis. (a) Close-up view of the investigated outcrop, highlighting the discontinuity sets identified during discontinuity mapping. Note the slope-parallel bedrock foliation (D1); discontinuity set D2, which is sub-parallel to the outcrop; and discontinuity set D3, which is sub-perpendicular to both D1 and D2. (b) Hillshade map of the slope showing the location of the investigated outcrop (red dot), which is outside the slide area. Black and white line mark the boundary of the landslide. Red line marks the boundary of the fast-moving toe. (c) Stereonet (lower hemisphere, equal angle) showing the results of the discontinuity mapping.

The bedrock outcrop that was surveyed is located at an elevation of about 1450 m a.s.l. on the east wall of the gully on the east side of the slide area (Figure 4a). The orientation and persistence of the discontinuities obtained by processing the point cloud in CloudCompare are plotted in the stereonet shown in Figure 7. The rock mass discontinuities can be placed into three main sets that are sub-perpendicular to each other and are referred to as D1, D2, and D3. D1 discontinuities are foliation planes. They are characterized by an average mapped persistence of 8 m and an orientation of  $36^\circ/228^\circ$  (hereafter, all orientations are expressed using a dip/dip direction convention), sub-parallel to the slope surface. D2 discontinuities have an average persistence of 5.7 m and are characterized by a sub-vertical orientation of  $87^\circ/135^\circ$ , sub-parallel to the gully and the outcrop surface. D3 discontinuities, with an average persistence of 4 m, dip into the slope with an orientation of  $44^\circ/19^\circ$ , sub-perpendicular to the slope surface. However, the orientation of this discontinuity set, combined with the low height of the outcrop (6–7 m), results in censoring [62] that is difficult to estimate and correct.

The results from the remote sensing outcrop-scale analysis display some agreement with field data reported by [32], including an average foliation orientation of  $27^\circ/207^\circ$  and a sub-vertical northwest-dipping set (referred to as J1) that correlates with D2 in this study. Reference [32] also reported two minor sub-vertical north- and northeast-dipping discontinuity sets in the west part of the landslide area; however, we did not observe them in the investigated outcrop. The observed differences are likely due to the greater number of localities investigated by [32], both within and outside the landslide area. In this study, only rock outcrops outside the slide area were investigated.

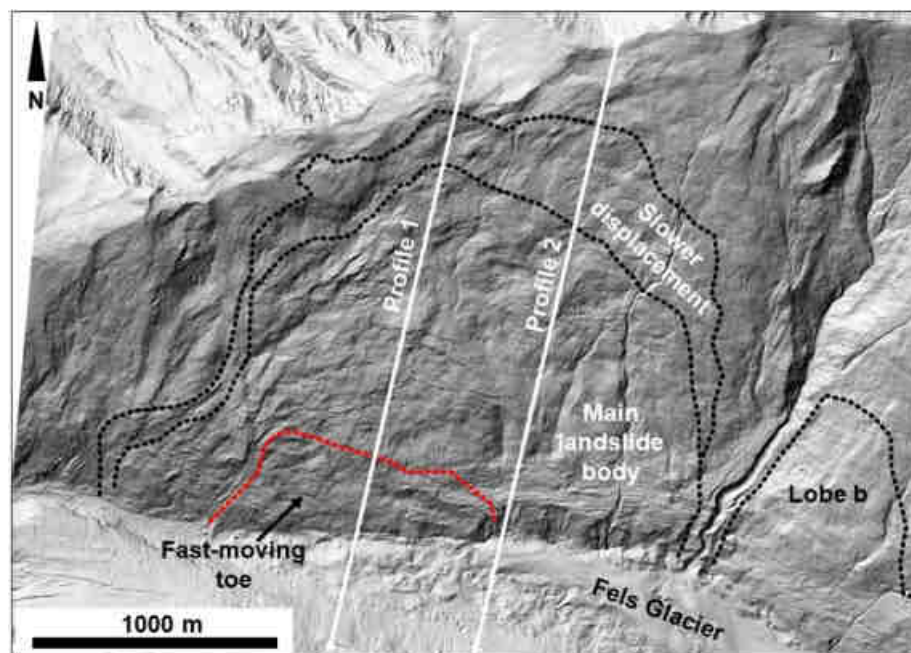
**Figure 12.** Locations of profiles 1 and 2. The boundaries of the entire landslide, the fast-moving toe, and the part of the landslide where the greatest displacements occur are shown.

Two longitudinal profiles were constructed down the steepest portion of the slope and parallel to the dip of the rock foliation (Figure 12). Both profiles extend across the entire body of the landslide, including the fast-moving toe. Analysis of profile 1 shows the increase in slope deformation in the 2015–2020 time window relative to the 2010–2015 period (Figure 13a). The increase in displacement begins near the upper boundary of the landslide, which, in this case, does not correlate with any obvious geomorphic feature and is maintained across the entire profile.

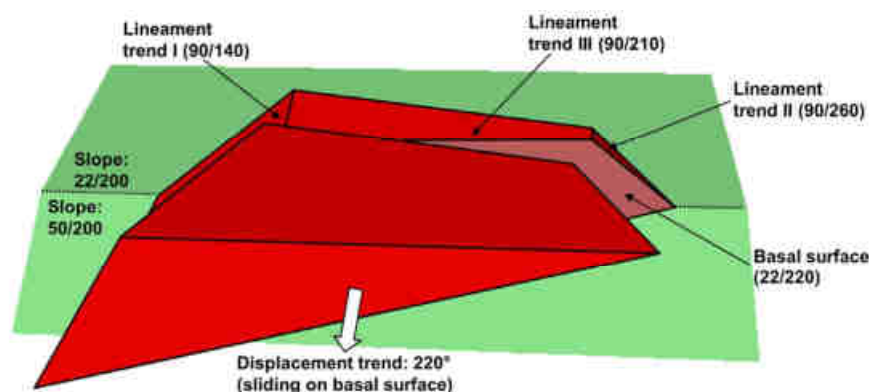
**Figure 14.** Simplified reconstruction of the landslide in the LE software SWedge 7, highlighting the correlation between the basal surface orientation and the computed displacement trends (view to the north). Note the progressive increase in landslide thickness toward the west.

To further investigate the form of the failure surface, a preliminary limit equilibrium (LE) analysis in the code SWedge [64] was conducted. For this analysis, trend I and II

lineaments were considered lateral release surfaces, trend III lineaments were considered tension cracks, and the foliation was assumed to be the sliding surface (foliation orientation within the slide area from [35]). According to the model, the sliding direction is exclusively controlled by the orientation of the foliation, thus justifying and supporting the progressive westward thickening of the Fels landslide body (Figure 14).

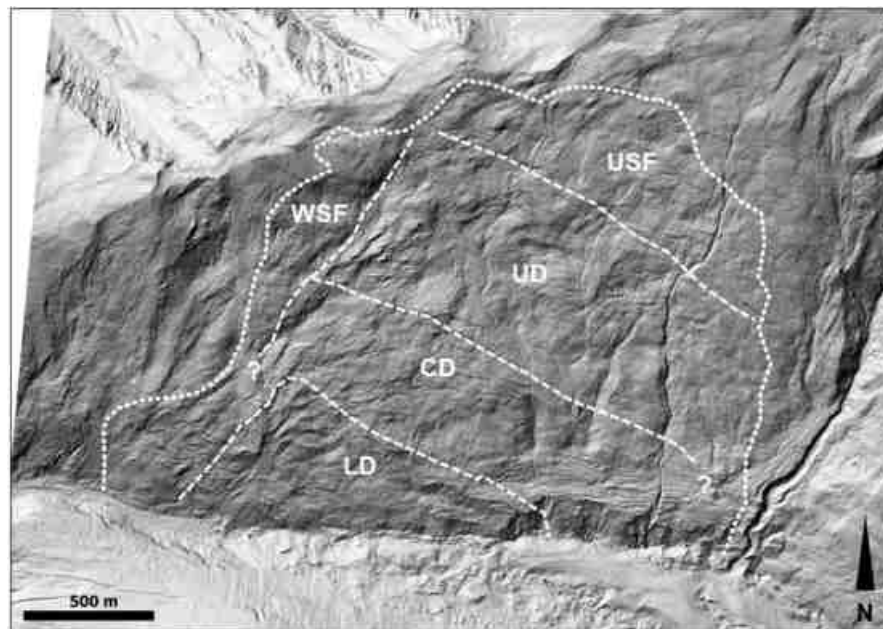
**Figure 15.** Slope domain subdivision. UD: upper domain. CD: central domain. LD: lower domain. WSF: western secondary failure. USF: upper secondary failure.

southeast direction of displacement, which indicates movement toward the void generated by the landslide movement. Due to the lack of pre-2010 monitoring data, it is unclear how long such secondary failures have been active. These areas of secondary failure are indicated as, respectively, the western secondary failure (WSF) and upper secondary failure (USF) domains (Figure 15).

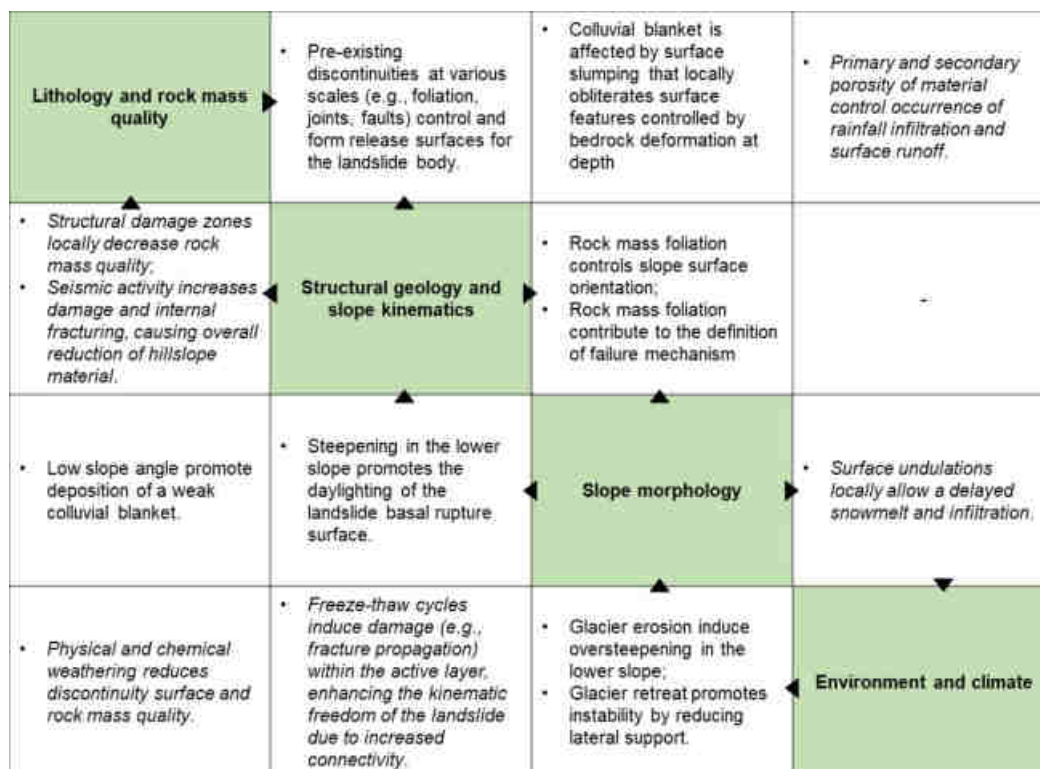
**Figure 16.** Interaction matrix summarizing the role of selected principal controlling factors (green cells along the main diagonal) on the stability and evolution of the Fels landslide. Italic font indicates interactions that are assumed but have not been investigated in detail in the present research.
