An interdisciplinary study of biodeterioration of the external marbles of Santa Maria del Fiore Cathedral, Florence (IT)

IOP Conf. Series: Materials Science and Engineering **949** (2020) 012085 doi:10.1088/1757-899X/949/1/012085

AP Santo[1], B Agostini[2], A Checcucci[3,4], E Pecchioni[1], B Perito[3]

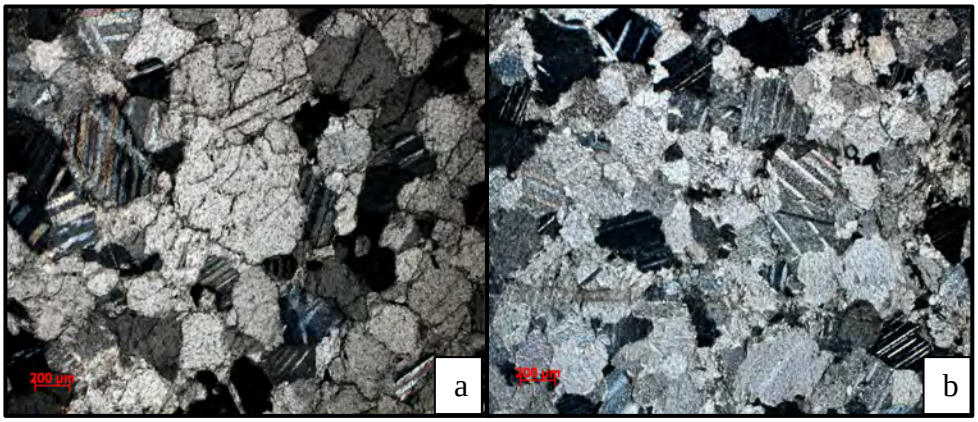
3.1. Mineralogy and Petrography. XRD analysis clearly indicated calcite as the dominant constituent of the studied marbles; small amounts of quartz are limited to a few rock samples. The microscopic observations confirm the presence of prevailing calcite which displays the typical polysynthetic twinning; the calcite crystals show heterogeneous grain-size, generally in the range 150-200 μm, up to 500 μm; the accessory mineral is essentially quartz, as identified also via XRD analyses. The SMFC marbles are characterized by a prevalent heteroblastic or, in some cases, homeoblastic mosaic texture with grain boundary shapes from straight to lobate-curved and sutured; no preferred orientation of the crystals is visible; limited to a few samples, fine-grained calcite crystals can be observed along the grain boundary. Under thin-section microscope observation, the marbles show low porosity; however, where the crystals boundary is prevalently straight, a slight grain detachment is observed.

Figure 3. Thin section photomicrographs of South-East (a) and North (b) exposed SMFC marbles showing the different grain boundaries shapes.

The different marble samples showed overall similar mineralogy and petrographic characteristics. However, some differences in boundary grain shapes have been observed; according to several authors [e.g. 11,13], the microstructure has a strong influence on physical parameters such as the open porosity and the water absorption thus affecting the marble resistance to physical weathering by change of temperature, humidity, freeze–thaw cycles; a microstructure showing straight grain boundaries results in more regular shape of intercrystalline pores and easier grain detachment, thus causing an easier water absorption in respect to a lobate-sutured grain boundary microstructure [14].

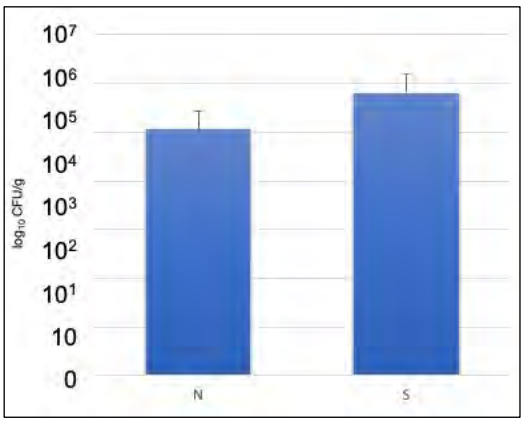
3.2.1. Bacteria. The first cultivation test was performed by plating marble suspensions from each sampling points of the North-West (N) and South-East (S) areas on LB plates. Results after 6 days of incubation are shown in Table 1. The whole CFUs data of N (N1+N2+N3) and S (S1+S2+S3) samples showed no statistically significant differences (figure 4).

Figure 4. Bacterial viable titers on LB medium of marble samples from Nort-Westh (N) and South-East (S) areas. Reported values indicate average from 3 replicates. Error bars indicate standard deviation. No significant differences (p-values > 0.05) between inoculants have been detected (one-way ANOVA).

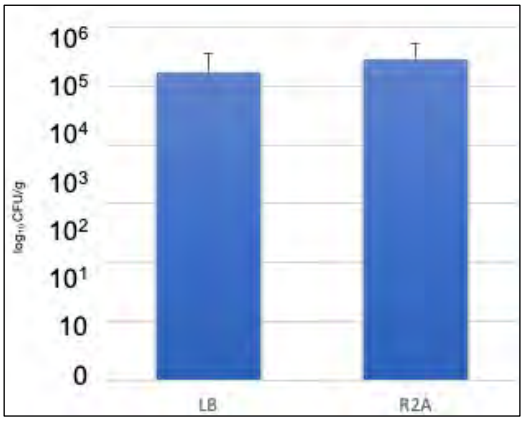
Figure 5. Barplots of the bacterial viable titers of North-West samples on LB and R2A media. *Values indicate average from 3 replicates. Error bars indicate standard deviation. No significant differences (p-values > 0.05) between inoculants have been detected (one-way ANOVA).*

No statistically significant differences between LB and R2A cultivation were detected. To verify if marble powder could have any factors helping growth of microorganisms isolated from the same material, suspensions of samples S and N were plated on the complex media supplemented with marble powder and aqueous marble extract. No significant differences were found in viable titers obtained with and without any marble addition.

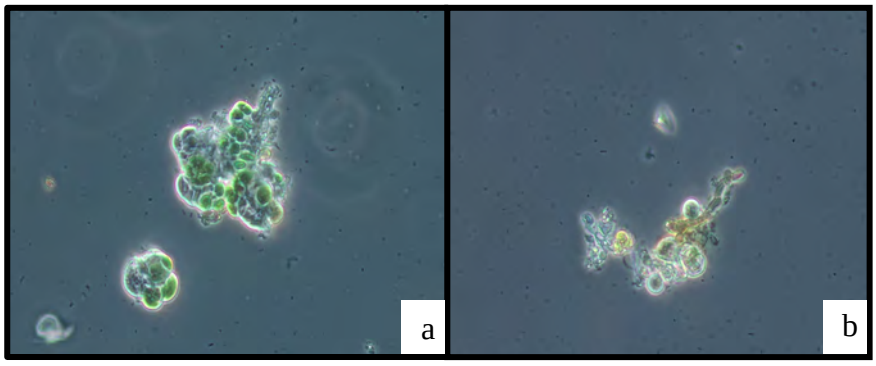
Dispersed composite aggregates of complex microbial communities constituted by phototrophic (algae, lichens, cyanobacteria) and non-phototrophic (fungi and bacteria) microorganisms were observed on marble samples, from the South-East as well as North site, by optical microscopy (figure 6).

Figure 6. Microbial aggregates from patinas covering white marbles observed at the light microscope (400X). a) aggregates of cyanobacteria from the South-East site sample; b) aggregate of algae and fungi from the North-West site sample. Free bacteria are visible in a) and b).

The microscopic observation of biodeteriorated marble showed the presence of a complex biofilm constituted of multikingdom microorganisms with a great potential in causing severe physico-chemical damage.
