Franzoni E and Pizzigatti C (2024), Onsite and  
laboratory assessment of repair mortars for  
reinforced concrete floor slabs in heritage  
buildings.

# Onsite and laboratory assessment of repair mortars for reinforced concrete floor slabs in heritage buildings

In the present paper, the use of different mortars for the repair of a reinforced concrete floor slab built in the 1930s was investigated, in terms of effectiveness and compatibility. The floor slab under testing is composed by a ribbed reinforced slab and hollow bricks, and it covered on the lower side by a layer of hollow brick and plaster, which was removed to investigate the state of the reinforced concrete beams, in view of the assessment of their load bearing capacity. Then, three concrete beams were reprofiled using three different commercial products, which were applied with procedures currently used in real practice, to highlight the performance of these solutions in real conditions. After some onsite inspection and testing, the three reinforced concrete beams were entirely cut and transported to the laboratory, where different characterization tests were carried out.

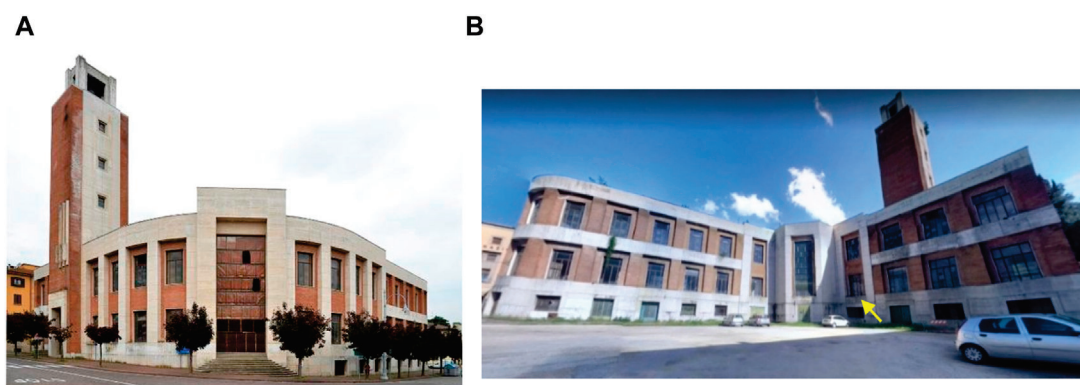
FIGURE 1

The former "Casa del Fascio": (A) front view facing the central square; (B) rear view (the arrow indicates the location of the slab under testing).
