Damage and collapses in industrial precast buildings after the 2012 Emilia earthquake

DAMAGE AND COLLAPSES IN INDUSTRIAL PRECAST BUILDINGS AFTER THE 2012 EMILIA EARTHQUAKE

SUMMARY – The present paper presents a complete and commented collection of cases of damage and collapse in reinforced concrete (RC) precast industrial buildings, observed by the authors during a series of field surveys after the 2012 Emilia earthquake in Northern Italy. They were selected among a total of about 2000 industrial RC precast buildings, whose structural characteristics and damage have been collected in a large database by the authors.

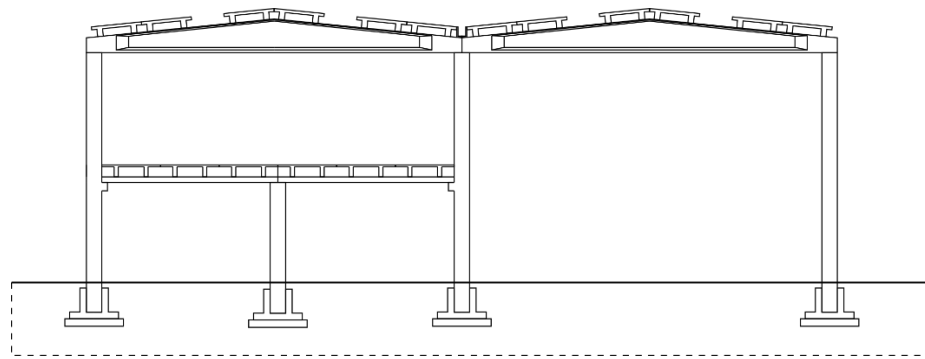
columns. These buildings have normally a single storey, eventually with an intermediate floor in a limited portion of the building on one side (see Figure 7a), where offices are typically located. Often, the presence of that intermediate floor on one side of the building caused an irregularity in the structural behaviour, with negative effects during ground motions.

Figure 7. Precast building with double slope roof beams (Type 1) and masonry infills, between beams and columns, carrying the horizontal loadings.

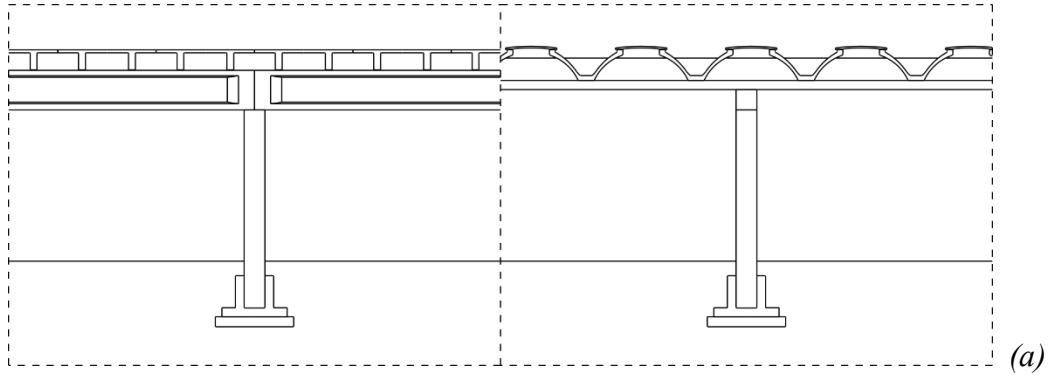
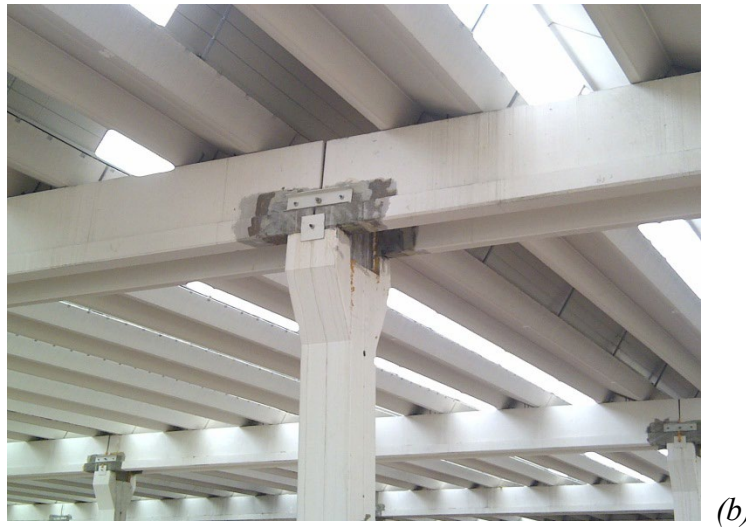
Type 2 precast buildings with planar roof are larger in plan than Type 1 structures. They are typically designed to obtain large empty spaces with only a few columns inside (see Figure 8). Planar precast RC girders (e.g., I- or omega-shaped beams) are supported on columns. In order to achieve long spans also in the slab direction, different kinds of prestressed elements are adopted for roofs or slabs, such as TT, Y-shaped, or shed profiles. More recently, the use of precast vaulted thin-web elements (called “wing profiles”) allowed to cover roof spans as long as 30 m (Figure 8b). In this case, curved panels made of glass or transparent polycarbonate are placed between the structural thin-web roof elements with the purpose of lighting the interior of the building. When this solution is adopted, quite commonly in the last 20 years for large industrial buildings (spans longer than 20 m in both directions), the roof is of course highly deformable in its plane. RC columns have large rectangular cross-sections (with sides up to 60-80 cm) and must bear both vertical and horizontal loads. In fact, cladding walls are RC panels, externally fixed to the columns and the upper beams, and expected to have no structural function.

Figure 8. (a) Precast buildings with planar roof (Type 2) and (b) long prestressed omega-shaped girders with thin-web roof elements for a production area. In the picture, the detail of a safety intervention executed before restart the working activity is also shown.
