Damage and collapses in industrial precast buildings after the 2012 Emilia earthquake

Savoia, M., Buratti, N., Vincenzi, L. (2017). Damage and collapses in industrial precast buildings after the 2012 Emilia earthquake. *ENGINEERING STRUCTURES*, 137, 162-180 [10.1016/j.engstruct.2017.01.059].

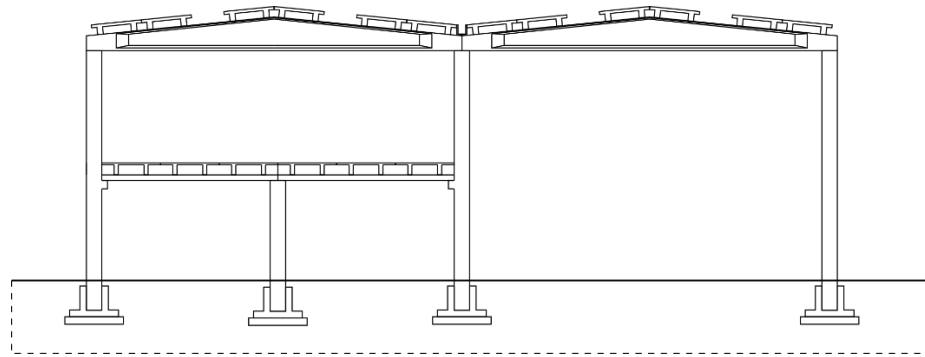
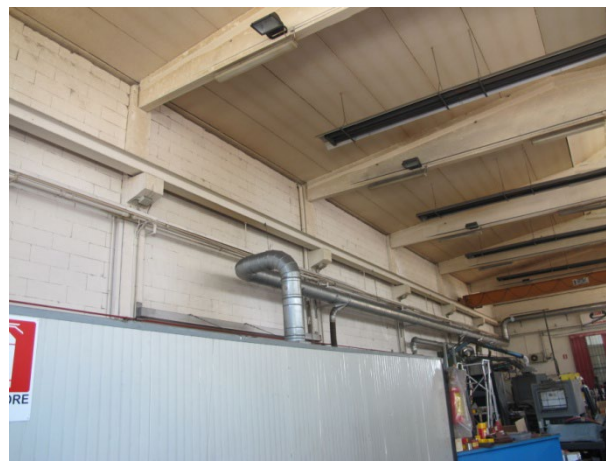
Figure 7. Precast building with double slope roof beams (Type 1) and masonry infills, between beams and columns, carrying the horizontal loadings.

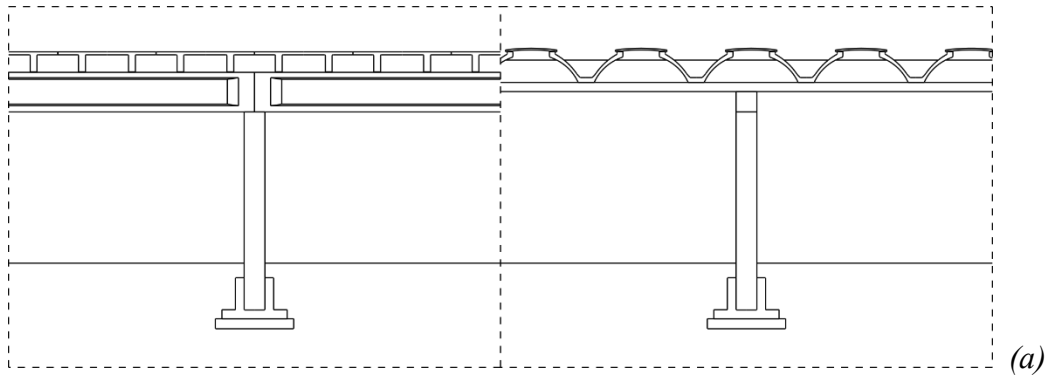
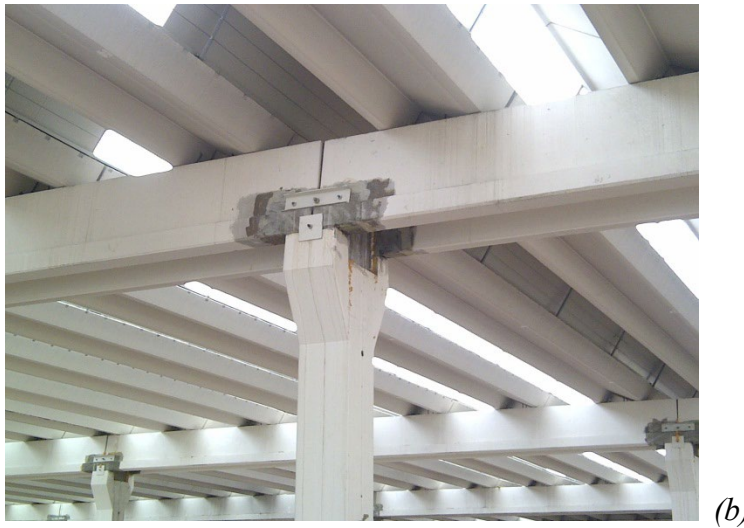
5 Type 2 precast buildings with planar roof are larger in plan than Type 1 structures. They are typically
6 designed to obtain large empty spaces with only a few columns inside (see Figure 8). Planar precast RC
7 girders (e.g., I- or omega-shaped beams) are supported on columns. In order to achieve long spans also in
8 the slab direction, different kinds of prestressed elements are adopted for roofs or slabs, such as TT, Y-
9 shaped, or shed profiles. More recently, the use of precast vaulted thin-web elements (called “wing profiles”)
10 allowed to cover roof spans as long as 30 m (Figure 8b). In this case, curved panels made of glass or
11 transparent polycarbonate are placed between the structural thin-web roof elements with the purpose of
12 lighting the interior of the building. When this solution is adopted, quite commonly in the last 20 years for
13 large industrial buildings (spans longer than 20 m in both directions), the roof is of course highly deformable

Figure 8. (a) Precast buildings with planar roof (Type 2) and (b) long prestressed omega-shaped girders with thin-web roof elements for a production area. In the picture, the detail of a safety intervention executed before restart the working activity is also shown.

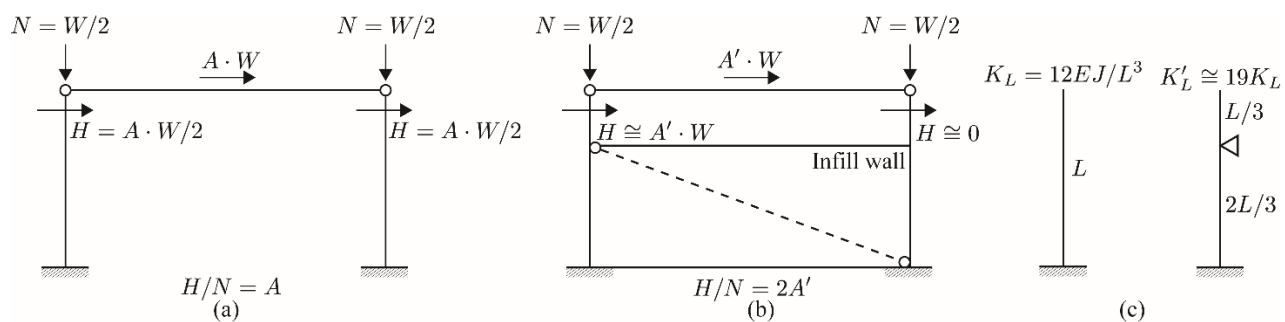
12 A general terminal frame with two base-clamped columns and a simply supported precast beam is
13 depicted in Figure 13a. Considering the presence of a flexible roof, the weight of the roofing elements
14 corresponding to the frame tributary area is indicated with W , and the total seismic lateral force is $A \cdot W$,
15 where A indicates the pseudo spectral acceleration (PSA_h) at the natural period of the frame, in units of g ,
16 i.e., $A = PSA_h/g$. Without the infill wall (as in the case of a central frame), this force will be equally
17 distributed between the two columns. Therefore, at the beam supports, the horizontal-to-vertical force ratio
18 is $H/N = A \cdot W/A = A$. Sliding of beams from their supports occurs if $H/N = A$ is be larger than the friction
19 coefficient, which can be assumed of the order of 0.5 for a concrete-concrete support (without neoprene
20 pads) [54]. That value was usually not exceeded, at least for frames oscillating with a period typically in

21 the range $1.2 \div 1.5$ s. Considering the pseudo-acceleration spectra in Figure 4, for $T = 1.2 \div 1.5$ s, $A = PSA_h/g$
22 is about 0.4, i.e. smaller than the friction coefficient. On the contrary, considering an infilled frame with a
23 strip window (Figure 13b) and assuming that the roof is moving in the right direction, because of the
24 interaction with the infill wall most of the lateral force will be acting on the left column. As an example, if

1 the height of the infill is $2/3 L$, assuming that the infill can be modelled as a rigid compression strut, the
2 lateral stiffness of the left column will be about 20 times larger than that of the right column (Figure 13c).
3 Therefore, the maximum H/N ratio on the left column is approximately $H/N = 2A'$, being $A' = PSA'_h/g$ and
4 PSA'_h the pseudo spectral acceleration at the natural period of the infilled frame, much shorter than the
5 natural period the bare frames (about 0.2÷0.4 s). For periods in that range, A' can be up to 0.8 ÷ 1.0 (see
6 Figure 4) and then $H/N = 2A' = 1.6 ÷ 2.0$, i.e., up to 4 times greater than the friction coefficient, causing
7 certainly the unseating of the precast beam. Horizontal forces in columns of the infilled side frames can be
8 even greater in the presence of a roof with some in-plane stiffness, because most of the horizontal force
9 related to the mass of the entire roof is transferred to the two columns of the end frames interacting with

Figure 13: Short column effect in a terminal frame with infill walls and a strip window: a) a central frame without infill wall; b) an infilled frame with strip window; c) stiffness variation due to the short column effect.
