Collapse and damage to vernacular buildings induced by 2012 Emilia earthquakes

Bovo, M., Barbaresi, A., Torreggiani, D., Tassinari, P. (2020). Collapse and damage to vernacular buildings induced by 2012 Emilia earthquakes. BULLETIN OF EARTHQUAKE ENGINEERING, 18(3), 1049-1080 [10.1007/s10518-019-00737-7].

# **Collapse and damage to vernacular buildings induced by 2012 Emilia earthquakes**

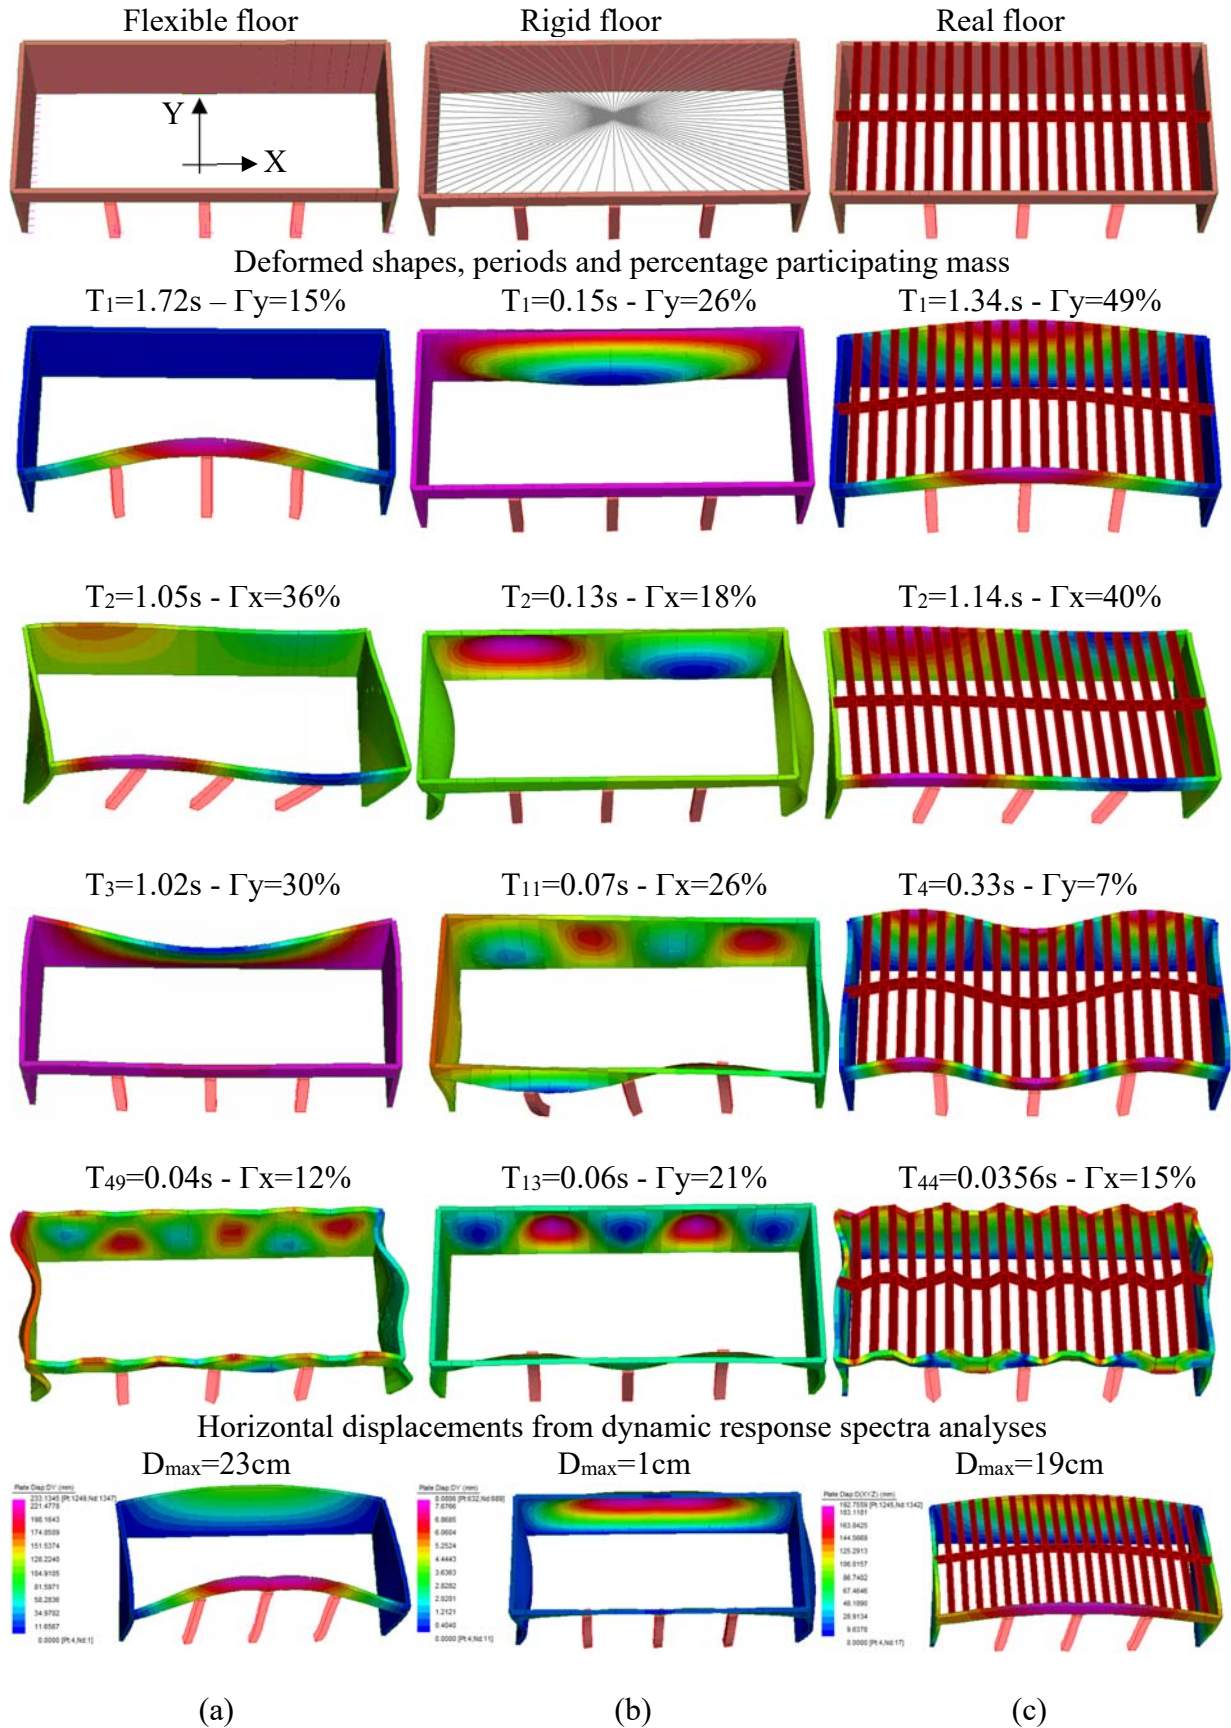
The first class of models, reproducing the whole geometry of building #22, is depicted in Figure 13. Three different assumptions, shown respectively in Figure 13a, b and c, have been made by considering alternatively an infinitely flexible floor, an infinitely rigid floor, and the real stiffness of the roof floor constituted by wooden beams. The walls were modelled by means of 4-node lagrangian shell elements. The masonry columns were elastic beams. For the masonry properties were selected the average values provided in [15]. They were a Young modulus  $E=2.6\text{GPa}$  and a Poisson ratio  $\nu=0.26$ . The models were clamped at the base. As far as the case simulating the real roof stiffness is concerned, beam finite elements were introduced in order to model the structural wooden members. The wooden elements have the cross-section dimensions detected

The deformed shapes associated at the two natural periods having the highest percentage of effective mass in X and Y directions (where X is parallel to the longitudinal direction and Y is parallel to the transversal direction) are reported in the figure for the different hypotheses. As expected, the flexible floor provides the longer periods and the deformed shapes are the local vibrating modes of the various vertical elements with their tributary mass. The considerable in-plane asymmetry, for seismic action component along longitudinal direction, do not produce significant torsional effects, since the vibrating modes mainly imposed translational displacements. On the contrary, the seismic response for the case of rigid floor hypothesis (Figure 13b) show deformed shape imposing roof displacement mainly governed by torsional vibrating modes. In this case, the natural periods are generally shorter than the previous and they are associated to deformed shapes that change also the vibrating shape of local modes. It is worth to note that the behaviour of the FEM with real floor (Figure 13c), have deformed shapes and range periods more similar to those of the infinitely deformable floor FEM, thus indicating that typical trussed wooden elements constituting the floors of historical “barchessa” are very far from rigid floor assumptions. In general, the existent roof solution does not introduce significant torsional effects. By the prospective of a seismic strengthening, in the design of the upgrading interventions for this class of buildings, the introduction of a very stiff floor does not create evident benefits, while it could even cause a worse global dynamic behaviour of the building. It is important to highlight that the displacements assessed by means of dynamic response spectra analyses are completely different for the case of the rigid floor (maximum expected displacement of 1cm), while are comparable for the real and deformable floor assumptions (respectively 19 cm and 23 cm). These values are in good agreement with those provided by the spectra in Figure 3d (about 13-21cm following the records of MIR01 station for  $T_1=1.4\text{s}$ ). In a first simplified modelling attempt, the deformable floor FEM provided a conservative displacements scenario.

Figure 13. Finite element modelling of building #22. Deformed shapes, vibrating period ( $T$ ), percentage participating mass ( $\Gamma$ ), and displacement demand in the hypothesis of (a) flexible floor, (b) rigid floor and (c) real floor.

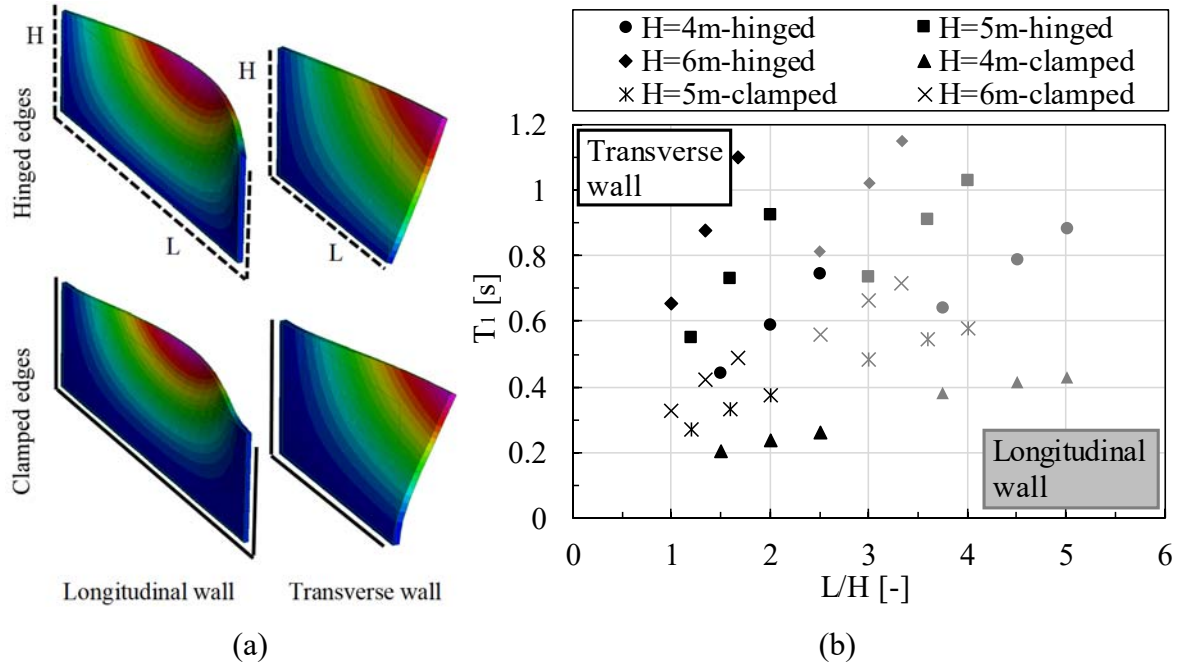
With the main goal to obtain a realistic range of the first elastic vibrating periods of wall local modes for the structure in classes A2 and A3, a second class of FEMs was considered. The period value can result useful to achieve a rough, but very rapid, estimation of the maximum displacement that a structure could have experienced during the recent earthquakes (for example by considering the Figure 3c-d or Figure 5). The considered FEMs and the main results in terms of first out-of-plane vibrating periods are reported in Figure 14. In the work, two different types of walls (i.e. longitudinal and transverse) were considered, with two different constraints along the supported edges (i.e. cylindrically hinged and clamped) and for different pairs of H and L characterizing the walls (H: height; L: length). For H the most typical values equal to 4, 5 and 6m were considered; for L values of 15, 18 and 20m for longitudinal walls and 6, 8 and 10 for the transverse have been considered. The masonry walls thickness has been set equal to 25cm. Even in this case, the walls were modelled by means of 4-node lagrangian shell elements. with Young modulus  $E=2.6\text{GPa}$  and a Poisson ratio  $\nu=0.26$ . The walls were restrained along three and two edges, respectively for longitudinal and transverse models (as showed by the deformed shape in Figure 14a). The Figure 14b, reporting the periods as a function of L/H ratio, shows that typical first vibrating periods of the vertical walls range from 0.2s to about 1.2s. The knowledge of the L/H ratio and the selected constraint condition, allows to evaluate the first vibrating period of a wall element, and the displacement experienced during the earthquake can be obtained from Figure 3c-d. The frequencies evaluated by the authors via FEM analyses were compared with the outcomes in [48] in order to check the validity of the models and their discretization. By the comparison on the first frequency, performed for the available L/H ratio, a maximum difference of 8% emerged, this value is widely acceptable for the scope of the work.

The “barchessa” studied in the present work has L/H ratio equal to 3.50 and 1.60 respectively for longitudinal and transverse walls. The comparison between vibrating periods of local and global models, shows that the most suitable restraint hypothesis for the walls is the one prescribing cylindrical hinge along the edges. In fact, the global models provide a vibrating period of 1.02s and 1.05s, respectively for vibrating modes involving local modes of longitudinal and transverse wall. The estimations of vibrating periods from local FEMs (with hinged edges) result very close to those correct, providing the Figure 14b values of 0.92s and 1.08s, respectively for longitudinal and transverse wall.

Due to reduced thickness, if compared to the other dimensions, the hinge restraint hypothesis may appear suitable for most of the structures in the categories A2 and A3. By means of the analysis of the displacements map of structures with first vibrating period around 1s, as the “barchessa” investigated here, the evaluation of the maximum displacements suffered during the event of May 29<sup>th</sup> provides values larger than 10cm for an epicentre distance of 15-20km (see Figure 5b2). This high seismic displacement demand could explain the overturning mechanisms observed in slender buildings, since in several cases it produced the exit of the vertical loads resultant from the wall base section.

Figure 14. Analysis of the first vibrating periods of vertical walls in buildings with flexible floor. (a) Finite element modelling and deformed shape for different types of restraint; (b) first out-of-plane vibrating periods as a function of the L/H ratio, with L and H as reported in figure.
