The problem of conservation of XX Century architectural heritage: the fibreglass dome of the Woodpecker dance club in Milano Marittima (Italy)

Cesare Pizzigatti¹, Elisa Franzoni^{1*}

Abstract

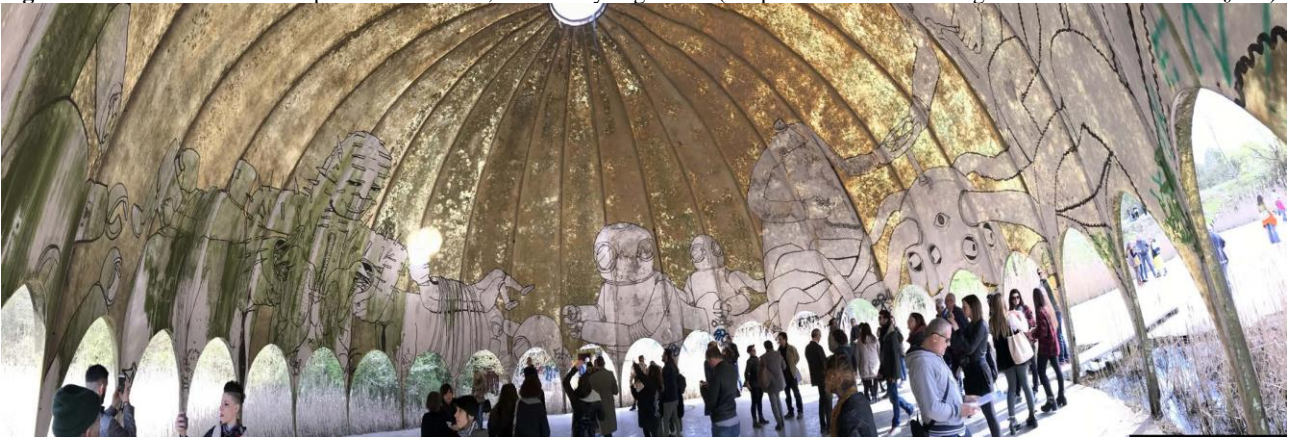
Furthermore, in the early 2000s a huge graffito was painted on the internal surface of the dome, representing a surrealistic subject. It was made with two colours only, namely black lines (probably brushed) and white backgrounds (probably made by rolls). Although no one has ever claimed its authorship, this graffito was attributed to Blu, an Italian street artist famous all over the world [21-22], as the subjects represented and the techniques adopted leave no doubts about his being the author (Fig. 4) [29-33].

Fig. 4 Graffito by Blu inside the dome.

According to the constraint imposed by the Municipality, the dome and the surrounding area must be repaired and conserved and the original use must be kept, possibly also adding new cultural and entertainment activities. In particular, a scientific conservation is requested for the dome. It should be noted that the council urban planning tools were the most effective way to safeguard this place, since this construction is less than 70 years old and hence it is not covered by ordinary protection regulations according to Italian laws. Moreover, the Municipality imposed a protective restriction also upon the graffito, requiring its conservation.

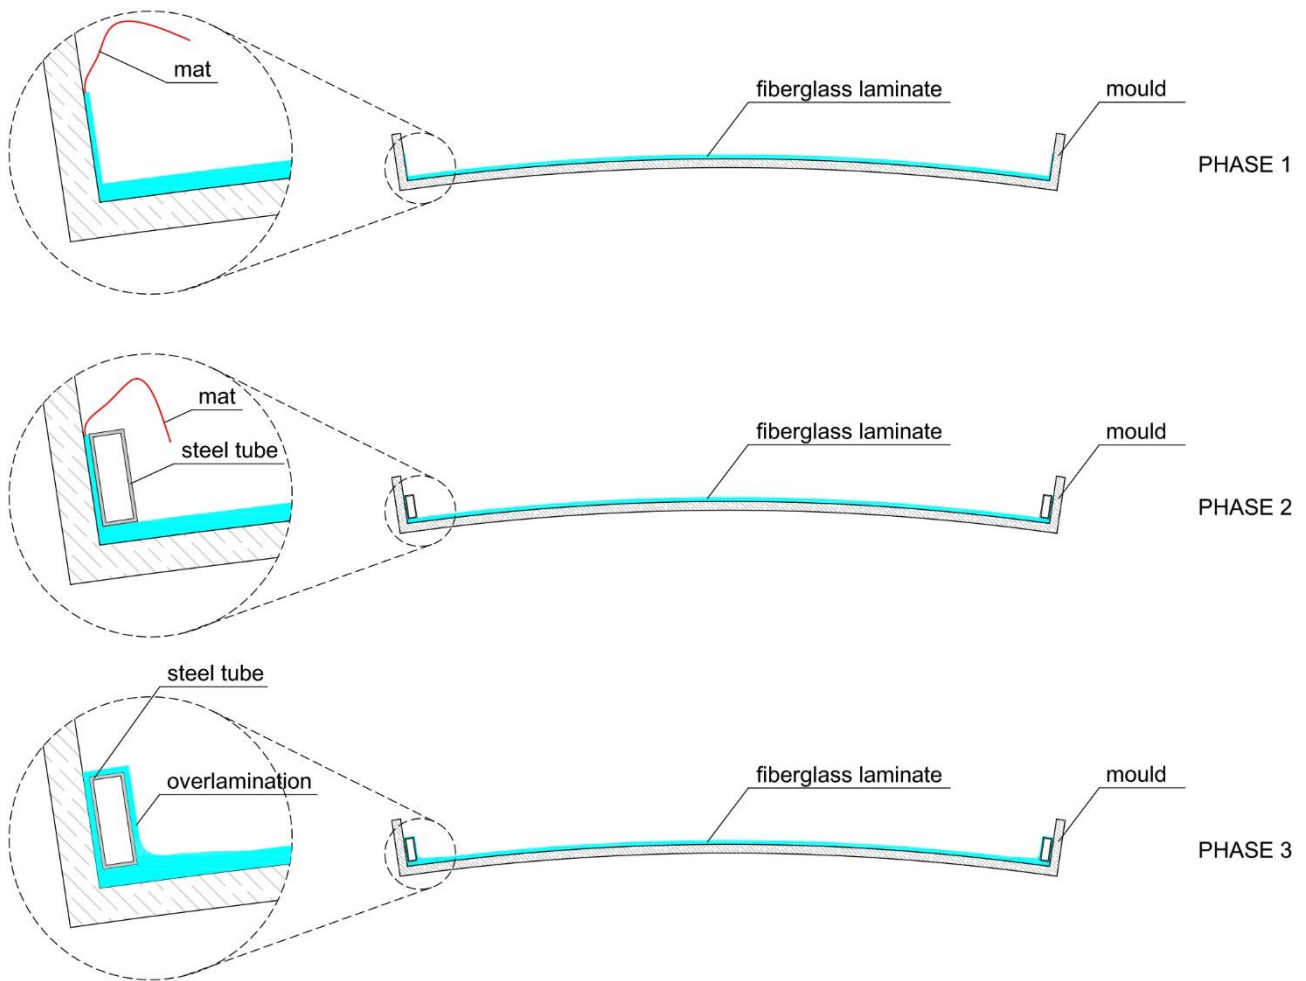
- The steel arches were embedded into the fibreglass through a manufacturing process named overlamination (Fig. 8) [26].
- Each single vault with two steel arches embedded along the main borders was manufactured at the shipyard, then transported to the construction site and assembled (see also the following issue).

Fig. 8 Schematic illustration of the process of overlamination.

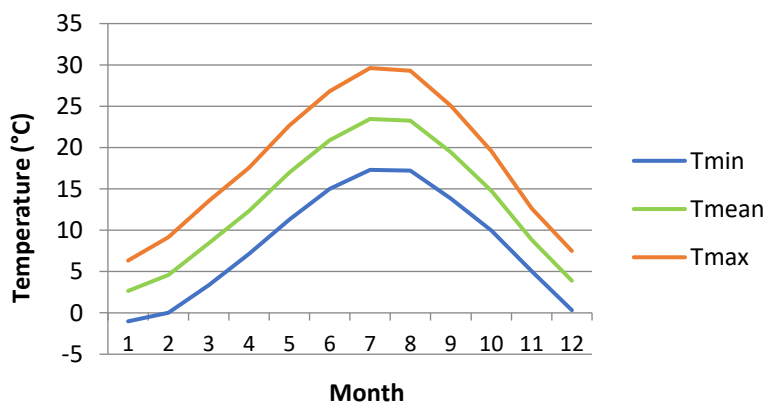
- The average maximum monthly temperature is above 25°C during all summer, i.e. from June to September, and around 30°C in July and August (Fig. 14). These conditions are certainly very aggressive for polymeric materials, as they boost temperature-related ageing processes for some months a year, especially considering that the dome is not sheltered at all by other constructions, being exposed to direct sun radiation from sunrise to twilight. Moreover, the minimum monthly temperature is less than 0°C in January and February (Fig. 14), hence possibly causing freeze-thaw cycles in those materials that exhibit micro-cracks.
- The average maximum monthly relative humidity is extremely high, namely about 90%, all over

Fig. 14 Mean monthly temperatures during the year.

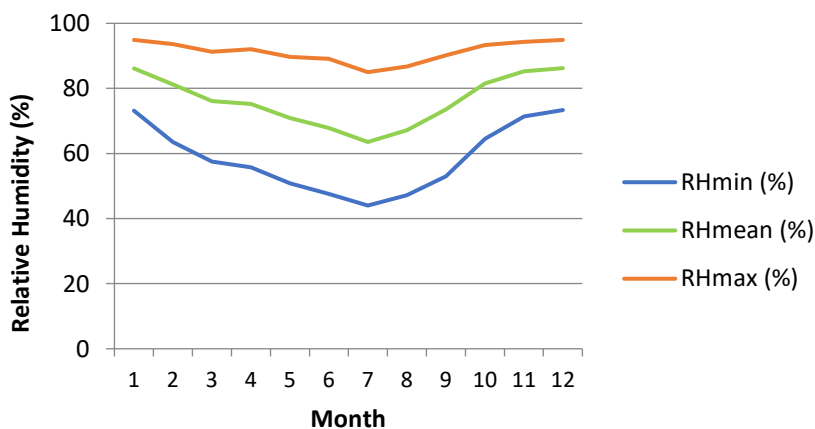
the year and the average monthly relative humidity remains above 80% during autumn and winter, i.e. from October to February (Fig. 15). This means that the dome is exposed to a very high air relative humidity for most of the year and this is a detrimental condition for the deterioration of the polymeric matrix, as moisture accelerates all the ageing phenomena.

Fig. 15 Mean monthly relative humidity values during the year.

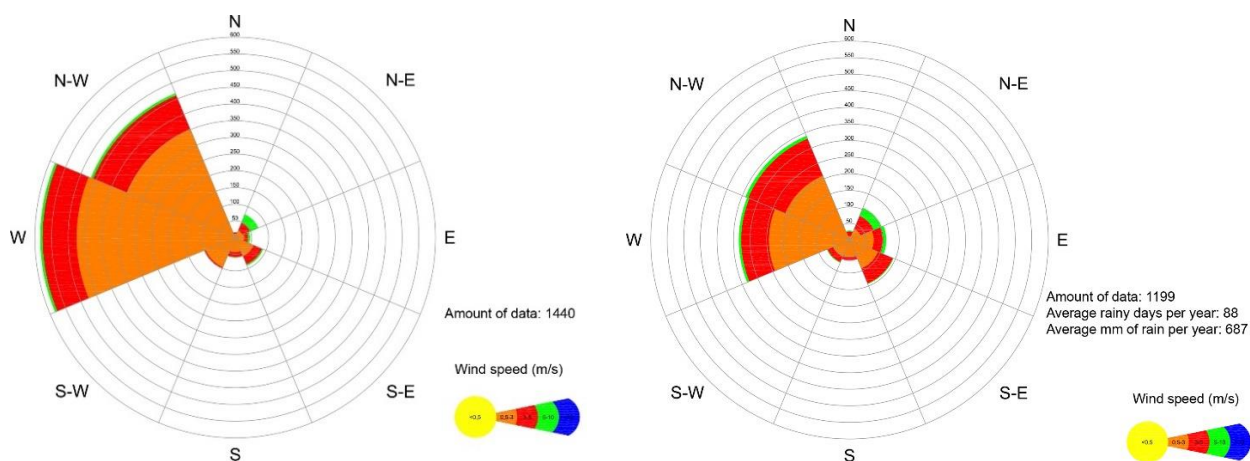
- Cold winds (autumn and winter) and rainy winds (i.e., winds corresponding to those days in which rain was registered) mostly come from the western side (Fig. 16). Conversely, the winds with highest speed mostly come from N-E. As the lichens on the dome are characterized by different morphology and colour, there seems to be a correlation between the distribution of the different lichens and the environmental context. The comparison between the dome extrados (Fig. 10, right) and the analysis of winds (Fig. 16) showed that orange-red lichens preferentially grew in an area more sheltered from cold winds, blowing in autumn and winter, but quite frequently exposed to rainy winds.

Fig. 16 Winter winds (*left*) and rainy winds (*right*).

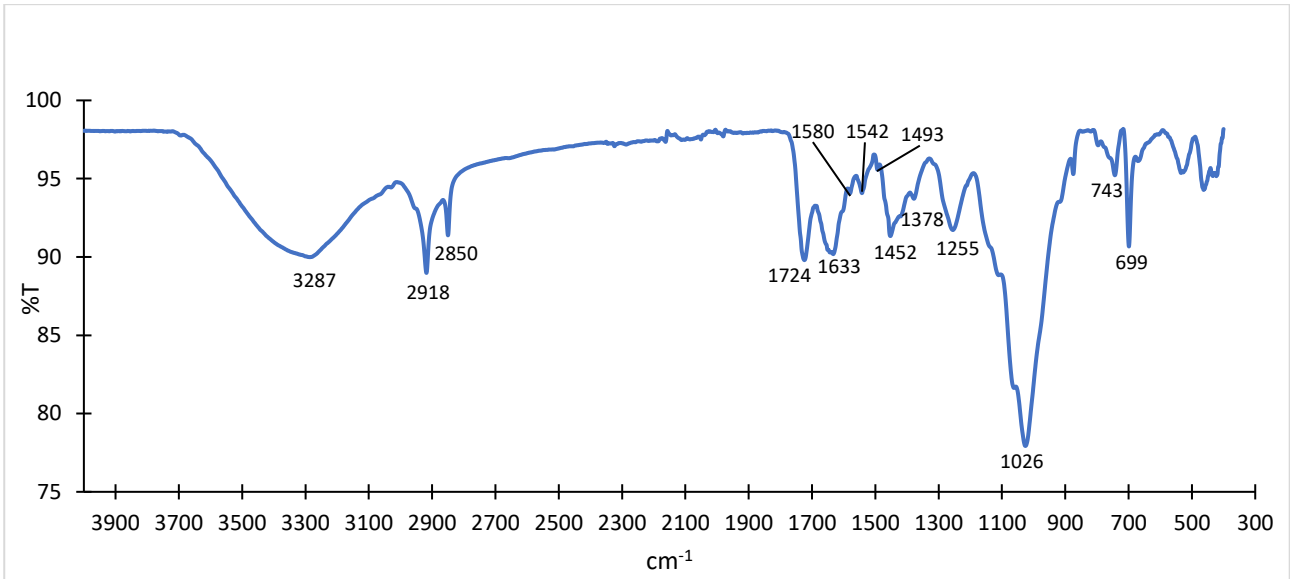
The FT-IR spectrum allowed the matrix to be identified as an unsaturated polyester resin (Fig. 17), which was the most widespread matrix in the production of fibreglass elements when the Woodpecker was built, due to its easy workability and a good performance to cost ratio [27, 55-57, 59-60]. The absorption bands were attributed as in the following:

Fig. 17 FT-IR spectrum of the resin sample S3.

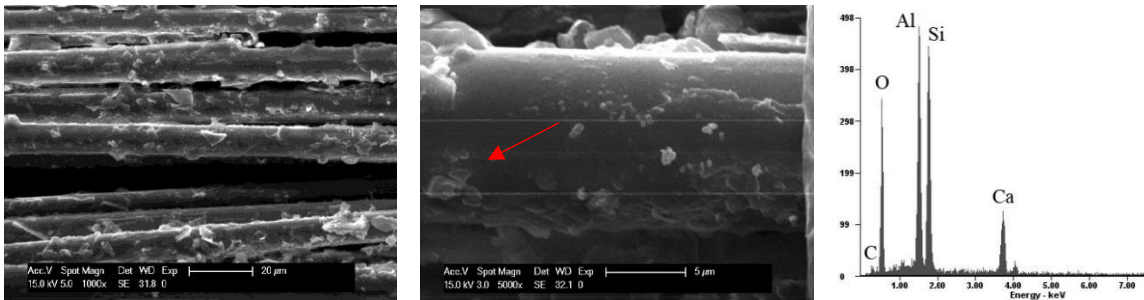
Fig. 19 Glass fibre samples. On the left: SEM image of the fibres in sample S6 (marker = 20 µm). At the centre: a fibre of sample S6 observed at greater magnification (marker = 5 µm). On the right: EDS analysis of the same fiber shown at the centre, carried out in the point indicated by the red arrow.
