Construction and Building Materials

An integrated approach to the monitoring of rising damp in historic brick masonry

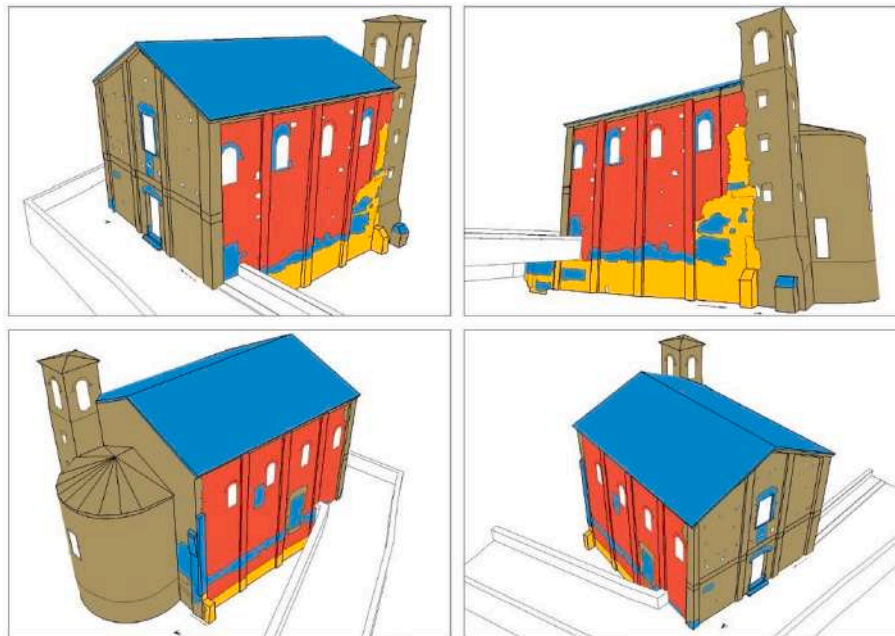
Fig. 2. Main phases of the church's construction: Phase 1 – AD 424–432 (yellow); Phase 5 – Mid of 12th century (red); Phase 7 – CE 1602–1612 (brown); Phase 8 – 20th century (blue) [28]. (For interpretation of the references to colour in this figure legend, the reader is referred to the web version of this article)

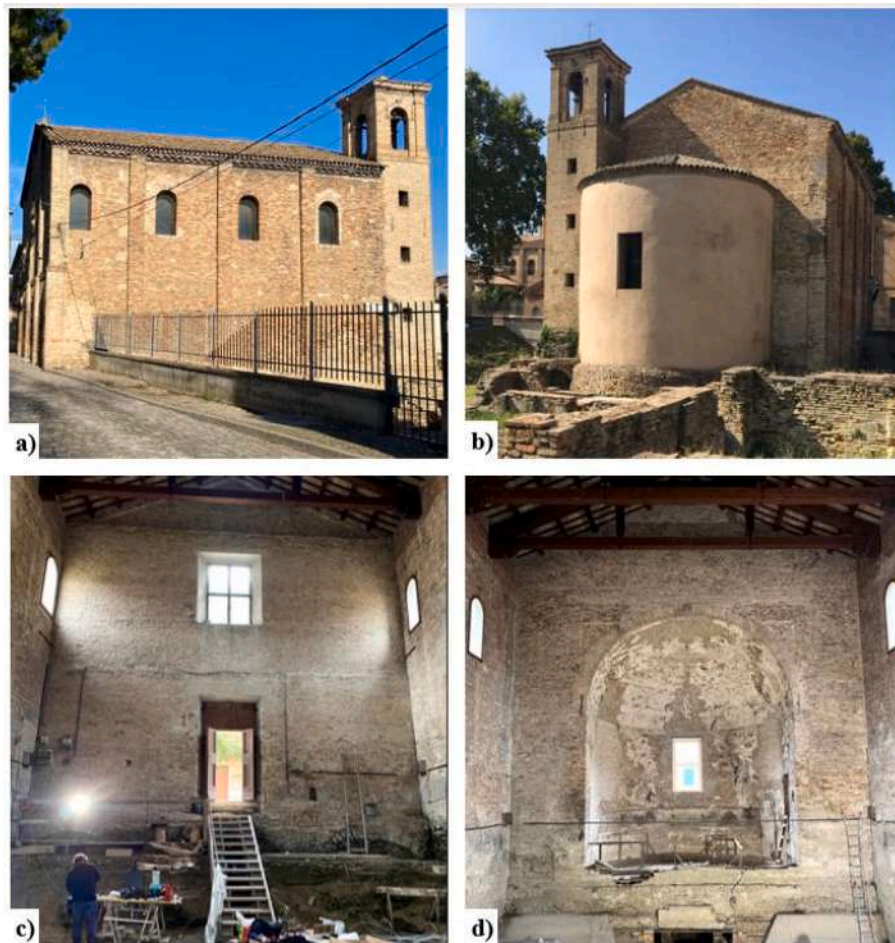
Fig. 3. The church of Santa Croce in Ravenna: a) exterior - south façade; b) exterior – east façade and apse; c) interior – main façade (west wall) and entrance; d) interior – east wall and apse.

By visual observation, the church is strongly affected by rising damp, and various deterioration patterns are present in building materials. The external surface of the masonry is affected by colour change (Fig. 4a), bricks flaking and crumbling, possibly due to freeze–thaw and/or salt crystallization cycles (Fig. 4b), mortar joints' deterioration, efflorescence, and occasional plant growth (Fig. 4d). The interior is mostly affected by intense biological growth in the lowest part (Fig. 4c). The internal floor is constituted by soil and is also affected by deposits of pigeons' guano.

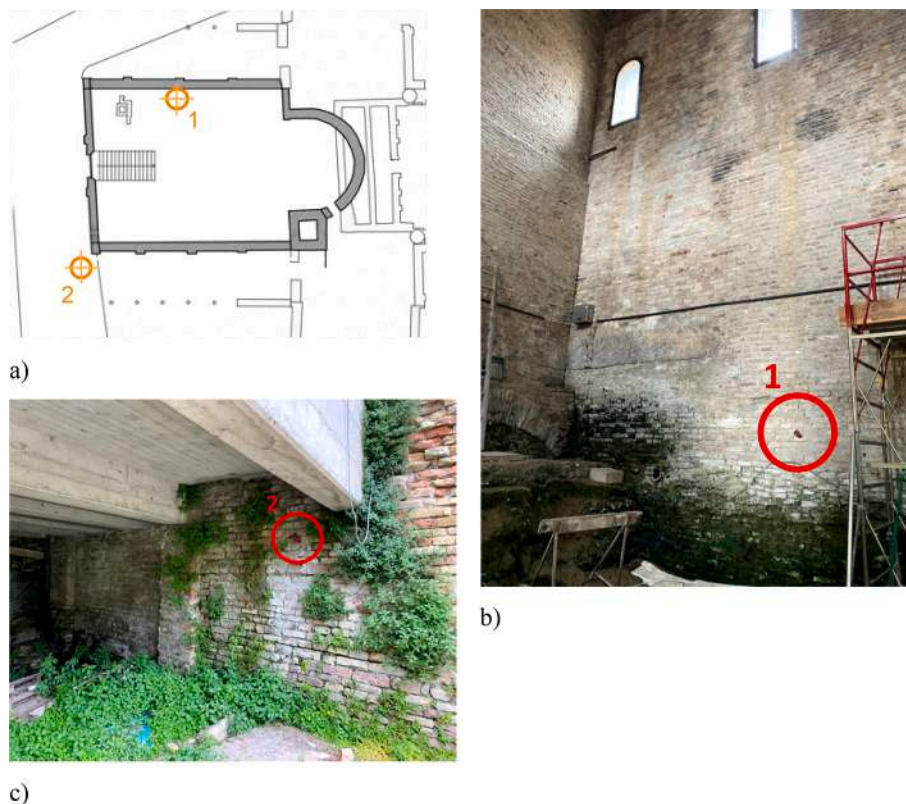
The temperature and relative humidity of air were monitored by two portable sensors with dataloggers (RS 172 by RS Components; temperature: resolution 0.1 °C and accuracy ± 2.0 °C; relative humidity: resolution 0.1 %, accuracy ± 5.0 %) located inside and outside the church about 2 m above the ground (Fig. 6).

Fig. 6. a) plan of the church with the location of the sensors (dataloggers) for the monitoring of air temperature and relative humidity; b) and c) the internal (#1) and external (#2) sensors, respectively.

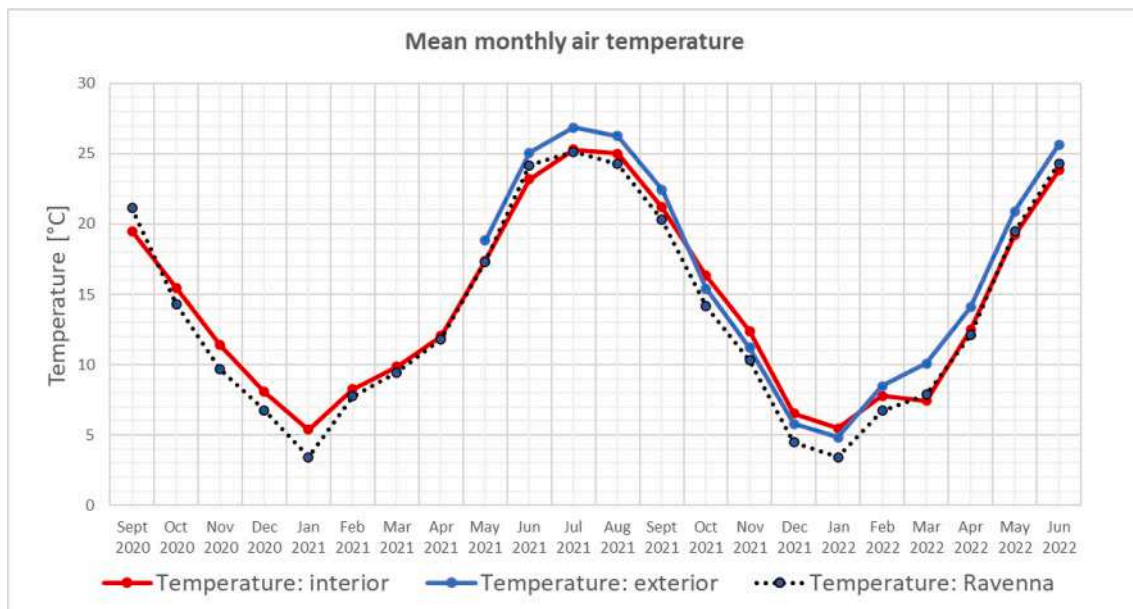
In Figs. 7–8, the air temperature and relative humidity measured by the sensors inside and outside the church are reported, together with the

Fig. 7. Mean monthly values of air temperature inside and outside the church.
