Article

The San Carlo Colossus: An Insight into the Mild Galvanic Coupling between Wrought Iron and Copper

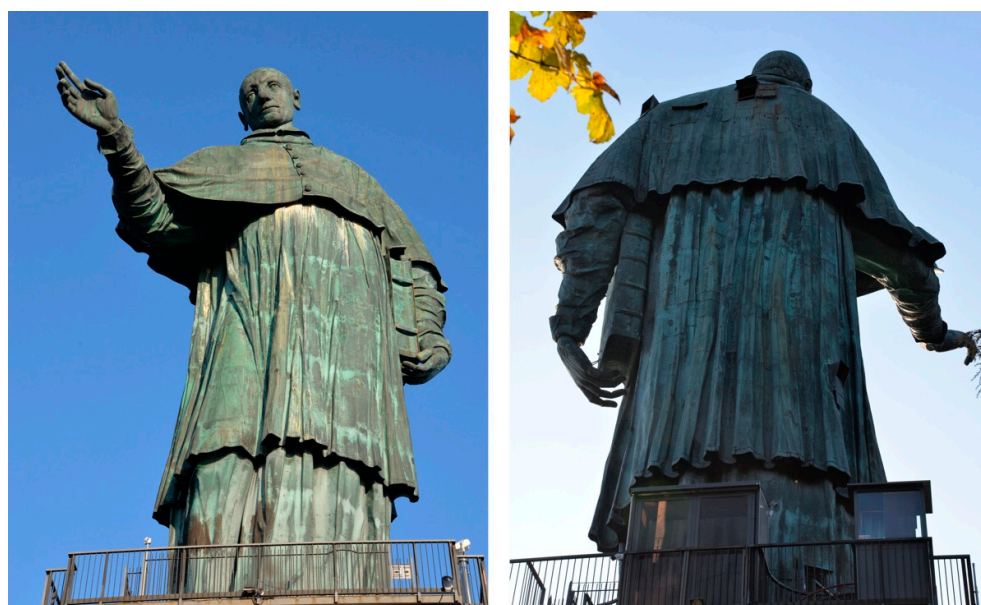
The Colossus of San Carlo Borromeo (1538–1584), called *San Carlone*, i.e., *Big Saint Charles* (Figure 1) due to its large size, located in Arona on the Lago Maggiore (Piedmont, Italy), was built between 1614 and 1698. The 22 m high statue (which is positioned on an 11 m high granite pedestal) was manufactured by a peculiar construction technique: An internal stone pillar supports a wrought iron structure, embossed with fixed copper sheets. The iron structure, in direct contact with the copper sheets, provides structural support and shapes the statue. Due to its construction technique and more than 300 years of outdoor exposure, the statue represents an opportunity for an in-depth investigation of the long-term galvanic coupling between the wrought iron and copper. Despite the frequent direct contact between the two metals, wrought iron presents only a limited number of areas heavily affected by corrosion, while the rest looks in quite good conservation condition.

Figure 1. The Colossus of San Carlo Borromeo (1538–1584), Arona (Italy), called *San Carlone*.

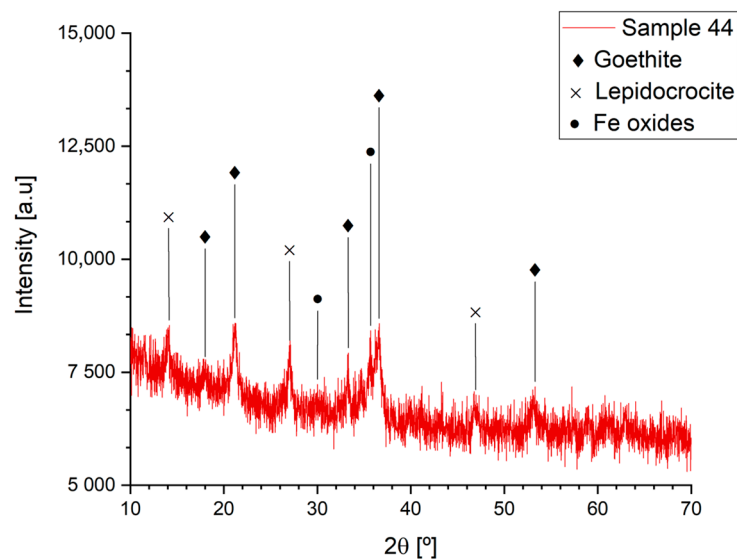
The same analysis was also performed on powder samples of corrosion products collected from iron bars with evidence of active corrosion (not necessarily in direct contact with copper sheets, which provided similar results. Both XRD and micro-Raman analyses identified goethite and lepidocrocite as the main corrosion products in association with magnetite, maghemite, and hematite. On powder samples akaganeite was also detected. Moreover, for these samples, a lower variety of corrosion products were detected by XRD than by micro-Raman, basically identifying goethite, lepidocrocite, and a low amount of hematite on a few samples. Moreover, on powder samples, significant amounts of deposits and contaminants were detected. In particular, gypsum was typically identified in the areas with evident active corrosion. Gypsum normally reaches the surfaces by wet and dry deposition, thus explaining the high amounts of deposits on the surface. Furthermore, the presence of gypsum could suggest that the higher corrosion rate of those iron bars might be associated with specific microclimatic conditions promoted by deposition or condensation phenomena. In fact, the presence of more severe corrosion phenomena in association with

Figure 9. XRD analysis of sample 44.

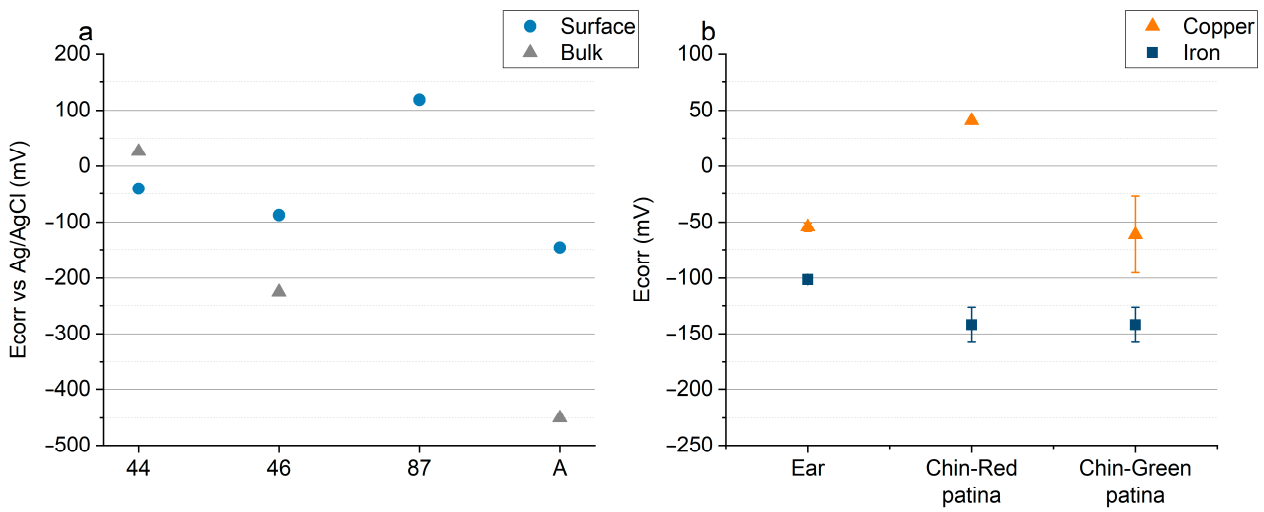
Figure 10a shows the E_{corr} values measured in the laboratory on the surfaces and polished cross-sections of the iron samples from the Colossus and on the reference sample A. On Sample 87, only surface measurements could be performed due to its very small dimensions. The bulk of Samples 44 and 46 show a more noble potential (25 mV and -225 mV vs. Ag/AgCl) with a E of +475 mV and +225 mV, respectively, with respect to the puddled iron ($E_{\text{corr}} = -450$ mV vs. Ag/AgCl). Moreover, the corrosion potentials measured on the surfaces of such samples are quite noble. Surprisingly, the highest value (+120 mV vs. Ag/AgCl) has been measured on the surface of the most corroded sample (87). Interestingly, the difference in corrosion potential between the surface and bulk alloy of Samples 44 and 46 is very low and significantly lower than the one measured on the reference sample A. Figure 10b shows the results of on-site E_{corr} measurements in the statue on adjacent copper and iron surfaces. In this case, all the iron bars appeared slightly corroded but were covered by compact corrosion layers adherent to the surface. The potential difference between the two surfaces never exceeded 200 mV, and in two cases out of three, it was lower than 100 mV. The three iron fragments from the Colossus and the reference sample A were electrochemically characterized by measuring the polarization resistance of their surfaces with LPR and EIS. Nyquist plots of Sample A (surface) and Sample 44 (section) are reported in Figure 11a,b, respectively. Average R_p values (Figure 12) were higher than $30 \Omega \cdot \text{m}^2$. The surfaces of Samples 44 and 87 resulted in the least resistance to corrosion. Sample 46 and the reference sample A showed R_p values higher than $150 \Omega \cdot \text{m}^2$, suggesting a good corrosion resistance.

Figure 10. Corrosion potential (E_{corr}) measured on surfaces of the *San Carlone* with a Ag/AgCl reference electrode. (a) E_{corr} measurements on the surfaces and the polished cross-sections of iron fragments; (b) on-site E_{corr} measurements on adjacent copper and iron surfaces.

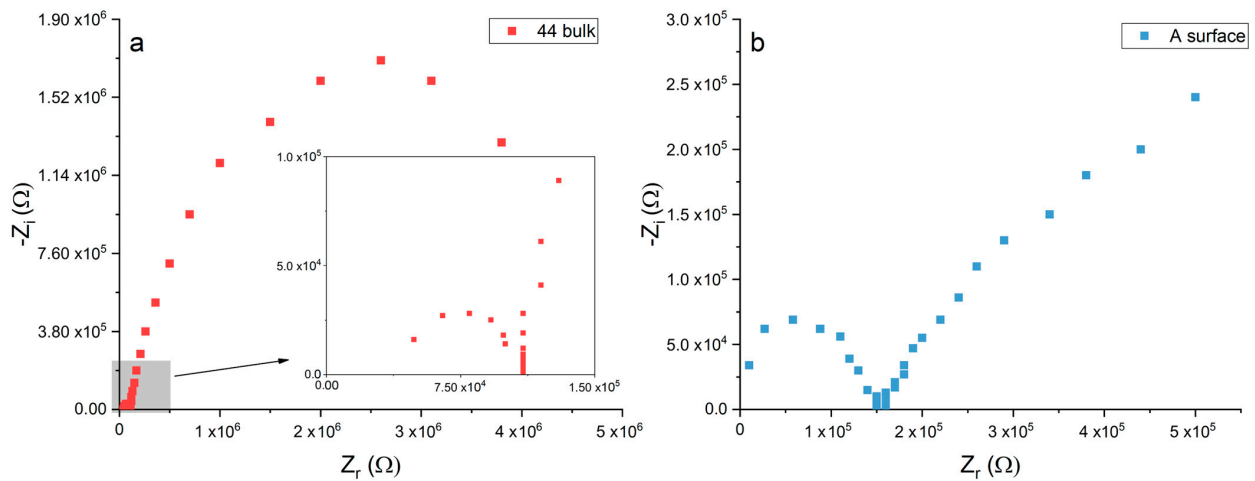
Figure 11. Nyquist plots of Sample 44 (a) and Sample A (b).

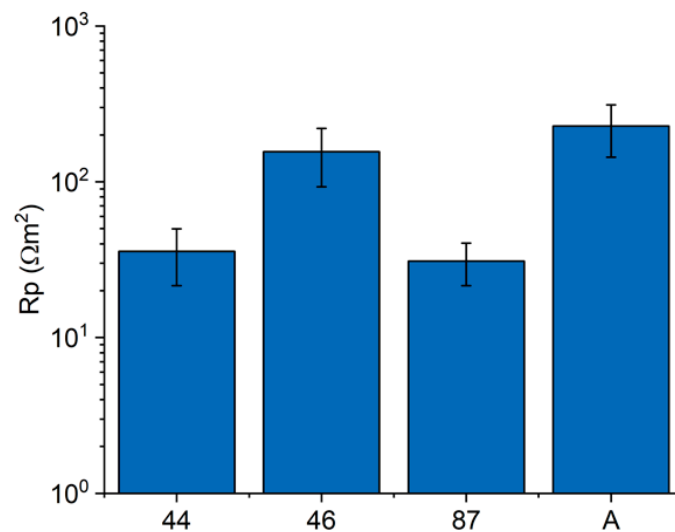
Figure 12. Polarization resistance measurements on iron fragments from the *San Carlone* of Arona.
