Decay Assessment of Stone-Built Cultural Heritage: The Case Study of the Cosenza Cathedral Façade (South Calabria, Italy)

Abstract: This study aims to assess the different decay phenomena affecting the Cosenza Cathedral façade (Calabria, South Italy) through the evaluation of the relative damage indices. For this goal, a multidisciplinary approach was applied exploiting both nondestructive and microdestructive techniques. Such a combination enabled proposing an intervention priority scale that can be helpful to institutions when planning a prompt restoration intervention. The results suggest the efficiency of this approach to obtain a multidisciplinary diagnostic and conservation system for the management and valorization of the Cultural Heritage also in terms of monitoring, maintenance, and selection of the most suitable restoration procedures over time.

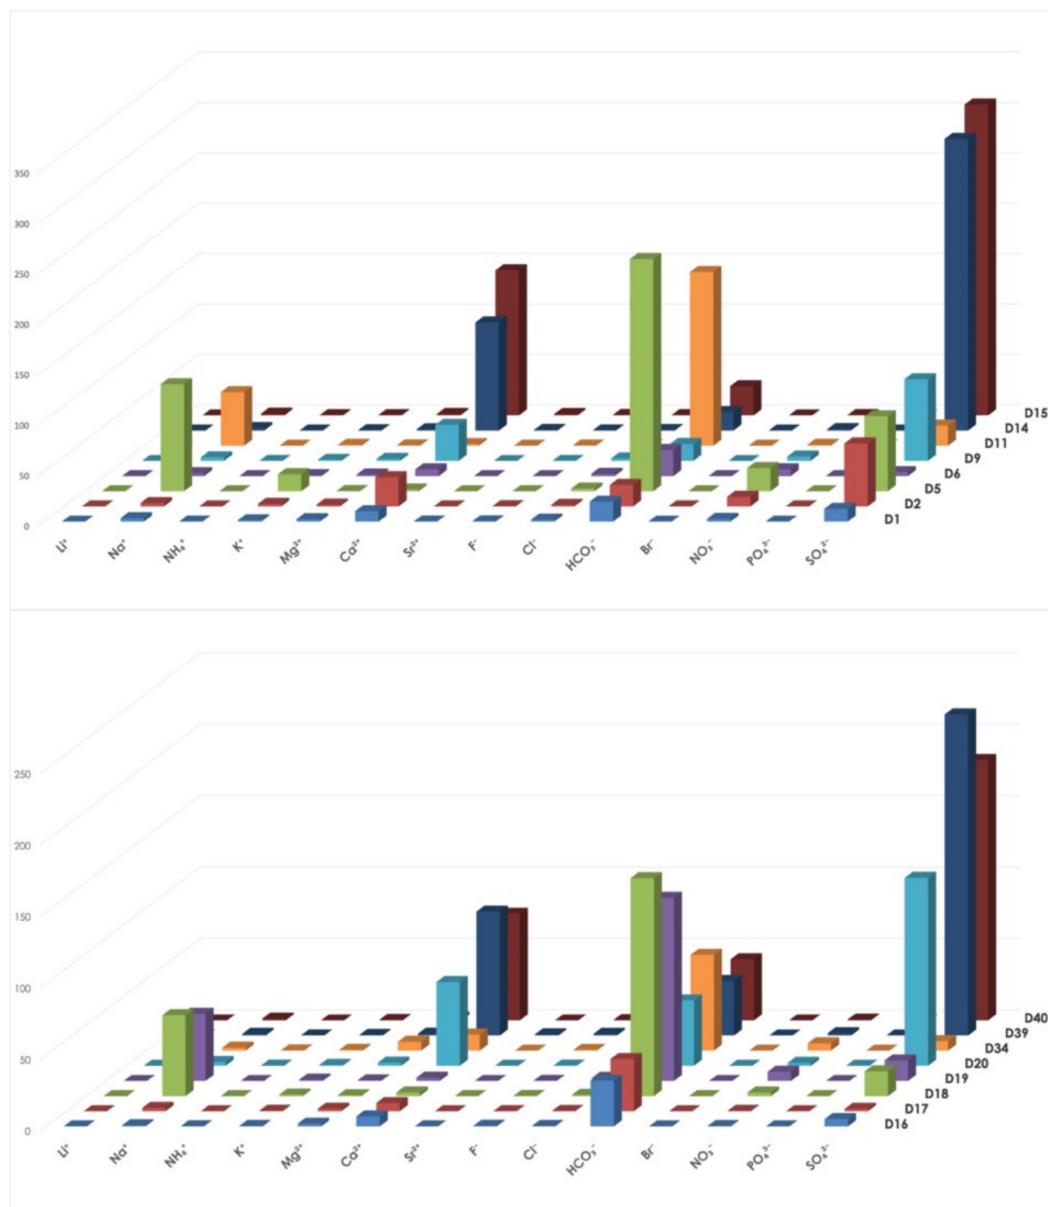
Figure 8. Anion and cation concentrations (mg/L).

IC analysis showed most of the samples were characterized by a high amount of sulphate and carbonate, associated with sodium and calcium (Table 5, Figure 8).

The IC results showed a good correlation between calcium and sulphate, testifying, according to FTIR analysis, that these two species were mainly present in the form of gypsum. The same behavior could not be determined for sodium and chlorine. In fact, an excess of sodium was evident in all samples compared to chlorine. This may be due to the presence of sodium sulphates as well as sodium chloride. As is well known, the presence and the crystallization of these soluble salts from repeated cycles of crystallization/dissolution within the porous matrix of the stone in porous materials is one of the major causes of rock decay in nature [25] and weathering of natural and/or artificial building material [26–28]. The growth of a crystal in a confined space (pore) can alter both the porosity and the pore size distribution of the stones, changing also their mechanical properties [29]. This process is emphasized in some sulphate species, particularly sodium sulphate. It exerts crystallization pressures on the pore walls, and in addition, undergoes a change in volume during its transition to the hydrated form (mirabilite), producing also a certain hydration pressure. The data collected in Table 4, report the largest concentration of these sodium sulphates in D5, D11, D18, and D19 coming from the portion of the church façade where efflorescences were much more intense. These samples also showed the highest rate of disintegration and fracturing, confirming the damaging effect of salt crystallization.

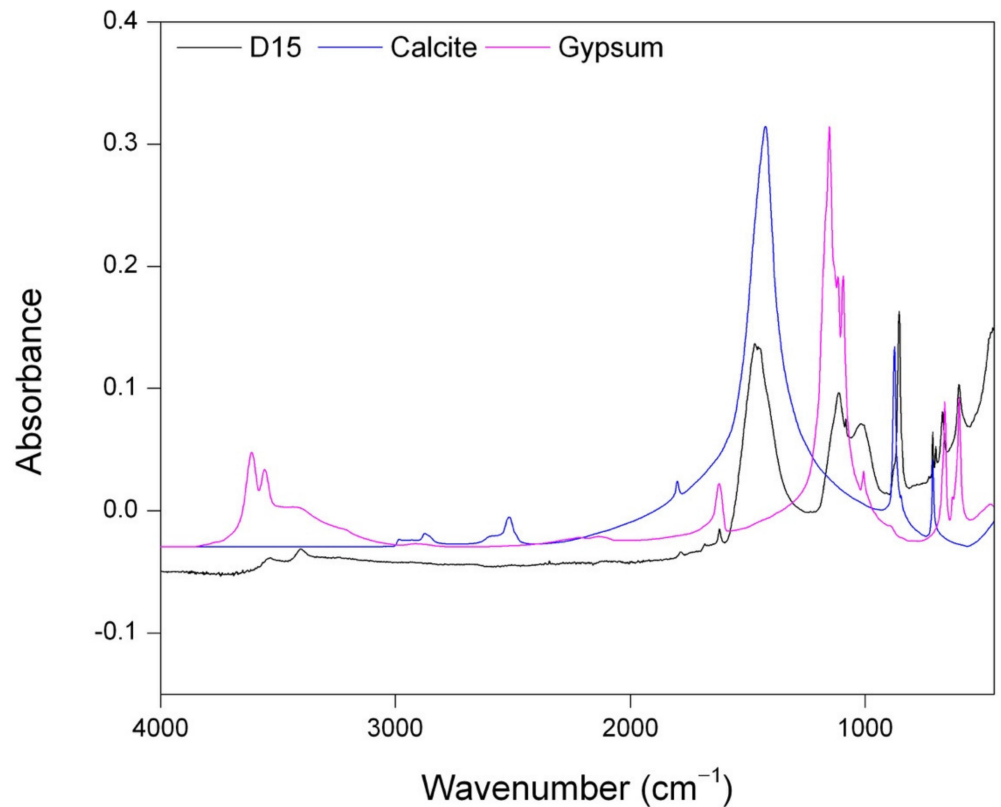
Figure 9. D15 sample IR spectra.

From the study of vibrational bands via FTIR, many mineralogical phases were identified, such as gypsum and calcite (Figure 9); moreover, traces of silicates were found (Table 6).

The presence of calcite can be attributed to the carbonate substrate while the presence of gypsum may depend on sulfation reactions caused by polluting agents, associated with black crust and efflorescence genesis.
