The problem of conservation of XX century architectural heritage: The fibreglass dome of the Woodpecker dance club in Milano Marittima (Italy)

Pizzigatti C., Franzoni E. (2021). The problem of conservation of XX century architectural heritage: The fibreglass dome of the Woodpecker dance club in Milano Marittima (Italy). JOURNAL OF BUILDING ENGINEERING, 42, 1-16 [10.1016/j.job.2021.102476].

# **The problem of conservation of XX Century architectural heritage: the fibreglass dome of the Woodpecker dance club in Milano Marittima (Italy)**

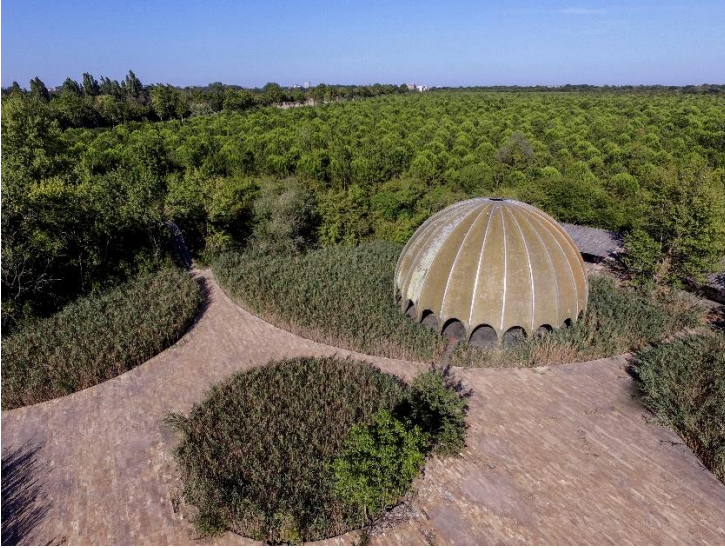
Several decades of abandonment compromised this place, but also provided it with a distinctive fascination, as the dome looks presently like an aerospace wreck among vegetation, covered on the whole external surface by variously coloured lichens that create an unusual illumination inside (Fig. 3).

**Fig. 3** Current state of the Woodpecker dance club, invaded by vegetation (the photo was taken through the drone described in § 3.1).

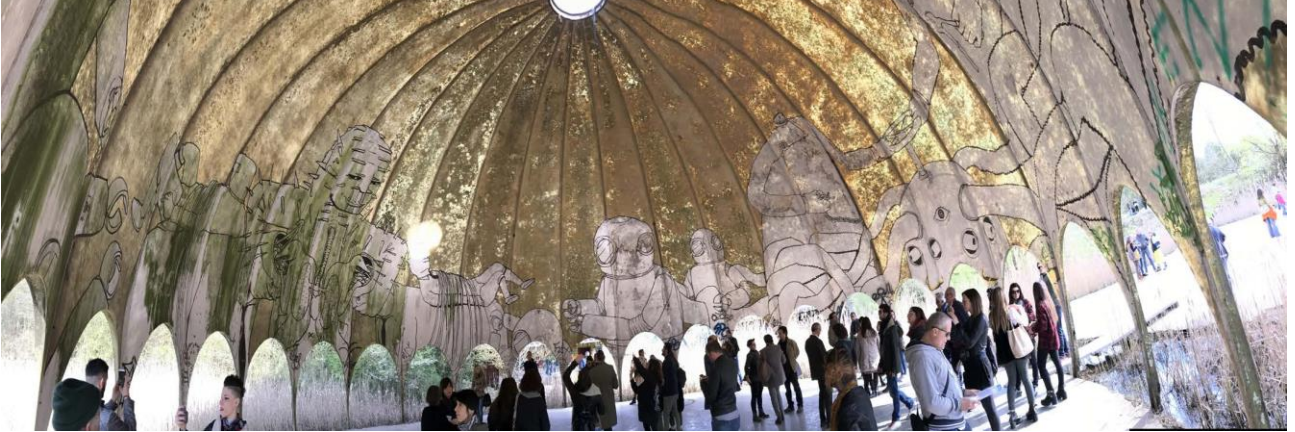
Furthermore, in the early 2000s a huge graffito was painted on the internal surface of the dome, representing a surrealistic subject. It was made with two colours only, namely black lines (probably brushed) and white backgrounds (probably made by rolls). Although no one has ever claimed its authorship, this graffito was attributed to Blu, an Italian street artist famous all over the world [21-22], as the subjects represented and the techniques adopted leave no doubts about his being the author (Fig. 4) [29-33].

**Fig. 4** Graffito by Blu inside the dome.

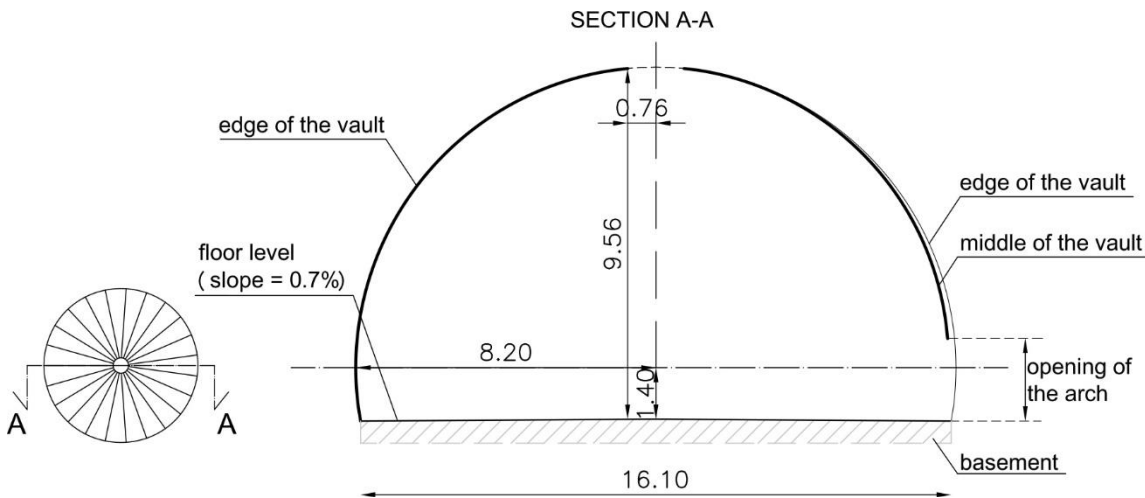
- it is a sphere of 8.20 m radius, sectioned 1.40 m below the horizontal diametral plane (Fig. 5);
- each vault has a sort of impluvium in the middle, which gradually increases from the top, where it is absent, to the bottom (Fig. 5).

**Fig. 5** Schematic representation of the cross section of the dome, drawn after a geometric investigation on site (sizes in m).

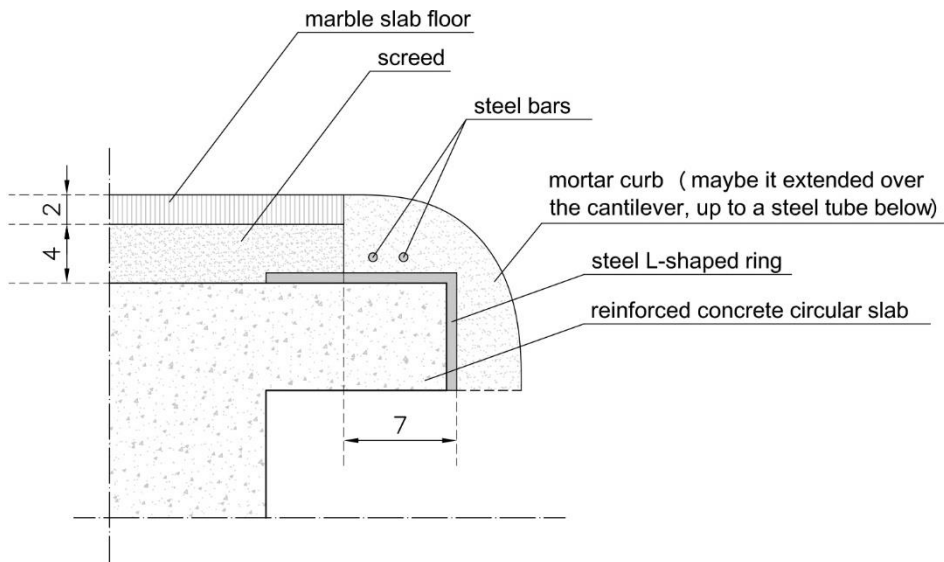
- the basement is a circular reinforced concrete slab, with a cantilever edge covered by a steel ring having a L-shaped cross section. This element, now completely rusted, was originally hidden under a mortar layer (Fig. 6), now mostly detached;

**Fig. 6** Edge of the basement: the cross section in correspondence of an opening of the dome, as inferred by the investigation on site (sizes in cm).

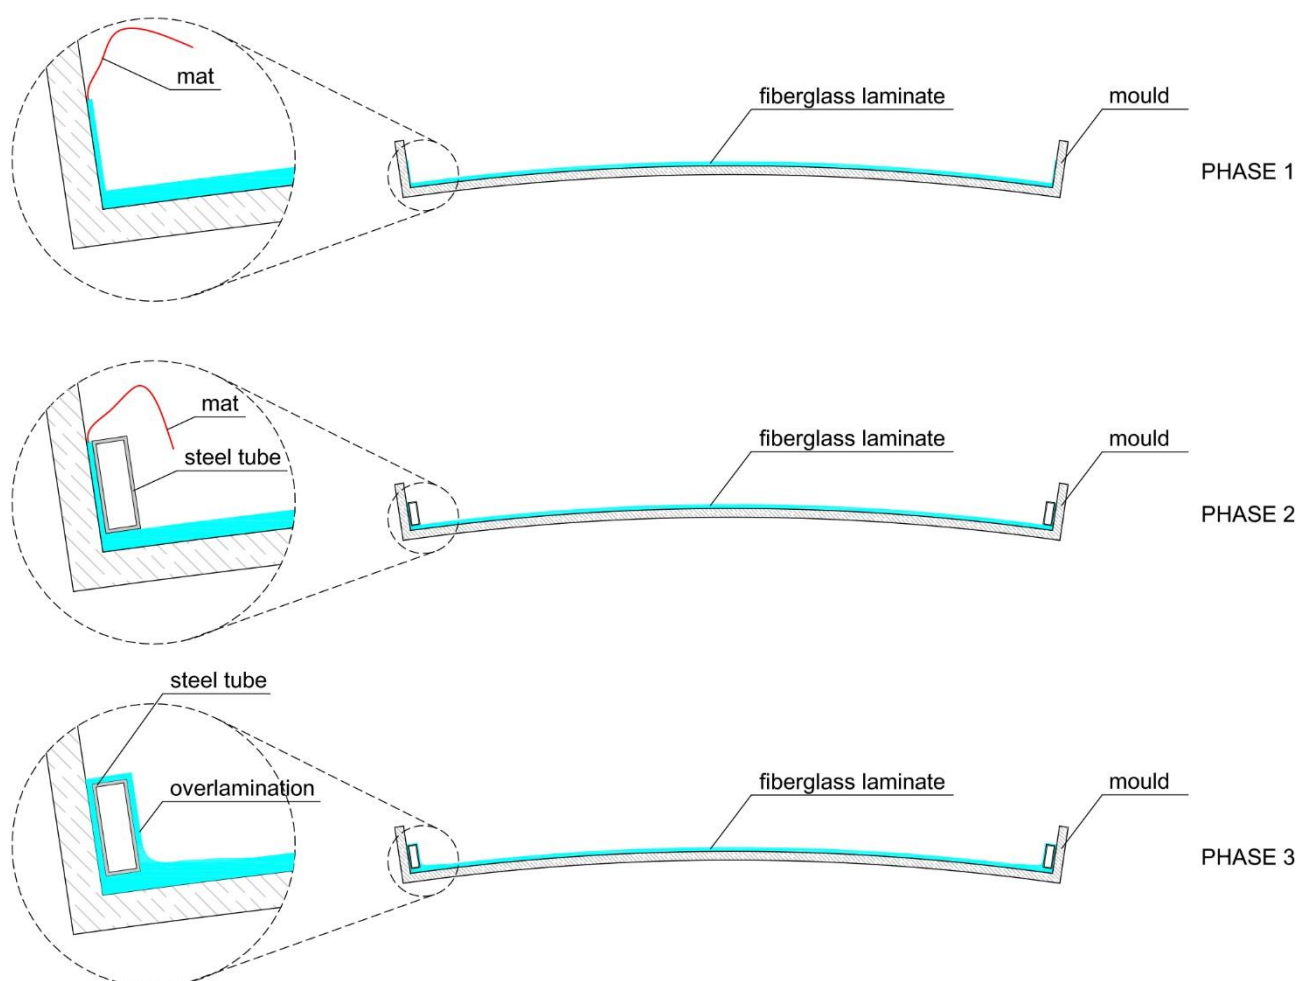
- The steel arches were embedded into the fibreglass through a manufacturing process named overlamination (Fig. 8) [26].
- Each single vault with two steel arches embedded along the main borders was manufactured at the shipyard, then transported to the construction site and assembled (see also the following issue).

**Fig. 8** Schematic illustration of the process of overlamination.

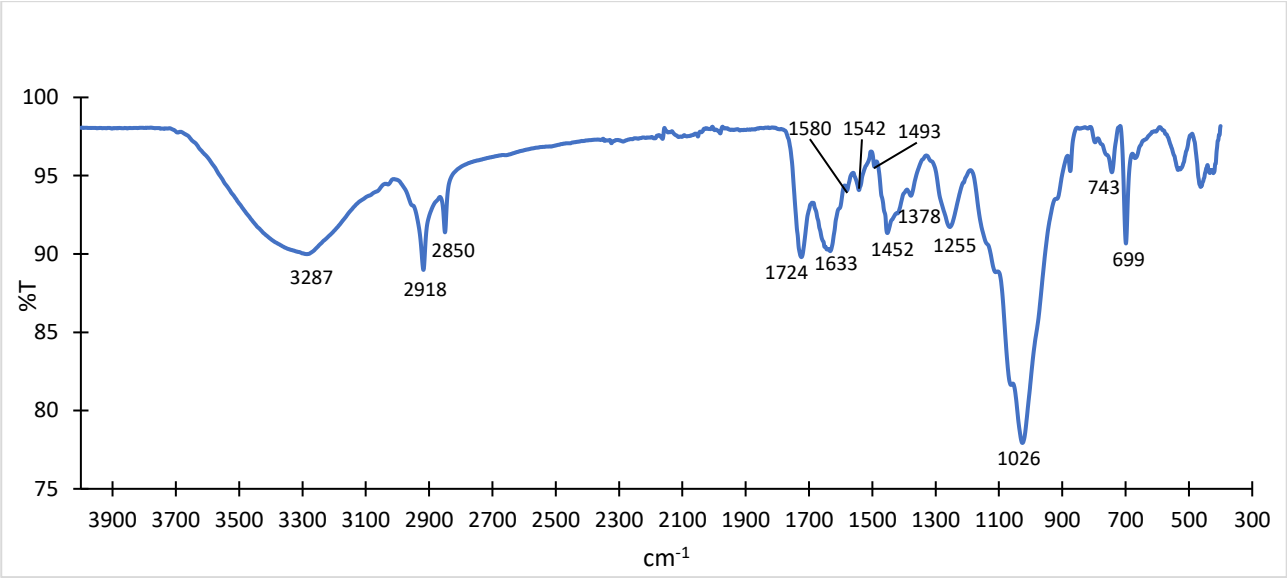
The FT-IR spectrum allowed the matrix to be identified as an unsaturated polyester resin (Fig. 17), which was the most widespread matrix in the production of fibreglass elements when the Woodpecker was built, due to its easy workability and a good performance to cost ratio [27, 55-57, 59-60]. The absorption bands were attributed as in the following:

**Fig. 17** FT-IR spectrum of the resin sample S3.

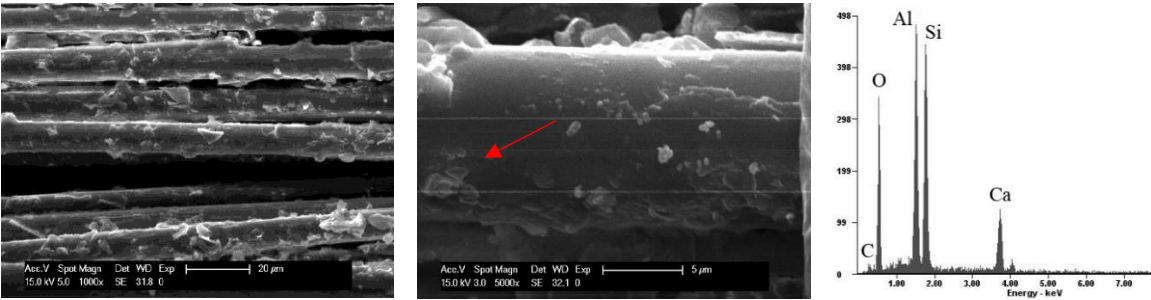
**Fig. 19** Glass fibre samples. On the left: SEM image of the fibres in sample S6 (marker = 20 μm). At the centre: a fibre of sample S6 observed at greater magnification (marker = 5 μm). On the right: EDS analysis of the same fiber shown at the centre, carried out in the point indicated by the red arrow.
