# **Collapse and damage to vernacular buildings induced by 2012 Emilia earthquakes**

Bovo Marco<sup>1,\*</sup>, Barbaresi Alberto<sup>1</sup>, Torreggiani Daniele<sup>1</sup> and Tassinari Patrizia<sup>1</sup>

## **Abstract**

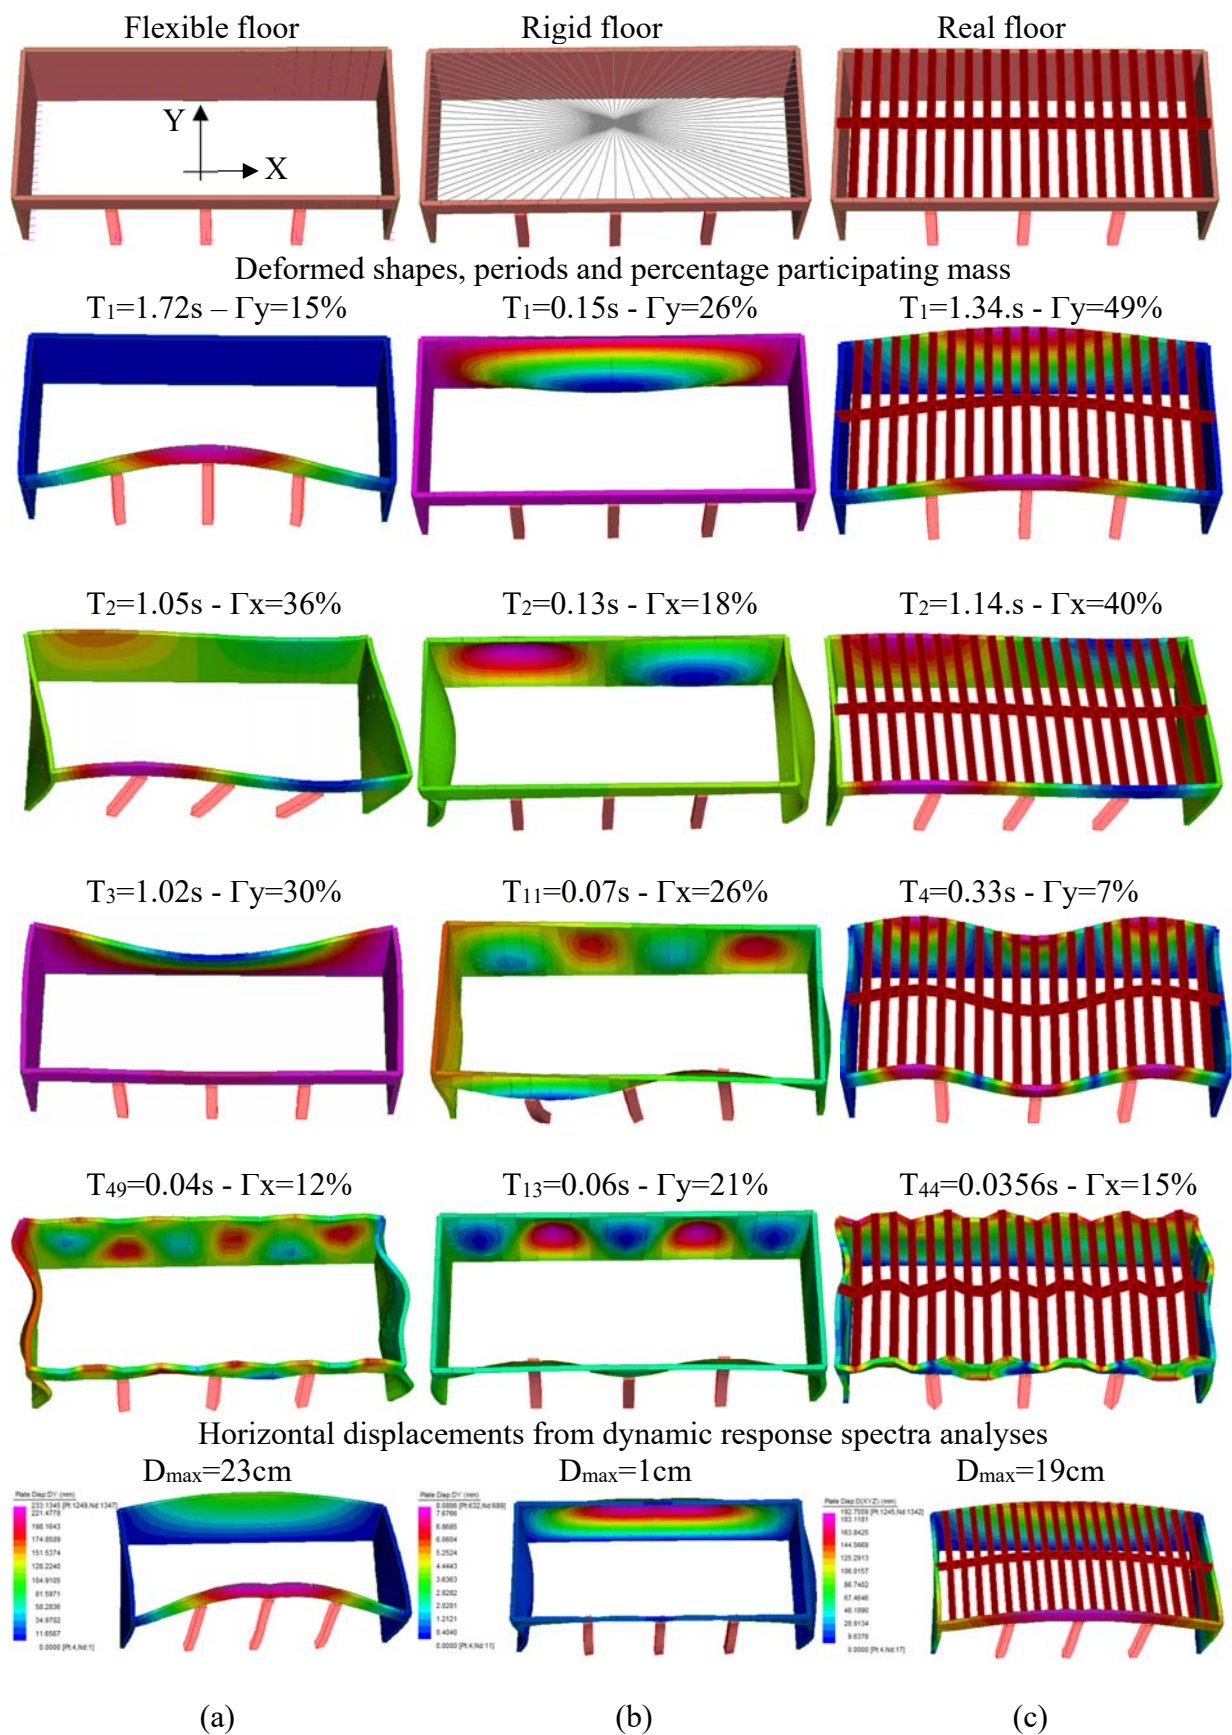
The first class of models, reproducing the whole geometry of building #22, is depicted in Figure 13. Three different assumptions, shown respectively in Figure 13a, b and c, have been made by considering alternatively an infinitely flexible floor, an infinitely rigid floor, and the real stiffness of the roof floor constituted by wooden beams. The walls were modelled by means of 4-node lagrangian shell elements. The masonry columns were elastic beams. For the masonry properties were selected the average values provided in [15]. They were a Young modulus  $E=2.6\text{GPa}$  and a Poisson ratio  $\nu=0.26$ . The models were clamped at the base. As far as the case simulating the real roof stiffness is concerned, beam finite elements were introduced in order to model the structural wooden members. The wooden elements have the cross-section dimensions detected

The deformed shapes associated at the two natural periods having the highest percentage of effective mass in X and Y directions (where X is parallel to the longitudinal direction and Y is parallel to the transversal direction) are reported in the figure for the different hypotheses. As expected, the flexible floor provides the longer periods and the deformed shapes are the local vibrating modes of the various vertical elements with their tributary mass. The considerable in-plane asymmetry, for seismic action component along longitudinal direction, do not produce significant torsional effects, since the vibrating modes mainly imposed translational displacements. On the contrary, the seismic response for the case of rigid floor hypothesis (Figure 13b) show deformed shape imposing roof displacement mainly governed by torsional vibrating modes. In this case, the natural periods are generally shorter than the previous and they are associated to deformed shapes that change also the vibrating shape of local modes. It is worth to note that the behaviour of the FEM with real floor (Figure 13c), have deformed shapes and range periods more similar to those of the infinitely deformable floor FEM, thus indicating that typical trussed wooden elements constituting the floors of historical “barchessa” are very far from rigid floor assumptions. In general, the existent roof solution does not introduce significant torsional effects. By the prospective of a seismic strengthening, in the design of the upgrading interventions for this class of buildings, the introduction of a very stiff floor does not create evident benefits, while it could even cause a worse global dynamic behaviour of the building. It is important to highlight that the displacements assessed by means of dynamic response spectra analyses are completely different for the case of the rigid floor (maximum expected displacement of 1cm), while are comparable for the real and deformable floor assumptions (respectively 19 cm and 23 cm). These values are in good agreement with those provided by the spectra in Figure 3d (about 13-21cm following the records of MIR01 station for  $T_1=1.4\text{s}$ ). In a first simplified modelling attempt, the deformable floor FEM provided a conservative displacements scenario.

Figure 13. Finite element modelling of building #22. Deformed shapes, vibrating period (T), percentage participating mass ( $\Gamma$ ), and displacement demand in the hypothesis of (a) flexible floor, (b) rigid floor and (c) real floor.

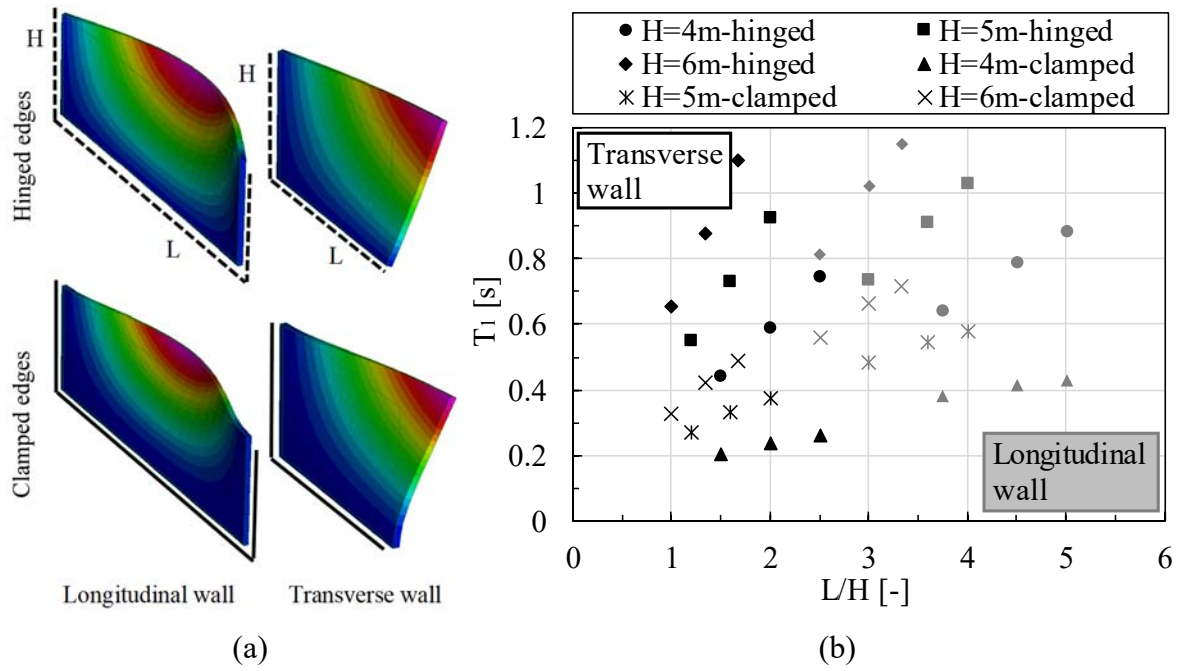
The “barchessa” studied in the present work has L/H ratio equal to 3.50 and 1.60 respectively for longitudinal and transverse walls. The comparison between vibrating periods of local and global models, shows that the most suitable restraint hypothesis for the walls is the one prescribing cylindrical hinge along the edges. In fact, the global models provide a vibrating period of 1.02s and 1.05s, respectively for vibrating modes involving local modes of longitudinal and transverse wall. The estimations of vibrating periods from local FEMs (with hinged edges) result very close to those correct, providing the Figure 14b values of 0.92s and 1.08s, respectively for longitudinal and transverse wall.

Due to reduced thickness, if compared to the other dimensions, the hinge restraint hypothesis may appear suitable for most of the structures in the categories A2 and A3. By means of the analysis of the displacements map of structures with first vibrating period around 1s, as the “barchessa” investigated here, the evaluation of the maximum displacements suffered during the event of May 29<sup>th</sup> provides values larger than 10cm for an epicentre distance of 15-20km (see Figure 5b2). This high seismic displacement demand could explain the overturning mechanisms observed in slender buildings, since in several cases it produced the exit of the vertical loads resultant from the wall base section.

Figure 14. Analysis of the first vibrating periods of vertical walls in buildings with flexible floor. (a) Finite element modelling and deformed shape for different types of restraint; (b) first out-of-plane vibrating periods as a function of the  $L/H$  ratio, with  $L$  and  $H$  as reported in figure.
