## Supplementary material for the manuscript:

Evaluation of the effectiveness of coatings for the protection of outdoor terracotta artworks through artificial ageing tests

S. Spadavecchia, C. Chiavari\*, F. Ospitali, S. Gualtieri, A.C. Hillar, E. Bernardi

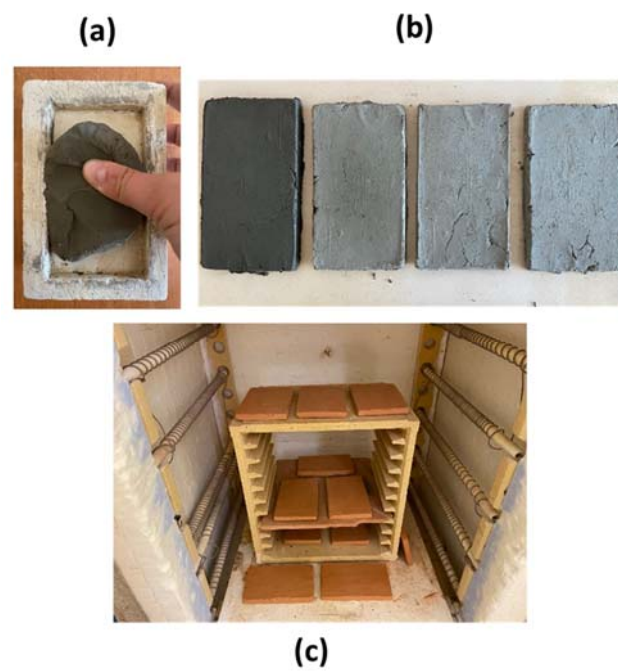
**Fig. S2.** Stages of specimens' preparation: *molding* (a), *drying* (b) and *firing* (c).

- Fig. S1.** “Muro del vento” (Wind Wall) by Domenico Matteucci, 1989, Martyrs of Liberty square, Faenza, Italy. pag.2
- Fig. S2.** Stages of specimens’ preparation: *molding* (a), *drying* (b) and *firing* (c). pag.2

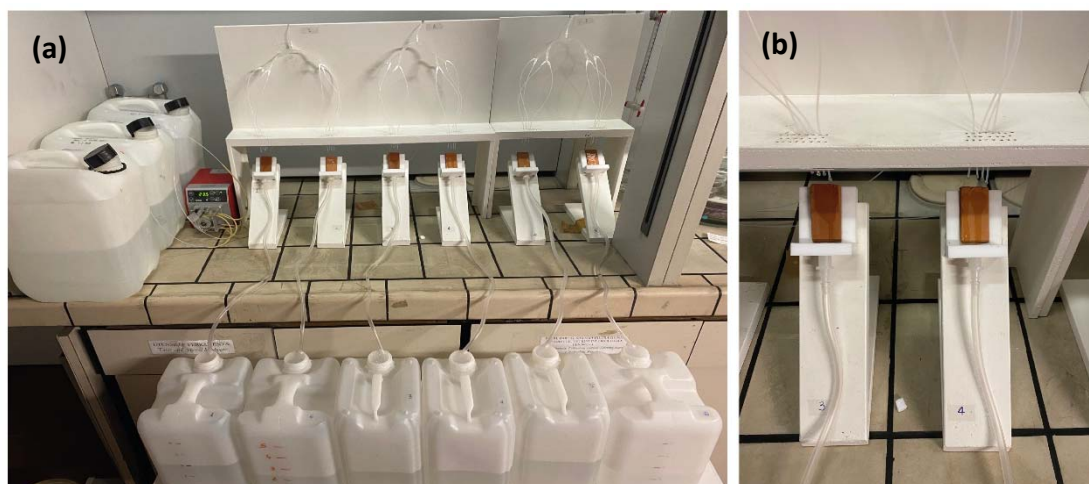
**Fig. S3.** Runoff test setup (a); detail of two runoff stations during the test (b).

- Fig. S3.** Runoff test setup (a); detail of two runoff stations during the test (b). pag.3
- Fig. S4.** Scheme of the climatic chamber cycle, shaded in yellow the segments where UVA irradiation was on. pag.3

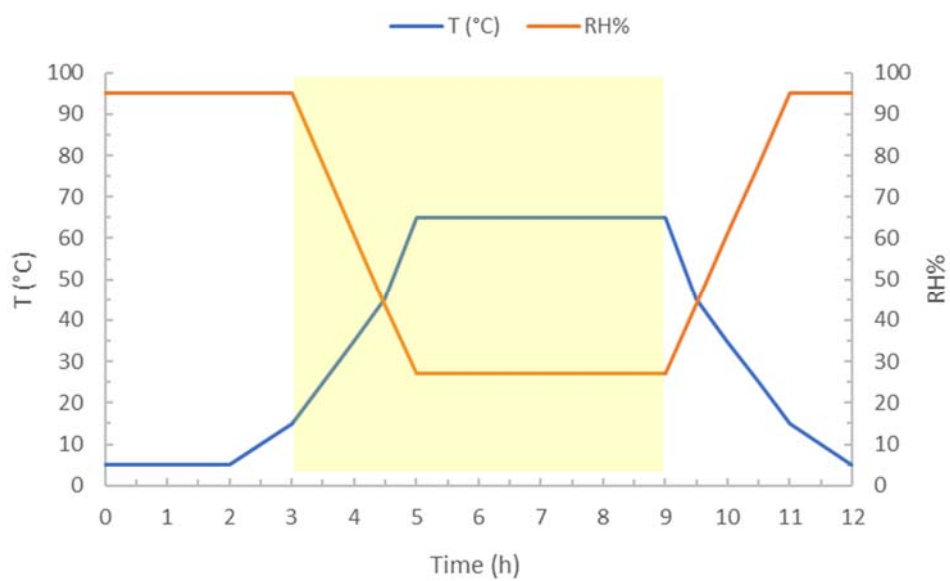
**Fig. S4.** Scheme of the climatic chamber cycle, shaded in yellow the segments where UVA irradiation was on.

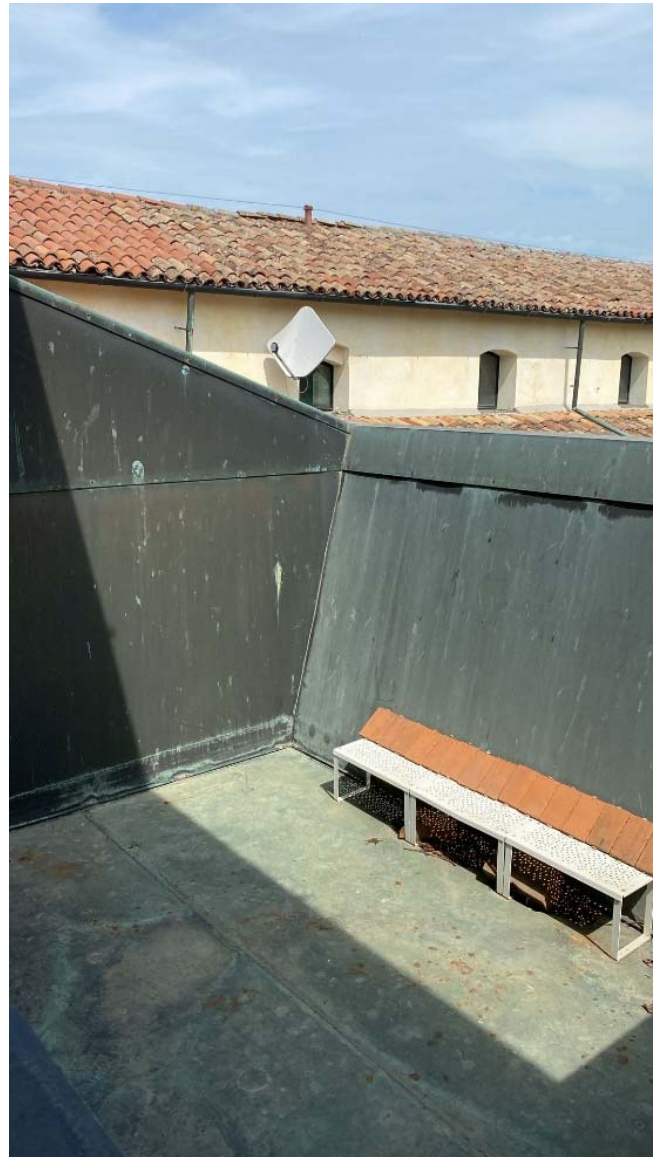
**Fig. S5.** Long-term outdoor ageing: general view of specimens exposed on a terrace at the Museo Internazionale delle Ceramiche in Faenza.

- Fig. S5.** Long-term outdoor ageing: general view of specimens exposed on a terrace at the Museo Internazionale delle Ceramiche in Faenza (Italy). pag.4

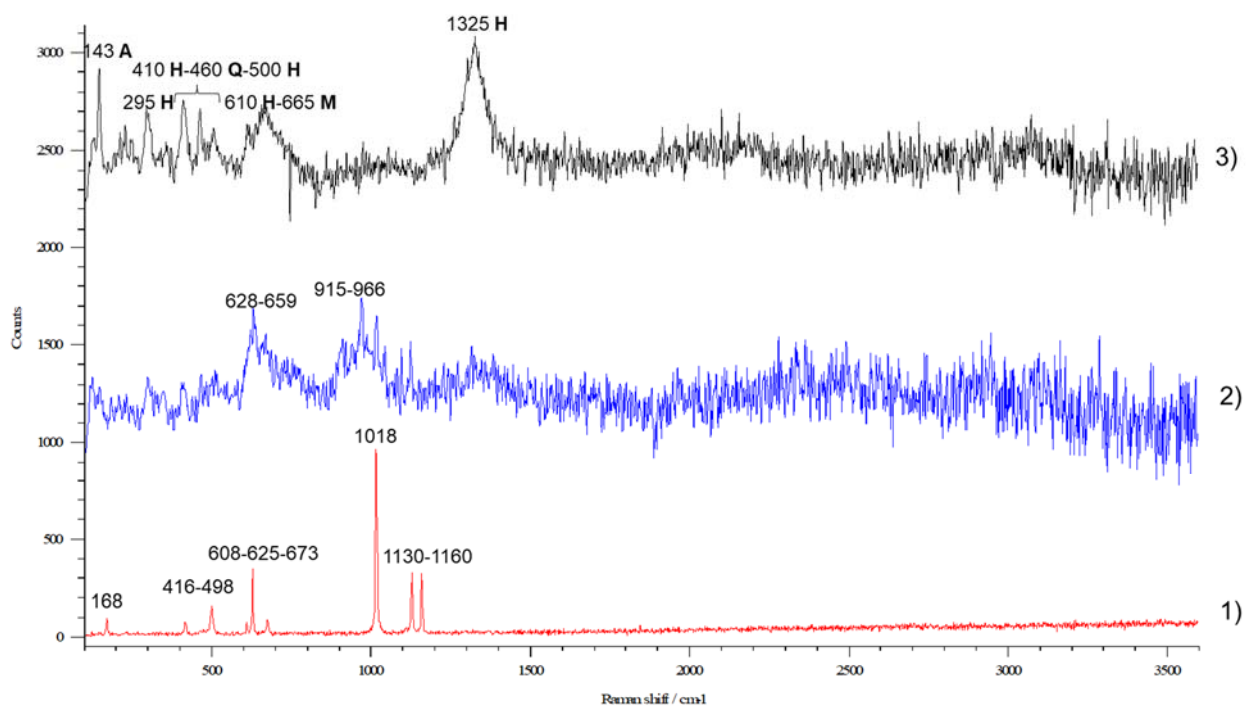
**Fig. S6.** Raman spectra of some minerals detected on the surface of a pristine terracotta sample. From bottom: 1) anhydrite; 2) simil-braunite; 3) iron oxides (haematite (H) and magnetite (M)), quartz (Q) and anatase (A).

- Fig. S6.** Raman spectra of some minerals detected on the surface of a pristine terracotta sample. From bottom: 1) anhydrite; 2) simil-braunite; 3) iron oxides (haematite (H) and magnetite (M)), quartz (Q) and anatase (A). pag.5

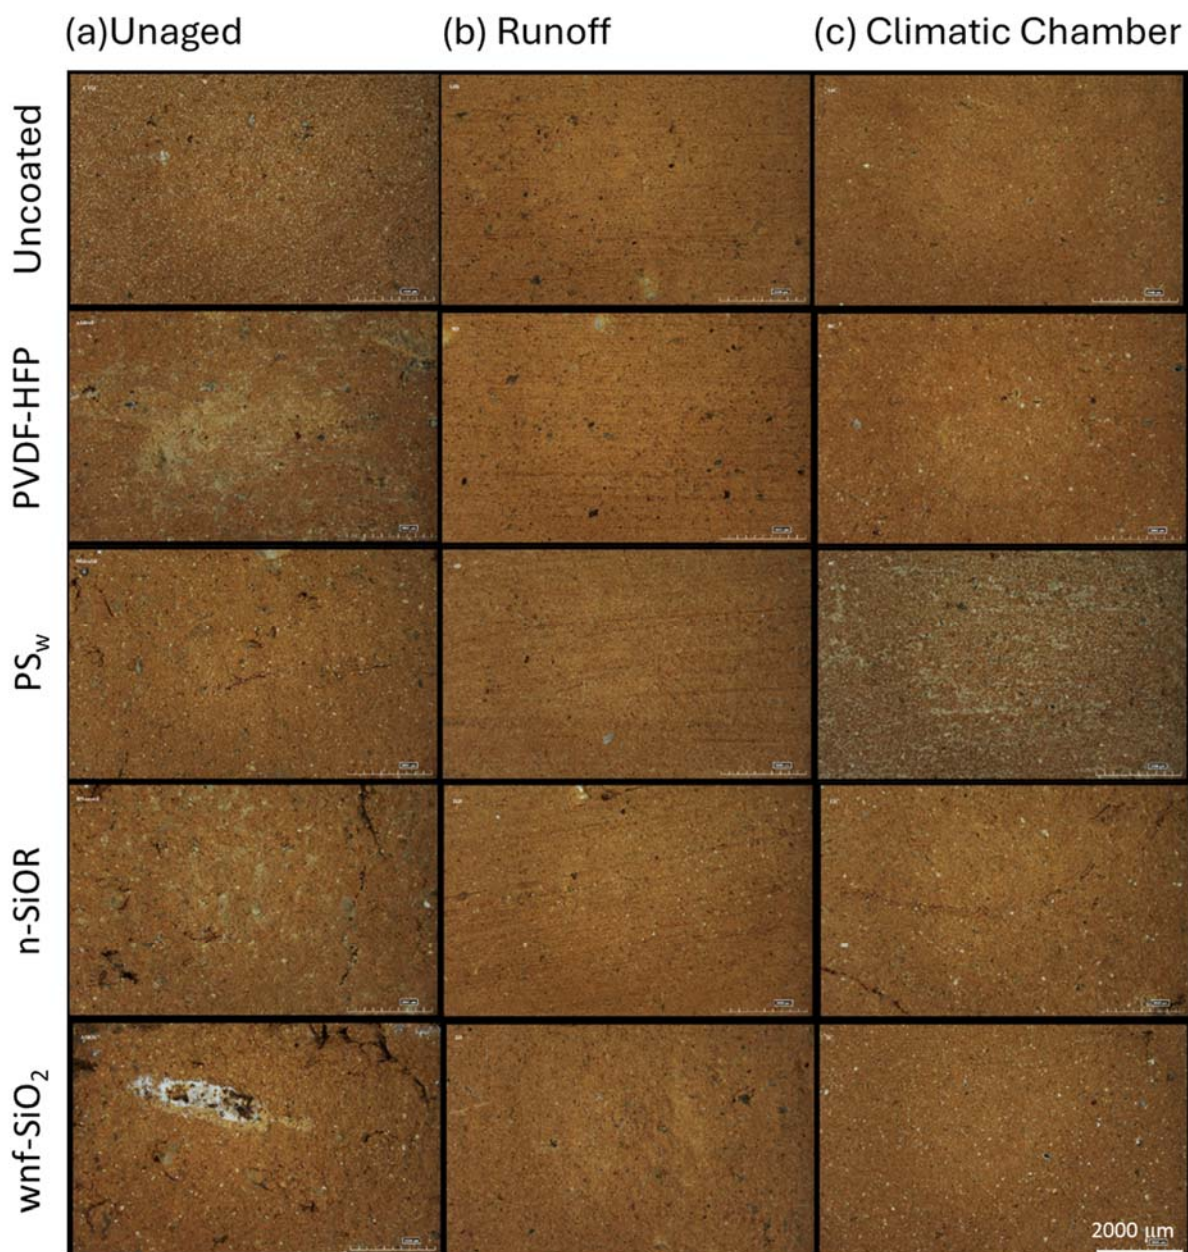
**Fig. S7.** 3D digital microscope images of coated and uncoated specimens, before (a) and after aging through runoff (b) and climatic chamber (c).

- Fig. S7.** 3D digital microscope images of coated and uncoated specimens, before (a) and after aging through runoff (b) and climatic chamber (c). pag.6

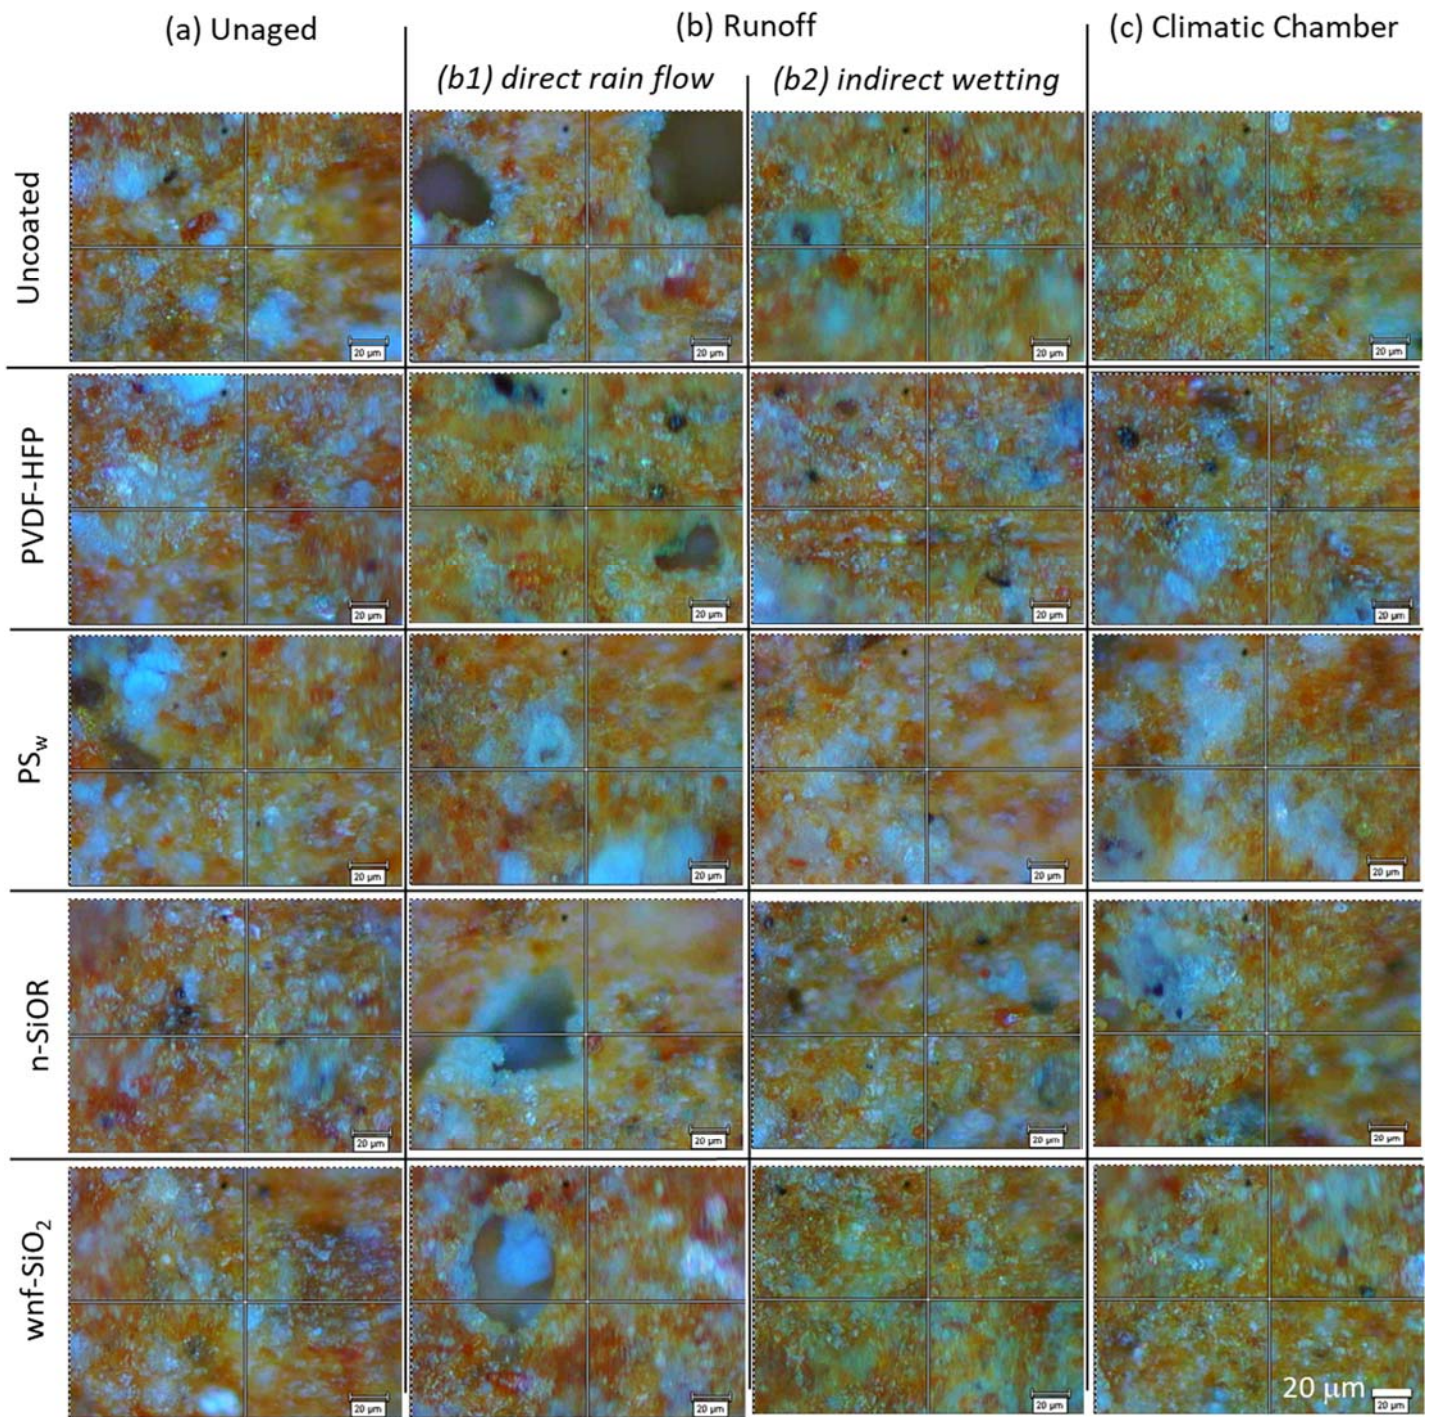
**Fig. S8.** Optical microscope images of coated and uncoated specimens, before (a) and after aging through runoff (b) and climatic chamber (c). In the case runoff, areas directly impacted by the rain (b1) and areas indirectly wetted (b2) are compared.

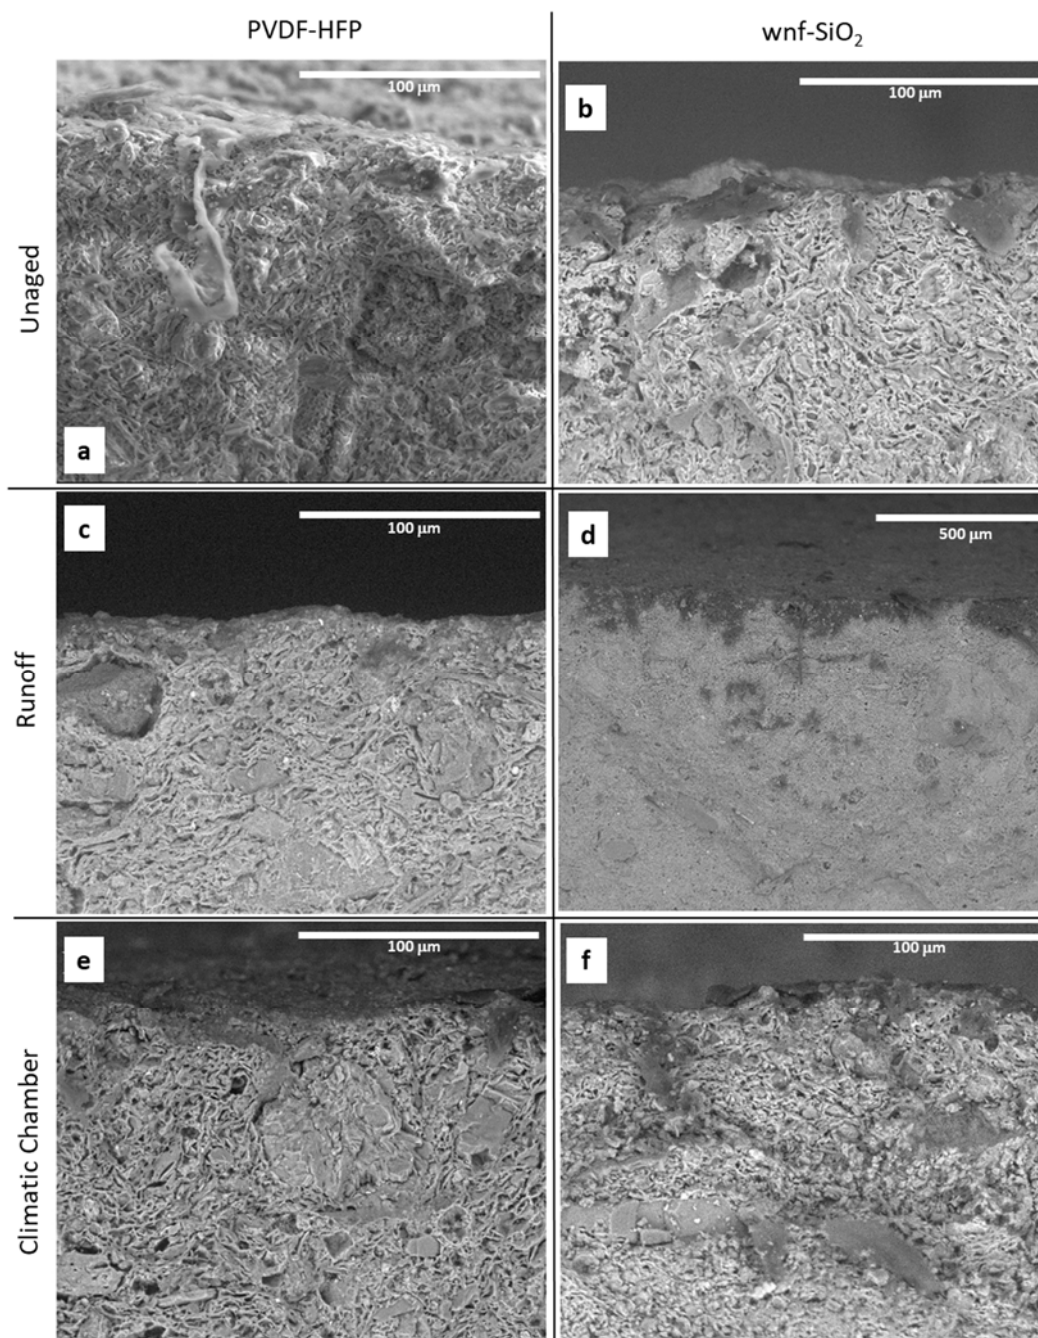
**Fig. S9.** ESEM images of cross-sections of specimens treated with PVDF-HFP and wnf-SiO<sub>2</sub> before (a, b) and after aging through runoff (c, d) and climatic chamber (e, f).

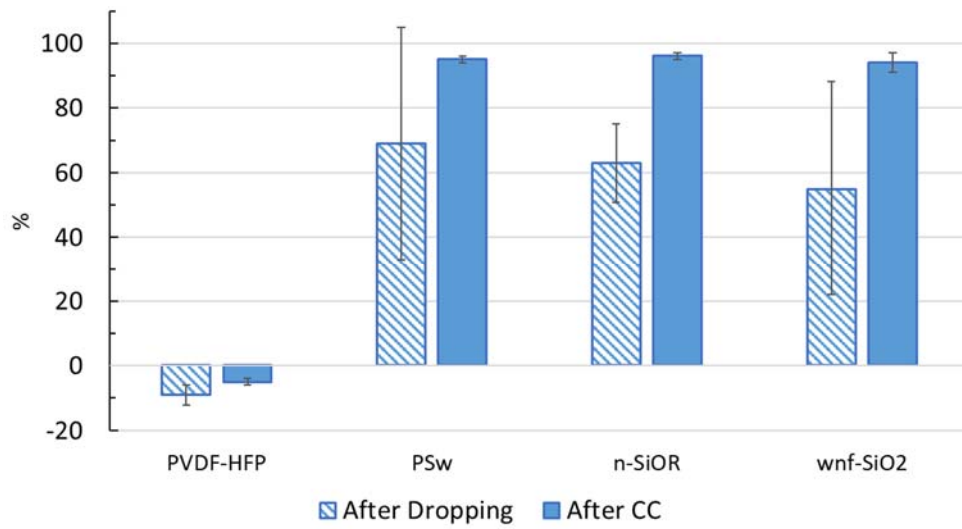
**Fig. S10.** Percent reduction of water absorption capacity ( $C_w\%$ ) of coated specimens after ageing by runoff and climatic chamber with respect to uncoated specimens aged in the same conditions.

- Fig. S10.** Percent reduction of water absorption capacity ( $C_w\%$ ) of coated specimens after ageing by runoff and climatic chamber with respect to uncoated specimens aged in the same conditions. pag.9
