Using pre-failure and post-failure remote sensing data to constrain the three-dimensional numerical model of a large rock slope failure

Using pre-failure and post-failure remote sensing data to constrain the three-dimensional numerical model of a large rock slope failure Davide Donati ¹*(ORCiD: 0000-0003-4083-5910); Doug Stead ¹; Marc-André Brideau ²; Monica Ghirotti ³

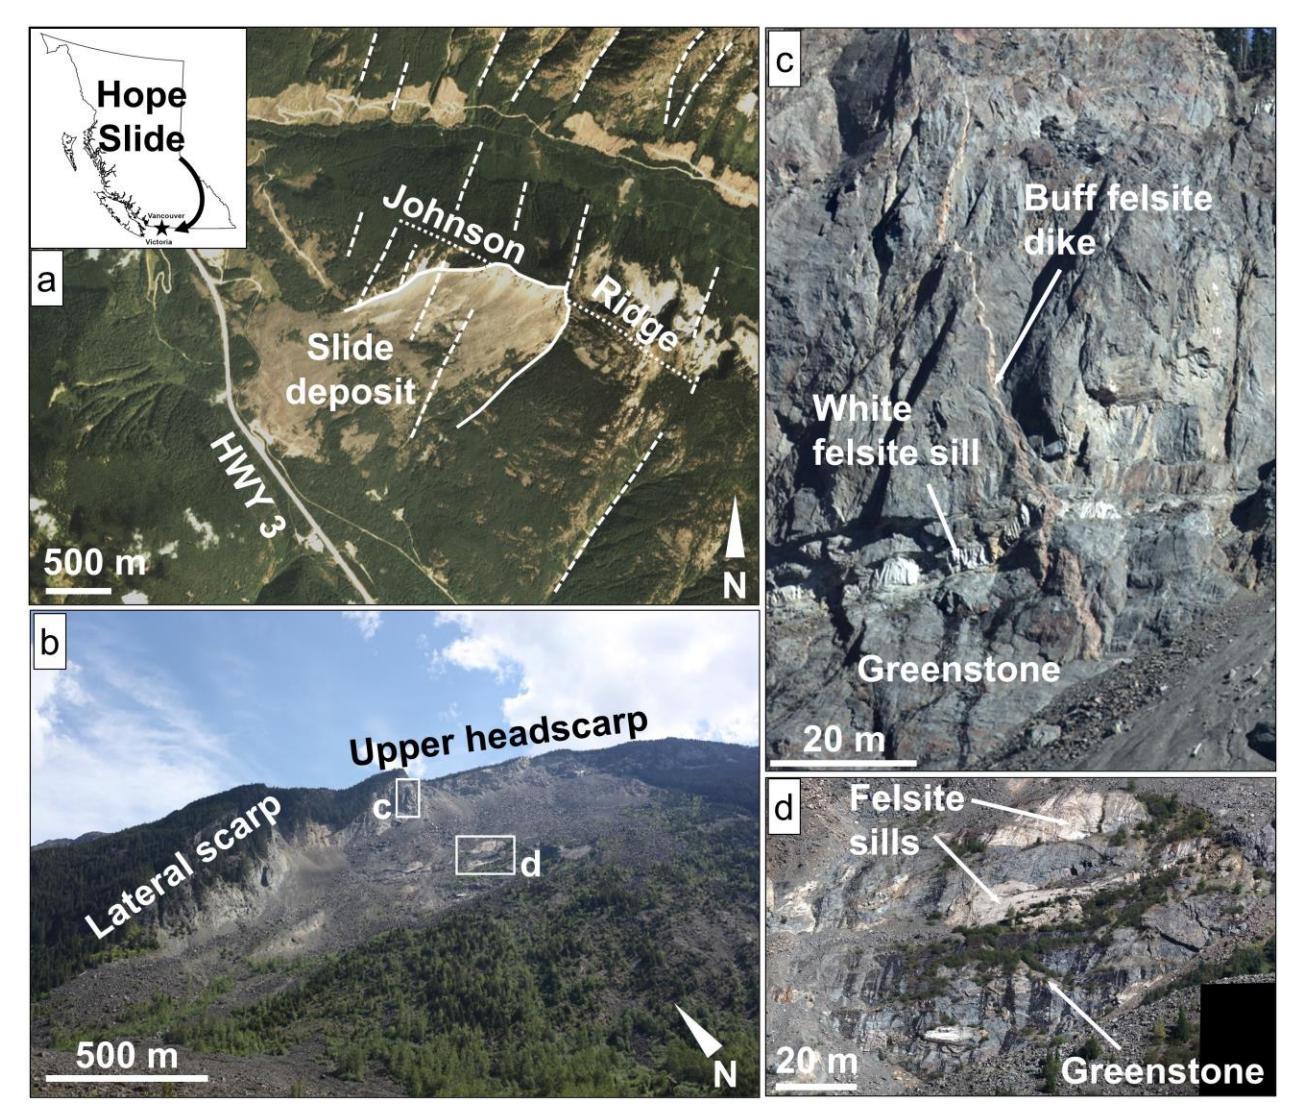
Fig. 1Geographic and lithological overview of the Hope Slide. a: 2018 satellite image (Planet Team,
2019) of the slide area. Dashed lines indicate linear structural features. Dotted curve outlines
the Johnson Ridge. Solid line shows the boundary of the 1965 slide area. In the inset, the star
indicates the location of the Hope Slide in British Columbia; b: view of the slide area from
the viewpoint at the base of the slope (photograph summer 2015); c,d: detail of the rock mass
and lithology contacts along the lateral scarp and within the daylighting part of the rupture
surface (photographs taken fall 2011).

The Hope Slide is located within the Northern Cascades Mountain Range, in southern British Columbia. The slide area is presently bounded on the northern and north-western sides by sub-vertical slopes, up to 150 m high, which define the lateral scarp and upper headscarp, respectively. The rupture surface dips in a westward direction at an angle of 30°. The basal sliding surface is largely covered by debris, except for a steeper, 200 m by 150 m area in the central part of the slope, where the bedrock outcrops (Fig. 1b).

The slope is formed by Paleozoic greenstone of the Hozameen Complex, a weakly metamorphosed mafic volcanic rock (Fig. 1c,d). The rock is massive in nature, and the volcanic texture and structure have been obliterated by metamorphic recrystallization (McTaggart and Thompson, 1967). Locally, the greenstone is intruded by sills and dikes of felsite, an aphanitic, volcanic rock that occurs as pinkish and buff colour varieties. Buff felsite is organized in sills dipping out of the slope. Two such sills clearly stand out within the daylighting portion of the rupture surface (Fig. 1d). Felsite-greenstone lithological contacts appear to be sharp and devoid of gouge, except within or close to tectonic structures (faults and shear zones), where clay-rich infill can be observed (Brideau et al., 2005).

- 128 The slide area is traversed by several NNW-SSE striking faults that form gullies and crevices on both sides
- 129 of the Johnson Ridge (Fig. 1a). Von Sacken (1991) suggested that the structures controlled the behavior of the slide,
- 130 and that one of the faults divided the volumes that failed in the two stages of the 1965 event. Brideau et al. (2005)
- 131 further investigated the structurally controlled nature of the slope failure, suggesting that tectonic shear zones may
- have acted as lateral release surfaces along the northern and southern boundaries of the slide. They also observed
- 133 changes in orientation of the basal rupture surface, which were associated with a regional scale synform.

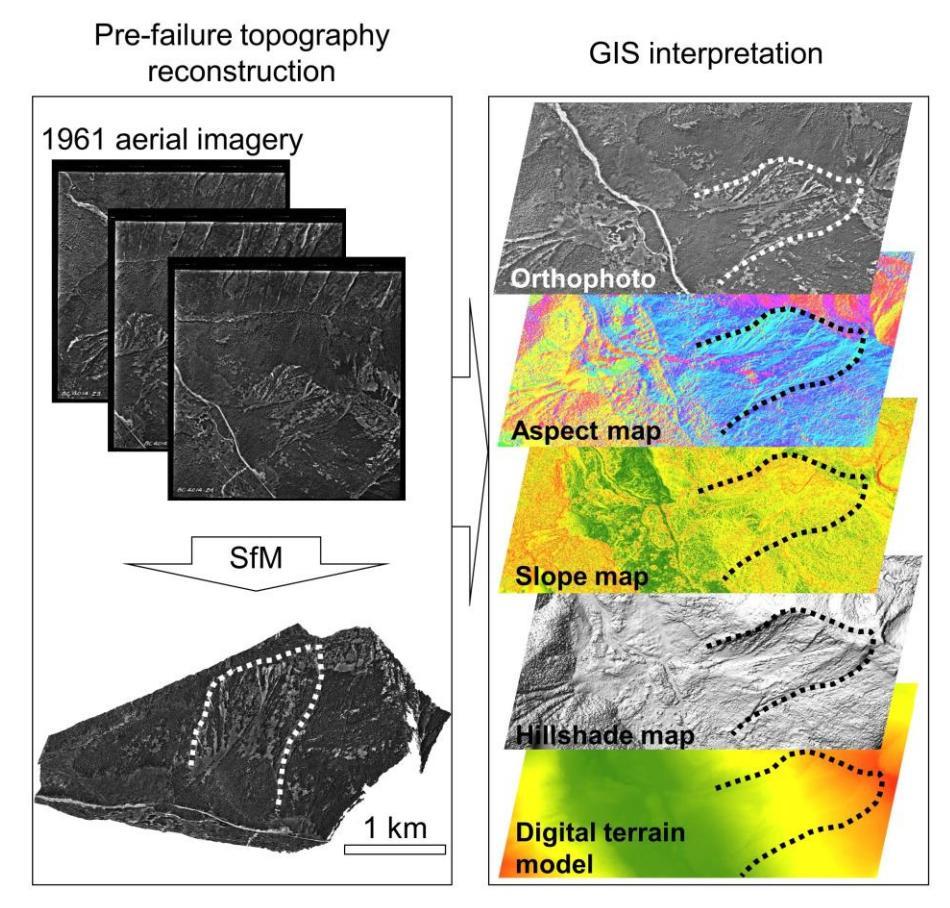
Fig. 3

Conceptual workflow for the reconstruction and analysis of the pre-failure slope topography. The 1961 historical aerial imagery was processed using a SfM approach to obtain the pre-1965 slope geometry. The dotted curve outlines the area affected by the slide.

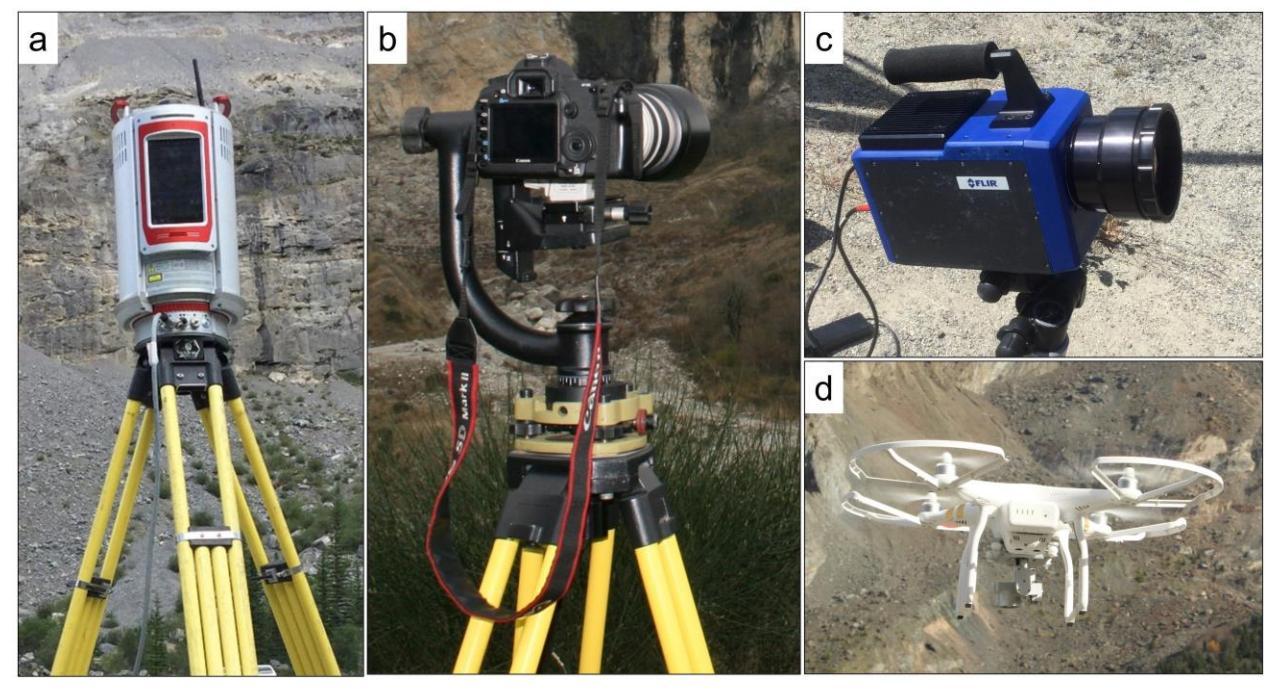
Fig. 4

Remote sensing equipment employed for the investigation of the Hope Slide; a: Riegl VZ-4000 terrestrial laser scanner; b: Canon EOS 5D Mark II DSLR camera with f = 400 mm focal length lens, mounted on a panorama frame; c: FLIR SC7750 thermal camera with f = 100 mm focal length lens; d: DJI Phantom 3 Pro Quadcopter.

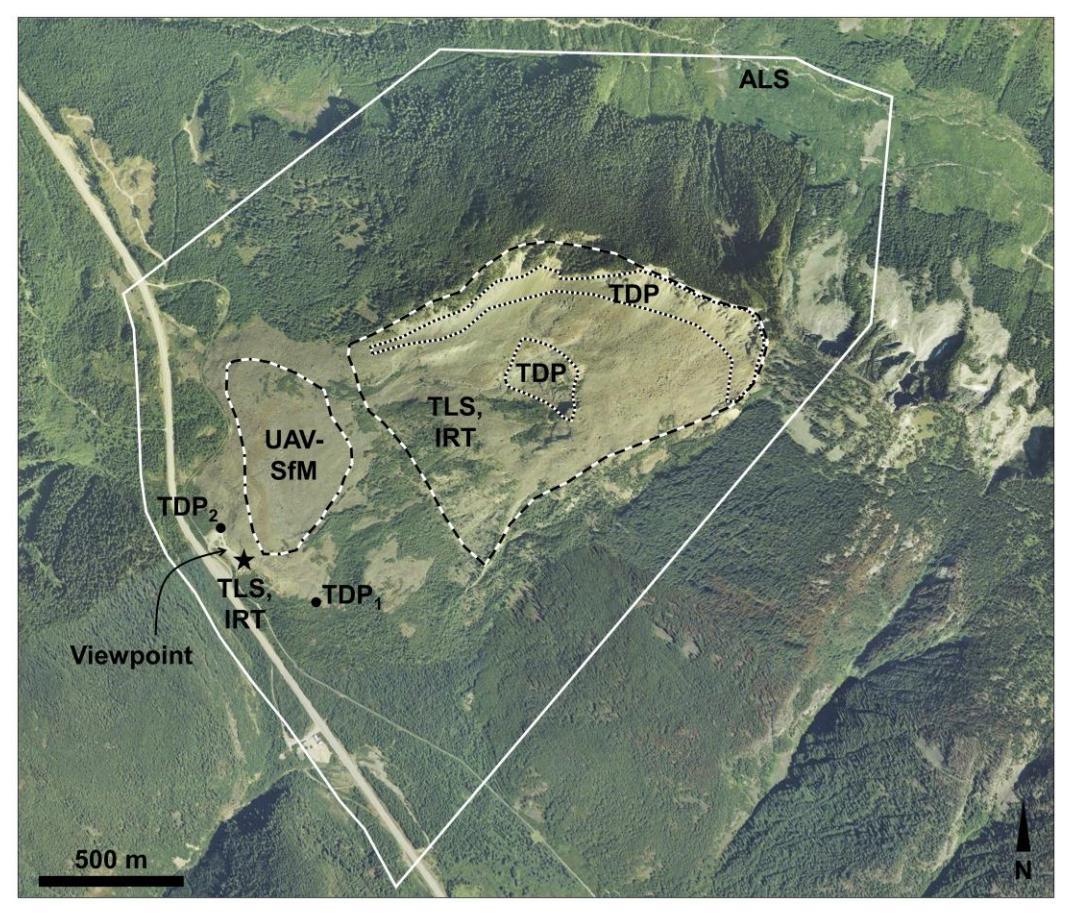
Fig. 5

Location of the remote sensing stations (photograph from Google Earth). Dots identify the camera stations used for the TDP survey of the headscarp; the star marks the location of TLS and IRT stations; polygons outline the areal coverage of each survey, including the surface of the slide deposit investigated using UAV-SfM. Historical imagery SfM datasets extend beyond the boundaries of the photograph.

305 A seepage investigation was performed using IRT. The FLIR SC7760 thermal camera was employed to 306 capture infrared imagery of the rupture surface from the viewpoint at the southwestern edge of the debris field (Fig. 307 5). Several seepage areas were identified and mapped, mostly located within the daylighting portion of rupture 308 surface in the central part of the slope (Fig. 12). Most of the seepage was found to occur along discontinuities in set 309 J1 and at lithological contacts between greenstone and felsite. The presence of excessive pore water pressure along 310 discontinuities sub-parallel to the slope orientation may have decreased the effective stresses along the rupture 311 surface, thus acting as a predisposing factor for the failure. However, the role of groundwater in 1965 is still unclear. 312 Mathews and McTaggart (1969) argued that pore water pressure did not have a primary role in the slope failure, due 313 to the low, below-freezing temperature observed in the area in the weeks prior to the event. In fact, they suggested 314 that freezing temperatures prevented snowmelt, while a continued seepage, due to the geothermal gradient, led to the 315 gradual depletion of hydrostatic pressure in the rock fractures. Conversely, Brideau et al. (2005) suggested that cold 316 temperature could have caused the groundwater to freeze at the surface, preventing seepage and thus the dissipation 317 of the hydrostatic pressure. Additionally, an increase in minimum temperature from -12°C to 0°C was registered at 318 the "Hope A" weather station (located at the Hope Aerodrome) in the two days prior to the failure. This increase in 319 temperature, together with the typically high rainfall in December and January (around 250-280 mm monthly

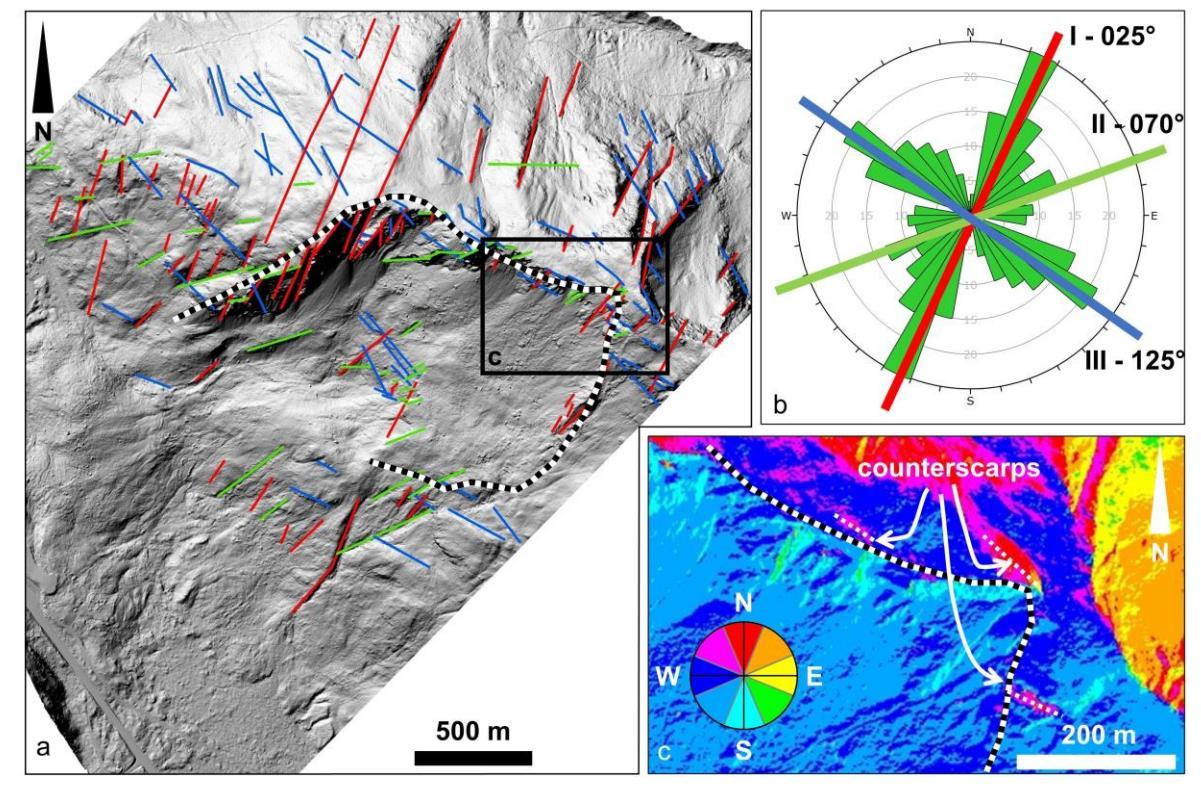
72 Fig. 6 73 74 75 Summary of the lineament analysis conducted on the ALS post-failure DTM of the Hope Slide. a: map of lineaments, color-coded based on the trend orientation. The dotted outline represents the boundary of the failed slope. The square window outlines the area represented in c. The basemap is the hillshade view of the ALS dataset. b: rosette diagram of the lineaments. The principal lineament trends are highlighted, and coloured based on the trends observed in a. c: aspect map of the western headscarp, showing the intersection with counterscarps with trend similar to III.

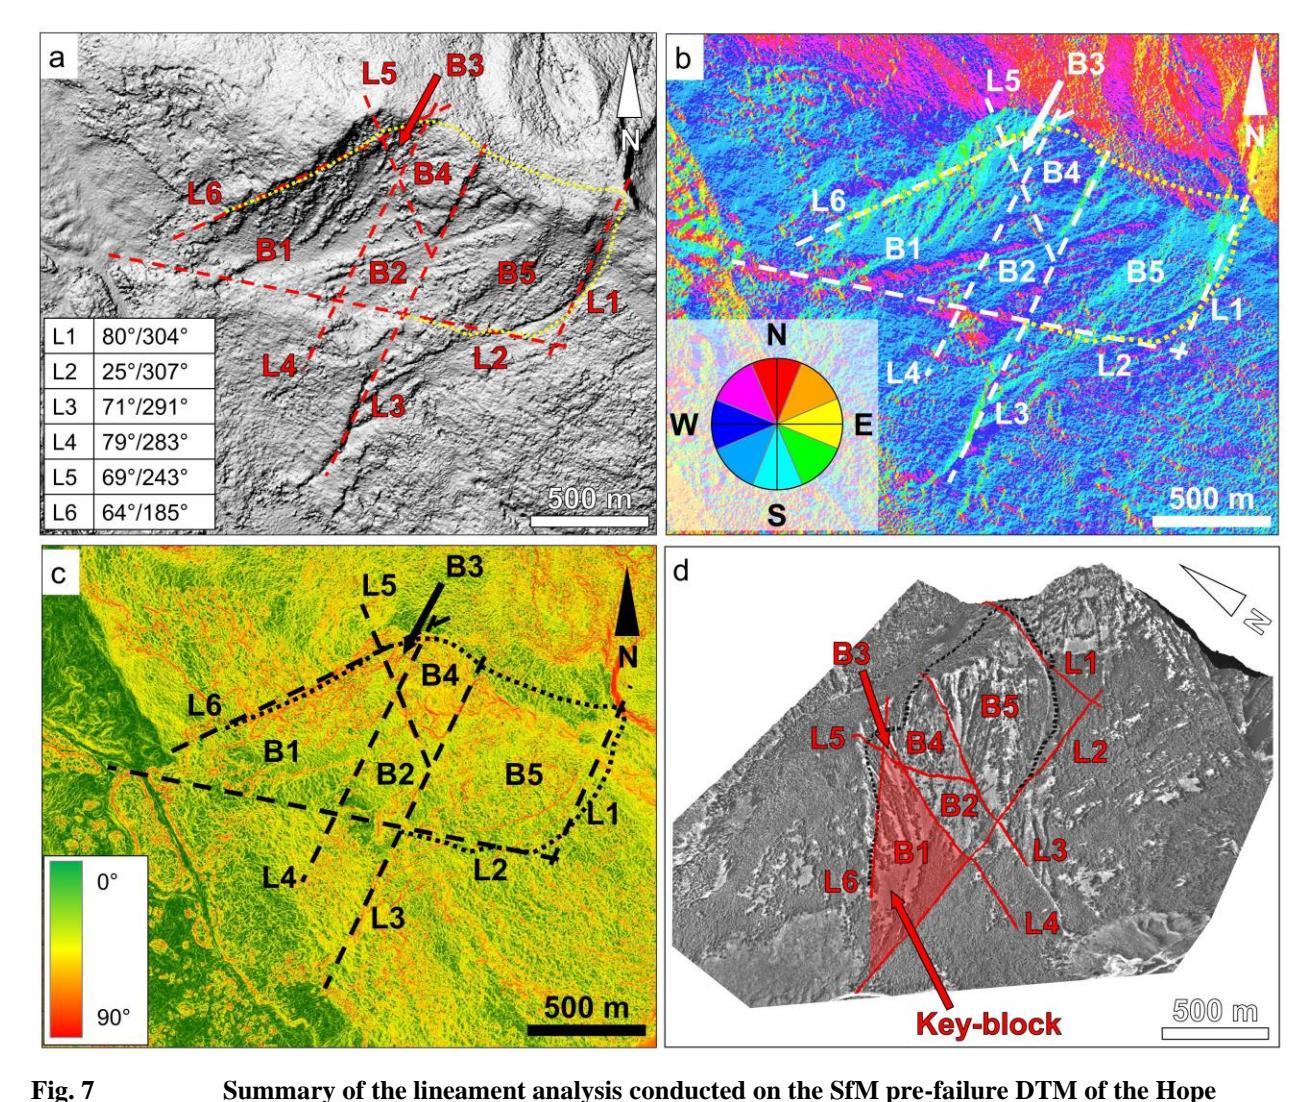
Summary of the lineament analysis conducted on the SfM pre-failure DTM of the Hope Slide. a: hillshade map. The inset table displays the orientation (dip/dip direction) of the mapped geological structures; b: aspect map; c: slope map; d: imagery draped onto prefailure 3D model. Note that B1 has been interpreted as a key block. In each map, dashed lines represent the mapped first-order lineaments, and the dotted curve outlines the area involved in the 1965 event. Lineaments are labelled from L1 to L6, blocks from B1 to B5.

Presently, the slide area is largely covered in debris, precluding identification of structural lineaments except for the outcropping part of the rupture surface in the central part of the slope. Therefore, the pre-failure DTM created based on the historical aerial photographs was used to investigate the structural configuration of the part of rock slope that failed in 1965. From the analysis of the hillshade, aspect, and slope maps, six large, first-order structural features were identified within the slide area and denoted as L1 to L6. The first-order structures subdivide the slide volume into five slide blocks, progressively numbered from the bottom of the slope to the crest, B1 to B5 (Fig. 7a-c).

212 A large-scale block theory investigation was then performed using the identified first-order structures. 213 Block theory analysis identifies all the blocks that may potentially form within a simplified slope, and classifies them 214 into "stable", "unstable", "infinite", and "key" blocks (Goodman and Shi, 1985). The objective of the analysis was to 215 identify key blocks, the removal of which may have caused the remaining blocks to fail retrogressively. According to 216 von Sacken (1991) and Brideau et al. (2005), the basal release surface of the Hope Slide was formed by a 217 discontinuity set sub-parallel to the slope, which was therefore included in the block theory investigation. The 218 analysis shows that block B1 represents a key block for the slope, and its removal would allow the subsequent failure 219 of blocks B2 to B5 (Fig. 7d).

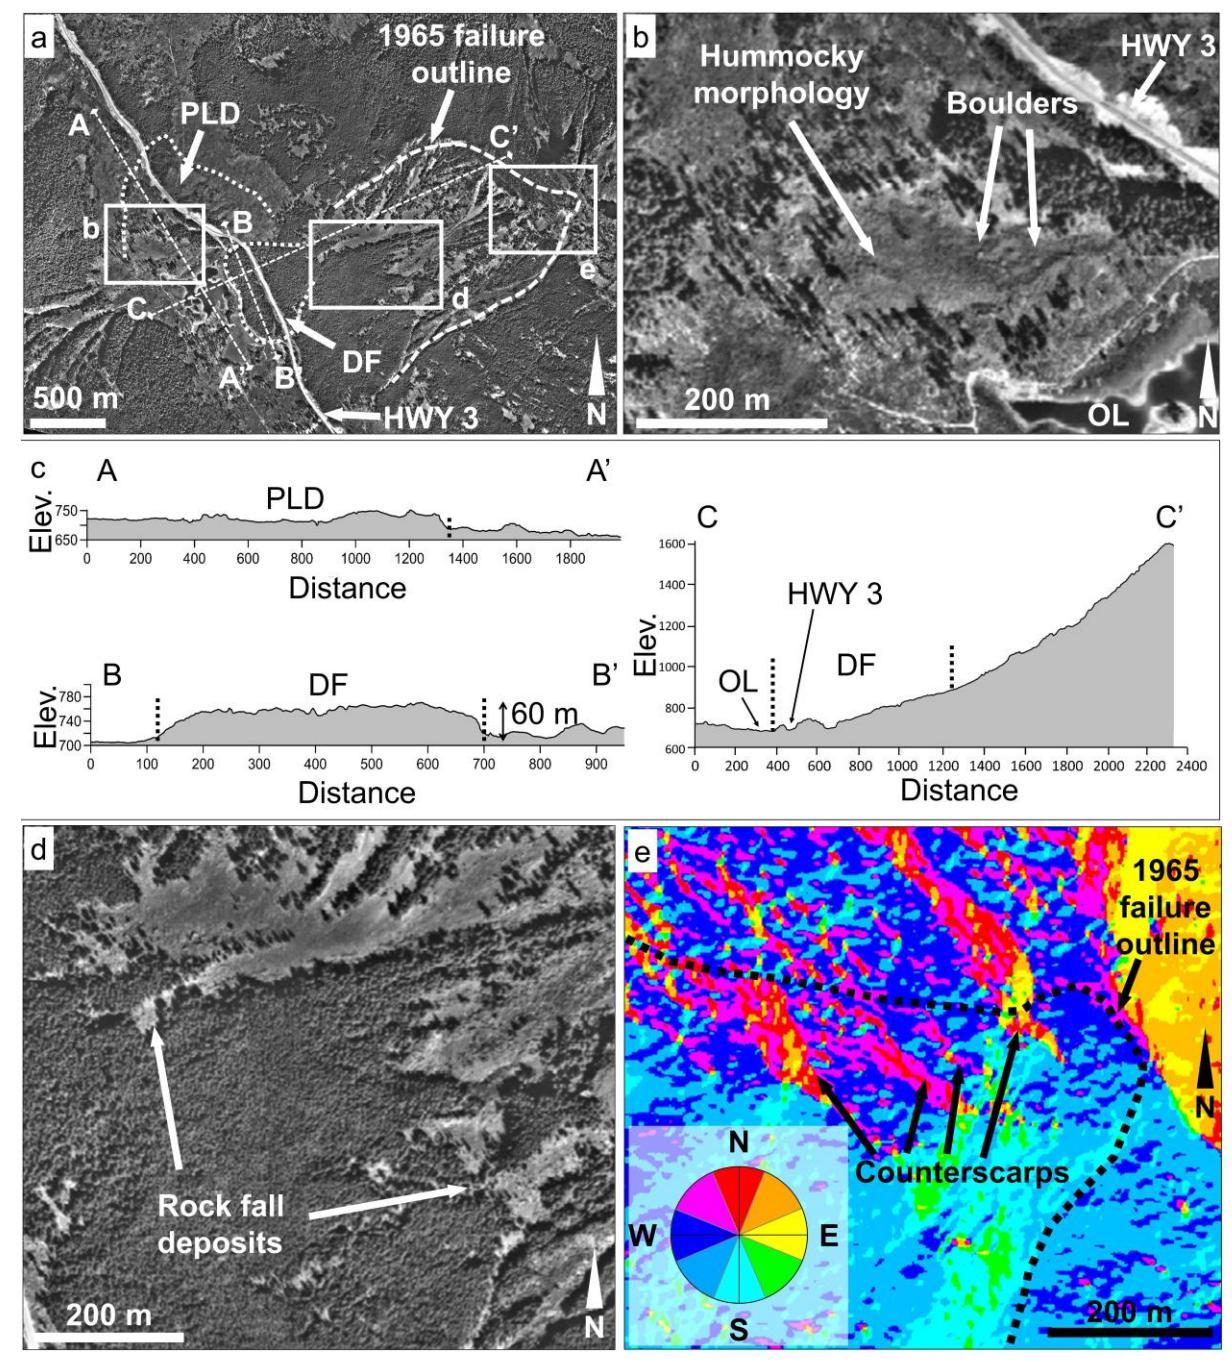
Fig. 8

Pre-failure geomorphic and slope damage analysis of the Hope Slide slope (photographs 1961). a: Orthorectified image obtained from the SfM model, showing the location of the investigated profiles and outlining prehistoric landslide deposit (PLD) and debris fan (DF). The former highway 3 (HWY 3) is also labelled. b: detail of the orthorectified image showing the surface of the prehistoric landslide deposit. The hummocky morphology north of the former Outram Lake (OL) and the boulders scattered throughout the deposit are labelled. c: interpreted profiles traced in the orthorectified image, highlighting the inferred northern edge of the prehistoric landslide deposit (A-A') and the morphology of the debris fan at the base of the slope (B-B', C-C'). d: detail of the rockfall deposition areas recognized in the prefailure slope, located above the debris fan in the lower slope, and on a structural ledge located mid-slope. e: aspect map of the upper pre-failure slope from the SfM model, highlighting the counterscarps resulting from slow, long-term slope deformation.

244 The analysis of the pre-1965 aspect map shows a series of counterscarps in the upper portion of the slope, 245 partially or completely free of vegetation (Fig. 8d). These features were truncated during the failure, as noted in the 246 ALS dataset (Fig. 6c). Such external slope damage features have been associated with the evolution of deep-seated 247 gravitational slope deformations of sackung type (Agliardi et al., 2012; Ambrosi and Crosta, 2006). The uppermost 248 counterscarp was only partially involved in the 1965 event, and presently shows evidence of slope movements (von 249 Sacken, 1991). Additionally, geomorphological field analyses showed evidence of a long-term deformation that was 250 ongoing prior to the 1965 slope failure, suggesting that the 1965 event represents the catastrophic outcome of a 251 sagging rock slope (Evans and Couture, 2002).

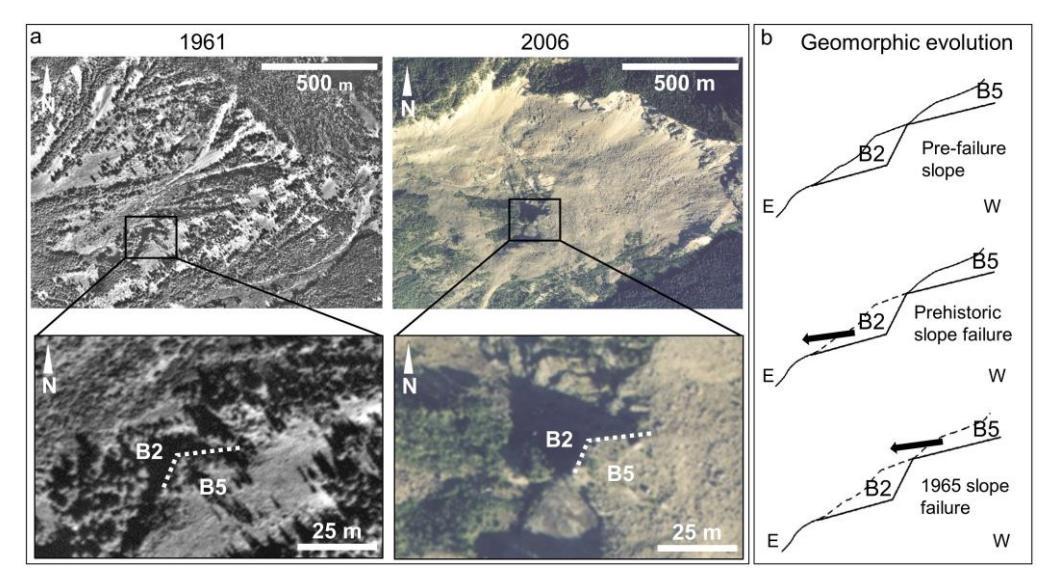
Pre- and post-failure aerial photograph comparison. a: location of the geomorphic feature observed in both pre- and post-failure imagery, identified at the boundary between blocks B2 and B5. b: conceptual reconstruction of the formation of the feature highlighted in a.

A visual analysis of the 1961 aerial photographs shows the presence of a prominent cliff, located at the boundary between slide blocks B2 and B5, which is recognizable in the slope both in the pre- and post-failure

- 254 imagery (Fig. 9a). This evidence suggests that only a minor volume of material originated from the section of the
- slope below this cliff feature. We propose that the prehistoric slope failure involved the detachment of slide blocks
- B1 and B2, with only limited contribution of material from the upper blocks, and, conversely, the 1965 event
- 257 predominantly involved the failure of blocks B4 and B5 (Fig. 9b).

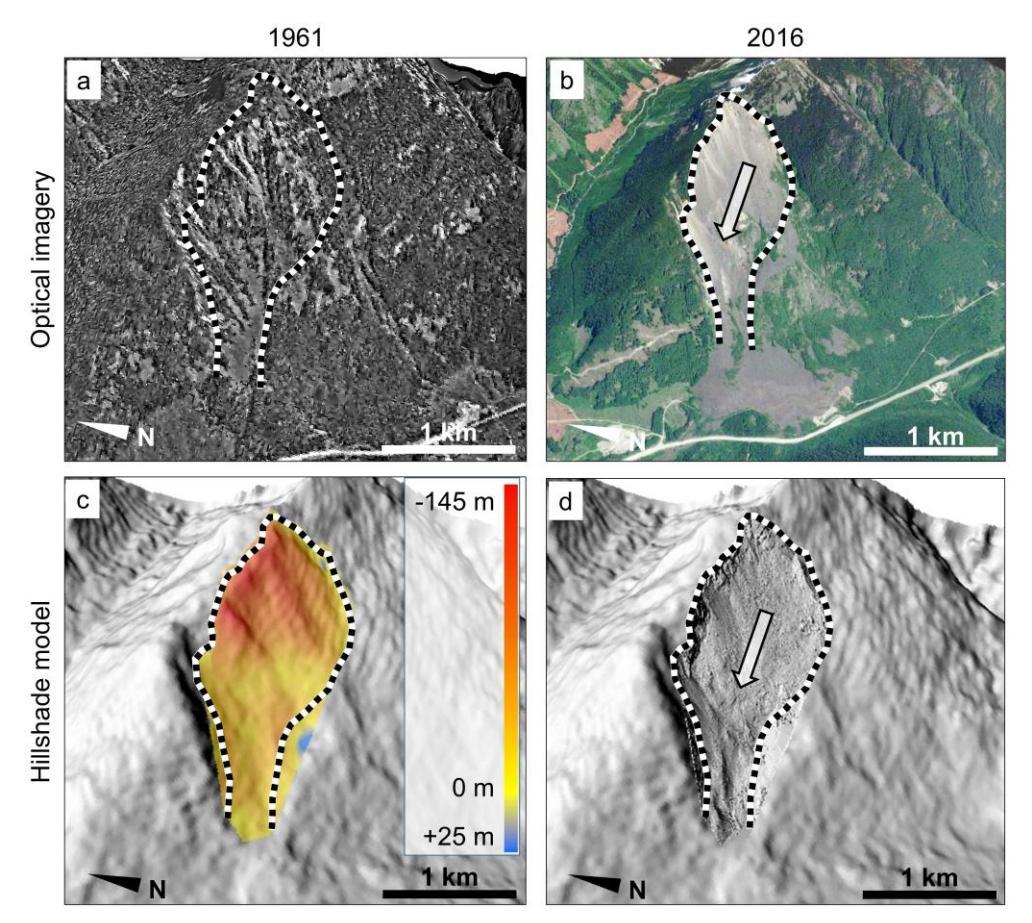
Comparison between pre-failure and present-day 3D models. a: oblique view of the 1961 SfM point cloud. b: oblique view of the present day slope from Google Earth (2016 imagery). c: oblique view of the 1961 hillshade SfM model. Colour scale shows the elevation loss after the 1965 event. d: hillshade model built by overlaying the 2015 TLS dataset onto the pre-failure SfM topography. Red, dotted curve outlines the 1965 slide area. In the present-day models (b,d) the arrow indicates the inferred displacement direction.

259 The volume and the thickness of the material involved in the 1965 Hope Slide event was estimated by 260 subtracting the pre-failure DTM (obtained from the SfM model) from the post-failure topography within the slide 261 area (Fig. 10a-d). For the volume calculation, the ALS and TLS datasets were considered independently. First, all datasets were registered considering the ALS as the reference surface. The volume was calculated using a cut-fill 262 analysis in ArcGIS 10.5. A total volume loss of 47.8 x 10⁶ m³ and 46.5 x 10⁶ m³ was computed using the ALS and 263 264 TLS ground surface, respectively. The differences are probably related to the presence of occlusions within the TLS 265 dataset, which resulted in local surface interpolation during the creation of the DTM. In both cases, the maximum thickness of the slide was observed in the upper portion of the slope, within block B5 (141 m) and block B4 (134 m). 266 267 Within blocks B1, B2, and B3 the maximum elevation difference ranges between 24 m and 53 m (Fig. 10c). The volume of the blocks forming the slide were separately investigated, and it was noted that the upper blocks (B4 and 268 269 B5) comprised approximately 80% of the volume lost during the 1965 failure. The contribution to the estimated 270 volume loss from the lower slope in the 1965 event (20% of the total volume) may be constituted by loose material 271 incorporated during the failure.

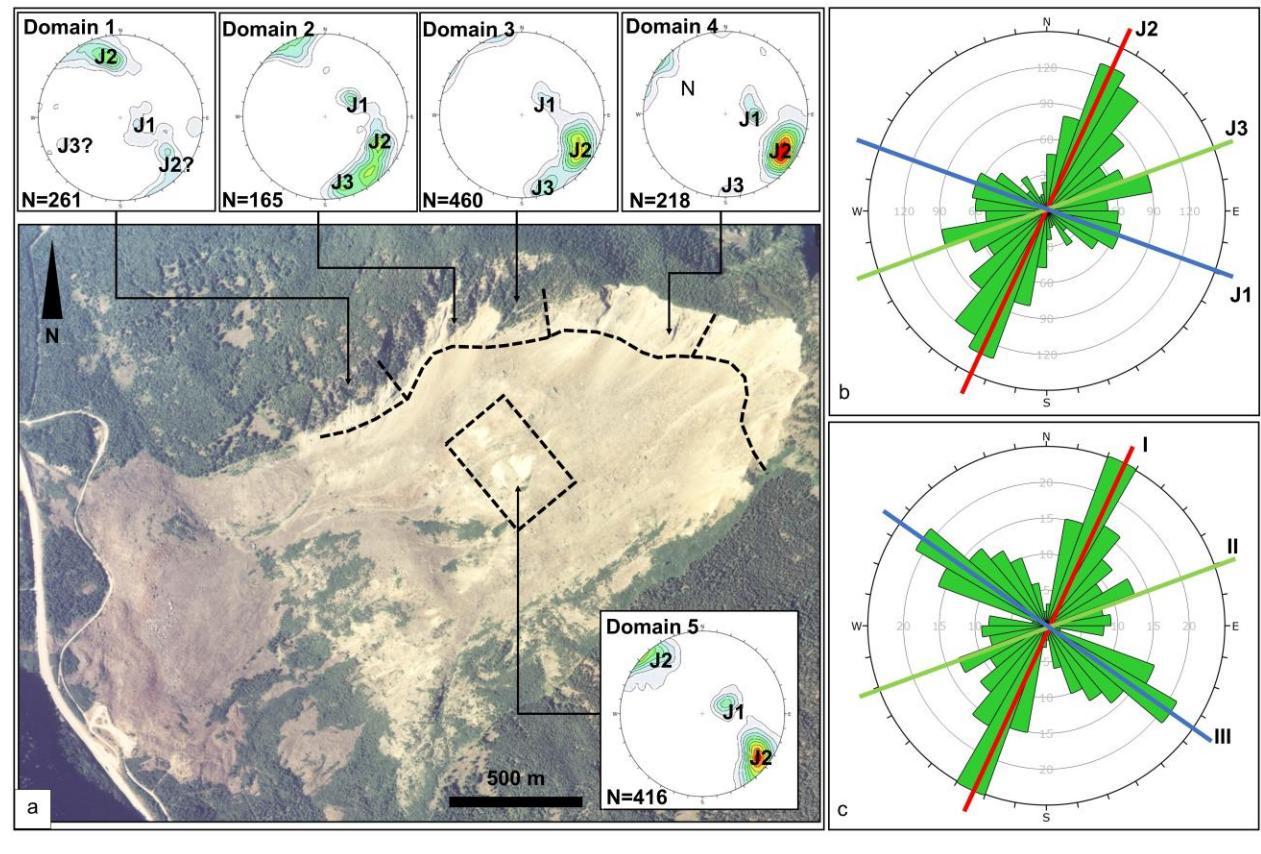
811	Fig. 11	Overview of the outcrop-scale second order discontinutiy mapping performed at the Hope
812		Slide. a: summary of the results from the TDP discontinuity mapping described in Donati et
813		al. (2013). All the stereonets are equal angle, lower hemisphere projections. On the aerial
814		photograph, the dashed lines outline the boundaries of the structural domains derived from
815		the discontinuity mapping (photograph 1996, courtesy of Province of British Columbia, roll
816		BCC96082, frame 19). b: rosette diagram that includes the mapped discontinuities. The
817		orientations of the principal discontinuity sets identified are highlighted. c: rosette diagram
818		obtained from the slope-scale lineaments. Note the similarities with the discontinuity set
819		orientations in b.

A comparison between the orientation of the first-order geological structures and lineaments, and that of the mapped second-order discontinuity sets was performed. A significant agreement was noted between the orientation main lineament trends I, II, III, and the discontinuity set J2, J3, and J1, respectively, as shown in the rosette diagrams (Fig. 11b,c). It is therefore suggested that the structural features mapped at slope-scale are strongly correlated to rock mass jointing. The orientation of the geological structures that intersect the slide area, and sub-divide the slide body into blocks (i.e., structures L1, L3, and L4 in Fig. 7), also display a general agreement with the orientation of the lineament trends and discontinuity sets, particularly trend I and discontinuity set J2.

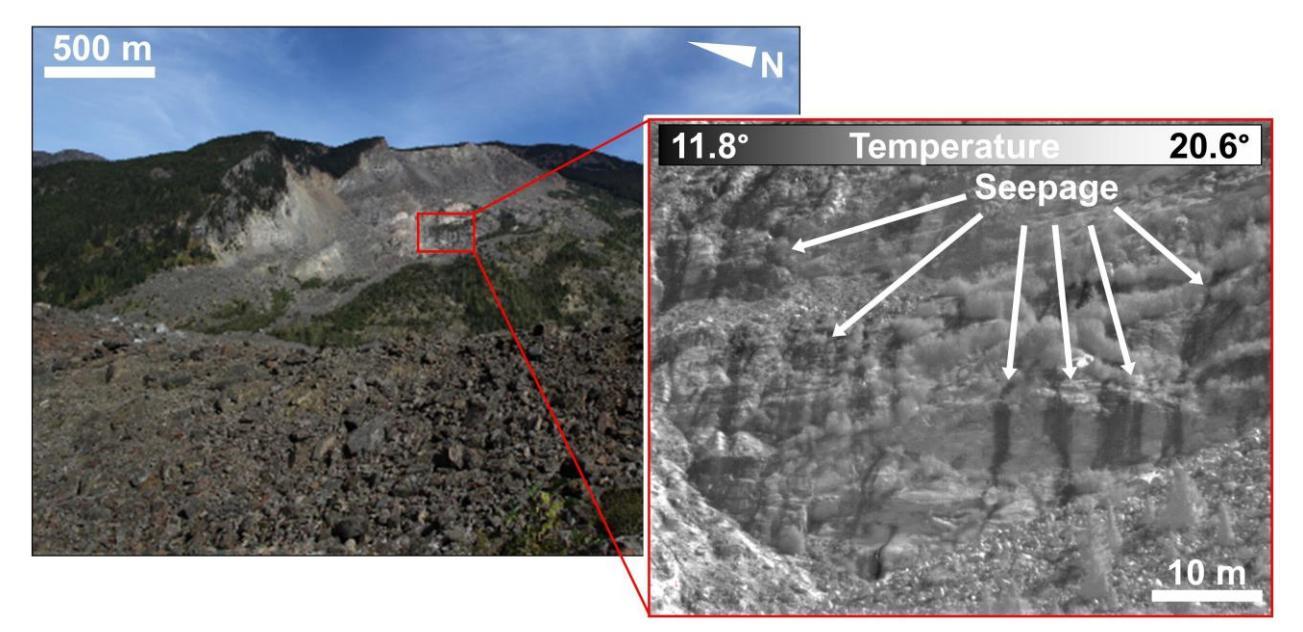
821	Fig. 12	Example of the thermal imagery collected at the Hope Slide. Darker colours indicate lower
822		temperatures, whereas brighter colours indicate higher temperatures. Low temperatures
823		(10°C to 12°C) identify groundwater seepage from J1 discontinuities and the
824		greenstone/felsite sill contacts. Imagery summer 2016.

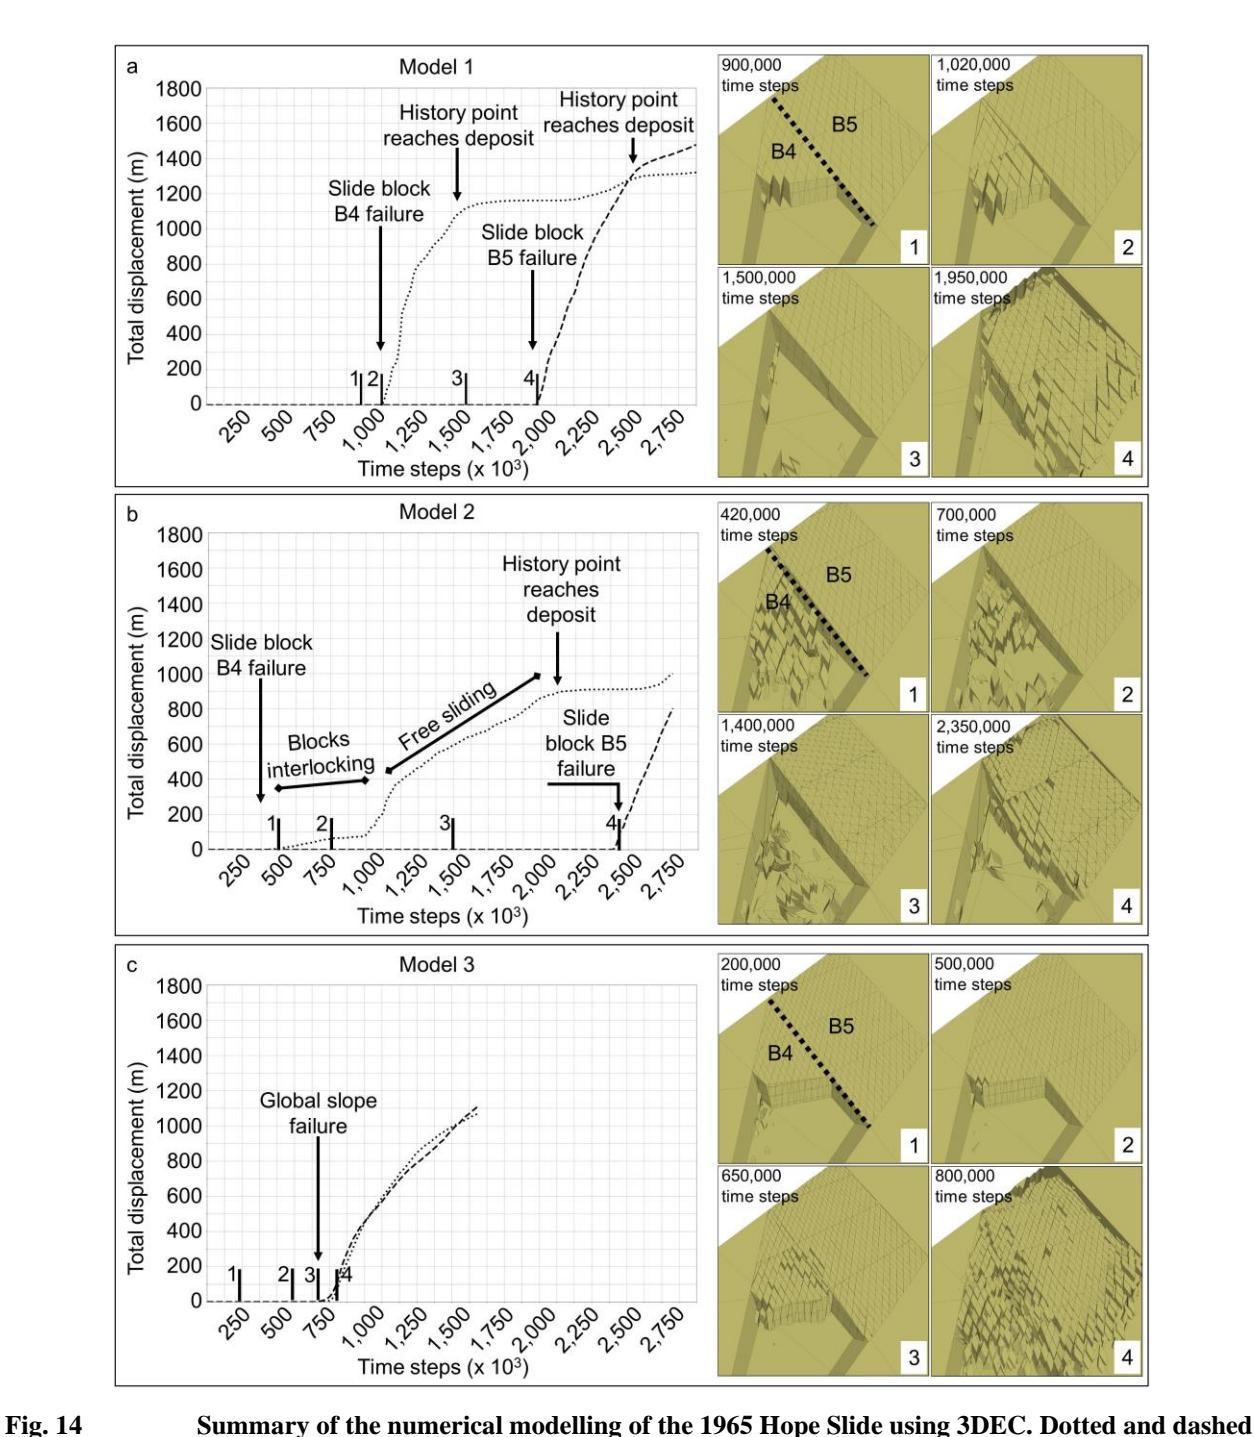
curves display total displacement magnitude of history points in slide blocks 4 and 5, respectively. a: Model 1 (Block size 20x largest block in landslide deposit). Plots 1-4 show block displacements for increasing numerical time steps. b: Model 2 (Block size 10x largest block in landslide deposit. c: Model 3 (Block size 5x largest block in landslide deposit). The failure of both slide block 4 (dotted curve) and slide block 5 (dashed curve) was simulated at the same time.

393 Three-dimensional numerical modelling of the Hope Slide realistically simulated the 1965 slope failure in 394 two stages as observed on site. The numerical results show that the block size affects the stability of the slope. When 395 larger block sizes are considered (10 and 20 times the largest block observed in the debris), a two-stage failure is 396 simulated (Fig. 14a,b), in which the failure of the slide block B4 occurs for higher cohesion values, compared to the 397 slide block B5. In model 2, the numerical displacement rate of block B5 immediately after the detachment of slide 398 block B4 (400,000 numerical time steps) is relatively low, possibly due to the interlocking of individual joint 399 bounded blocks. As the individual blocks become kinematically free, the numerical displacement rate increases (Fig. 400 14b). The joint bounded block comprising the history point of slide block B4 acquired full kinematic freedom after 401 900,000 numerical time steps, as indicated by the steepening of the numerical displacement vs. numerical time step 402 curve (Fig. 14b). The curve flattens when the joint bounded block comprising the history point reaches the deposit 403 (Fig. 14a,b). No obvious block interlocking has been observed during the failure of slide block B5. When a smaller 404 block size (5 times the largest block) is used in model 3, the failure occurs in a single stage, and the displacement 405 rates within the slide blocks B4 and B5 increase at the same time (Fig. 14c). Table 3 summarizes the cohesion 406 magnitudes at which the failure of slide blocks B4 and B5 was simulated.

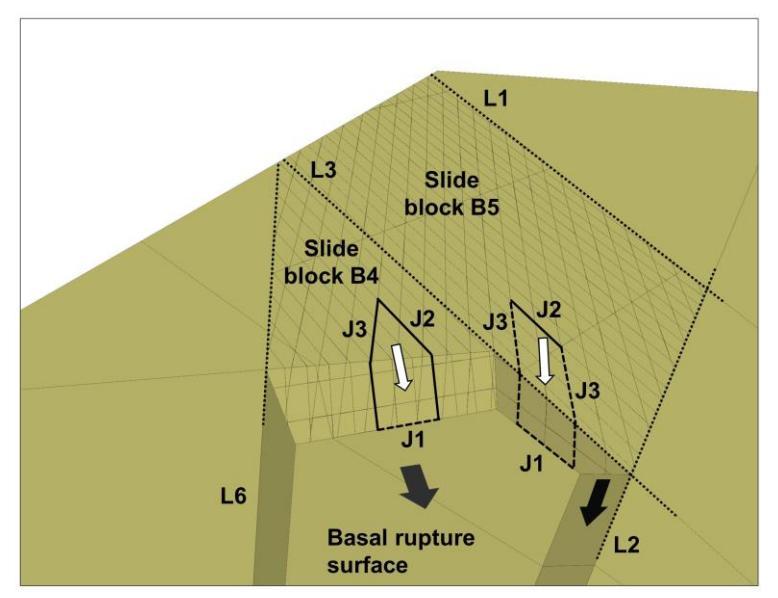
842	Fig. 15	Kinematics of the Hope Slide blocks at large and small scale. At model scale, the slide block
843	-	B4 acts as key block for the failure of the slide block B5. Black arrows indicate the
844		displacement direction of the slide blocks. Slide block B4 is kinematically free to slide along
845		the basal rupture surface. Slide block B5 slides along the basal rupture surface and L2, with
846		the latter kinematically constraining the block along the lower side. At the element scale, the
847		stability of the individual joint bounded blocks forming slide block B4 is governed by the
848		shear strength (dashed traces) along J1 and the tensile strength (solid traces) along J2 and
849		J3. In slide block B5, only J2 fails in tension, while shear strength controls sliding along J1
850		and J3. White arrows indicate the sliding direction of the individual joint bounded blocks.

The numerical model results suggest that the slide block B4 acted as key block in the 1965 Hope Slide failure, its removal providing kinematic freedom for slide block B5 to displace. According to this interpretation, the first-order geological structure L2 plays a critical role in the evolution and progression of the failure. The slope below this structure was not involved in the 1965 Hope Slide failure, and may have acted as a buttress, resulting in the development of the wedge failure mechanism.
