# Classification of natural and engineered rock slopes using UAV photogrammetry for assessing stability

N Bar<sup>1</sup>, L Borgatti<sup>2</sup>, D Donati<sup>2</sup>, M Francioni<sup>3</sup>, R Salvini<sup>4</sup> and M Ghirotti<sup>5</sup>

Abstract. Ground failure on natural and engineered rock slopes is a geological hazard with potentially fatal consequences to the public or personnel in the mining industry. Aerial reconnaissance with the use of unmanned aerial vehicles (UAV) is rapidly becoming standard practice for geotechnical and engineering geological site investigations, enabling faster and safer data collection on slopes, which are often difficult to access on foot. Data obtained from aerial reconnaissance alongside conventional field investigations assist in the development of an engineering geological model that can form the basis of various stability analyses including kinematic, limit equilibrium and finite element analyses, and even rock fall simulations. This paper presents two case studies in which remote reconnaissance is used as an initial method of site investigation to classify natural and engineered rock slopes. The case studies from San Leo in Italy and an

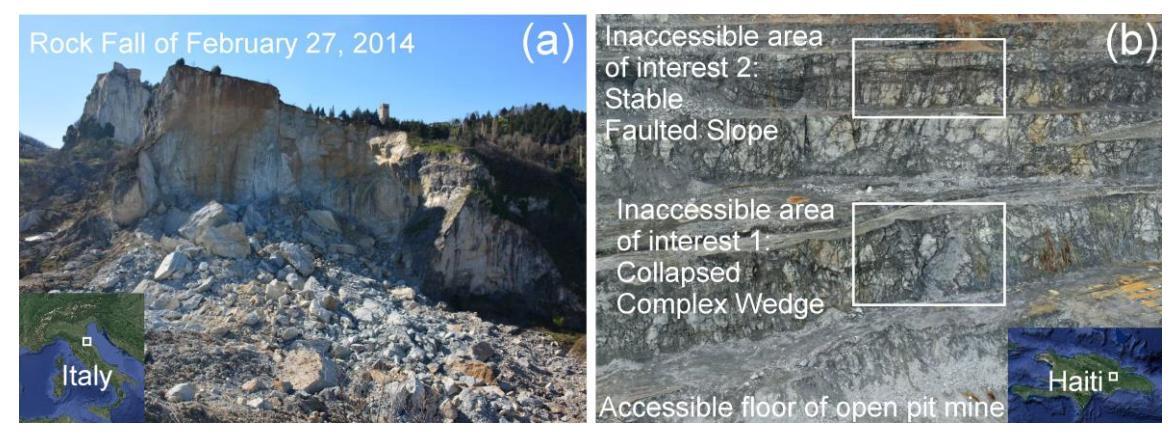
**Figure 1.** The case studies: (a) the scarp of the 2014 San Leo rock fall; (b) unreachable benches of an open pit mine in the Caribbean.

In this paper, two case studies, represented by the San Leo (natural) slope in Italy and individual benches in an open pit mine in the Caribbean are shown (figure 1), with the goal of demonstrating how output from UAV photogrammetry can be adopted for applying the Q-slope method in rock slope engineering for natural and excavated slopes which are otherwise not safely accessible on foot.

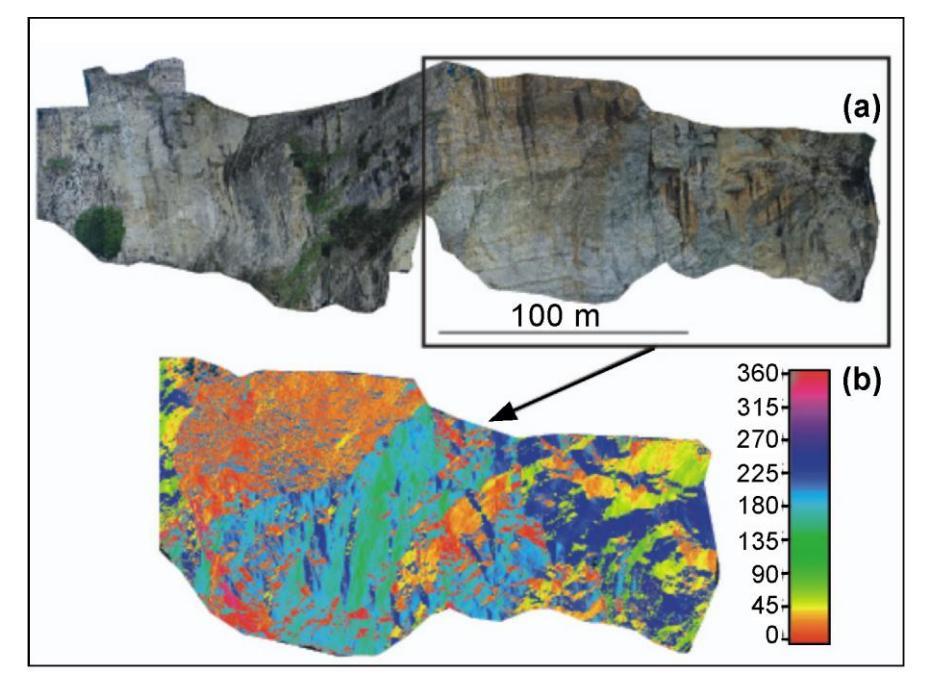
**Figure 2.** San Leo slope: (a) 3D point cloud extracted from UAV survey; (b) CloudCompare output; color scale represents slope face dip directions.

The results presented incorporate the use of UAV photogrammetry for rock mass classification using Q-slope. Due to safety risks associated with rock fall and limited physical access to the physical, UAV surveys have been carried to improve the amount and quality of data available for the analysis. The post processing of UAV photographs allowed for the creation of 3D photogrammetric models representing the slopes under study. Figures 2 and 3 show the 3D models of the San Leo slope and benches in the open pit mine, respectively.

Regarding the San Leo case study, the natural slope, about 80 m high, is sub-vertical and characterized by a large slope (planar) failure that in 2014 lead to a subsequent rock fall. The structural/geomechanical analysis highlighted the presence of three discontinuity sets (Fig. 4, which excludes bedding). The other parameters useful for the estimation of Q-slope can be summarized as it follows. The RQD is equal to 100%, testify a good quality of the rock mass. The main discontinuity set involved in the instability of the slope (Set A, Table 1) is characterized by a clean, irregular, undulating surface (joint roughness -  $J_r$  of 3). The environmental and geological conditions are typical of a wet environment with a  $J_{wice}$  of 0.7. Considering the very unfavourable orientation of Set A (causing failure if unsupported), with an orientation factor of 0.25, the calculated Q-slope is equal to 5.83.

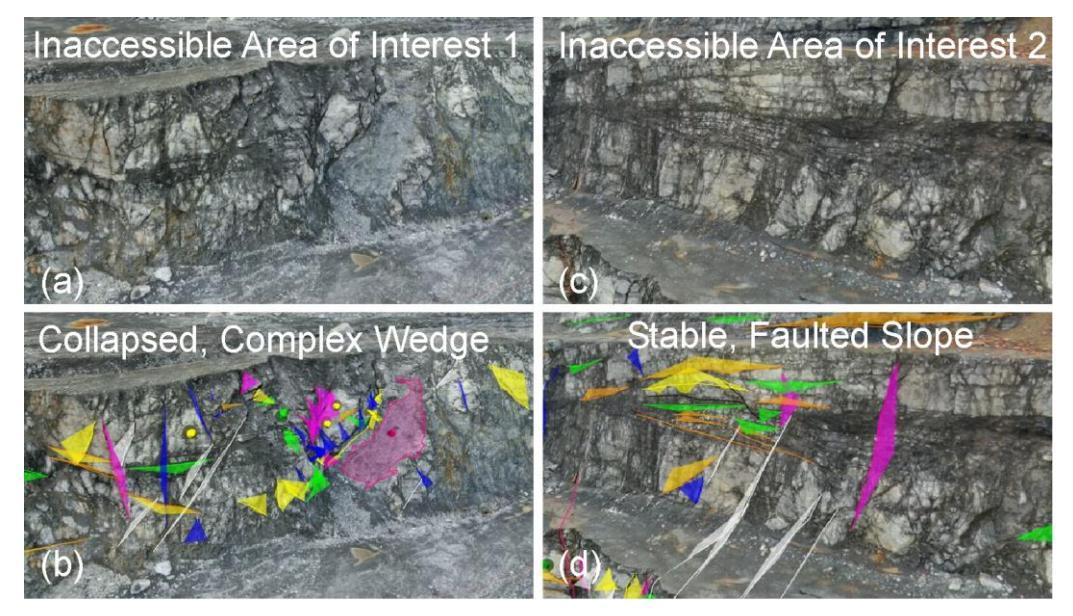
**Figure 3.** Open pit mine benches in the Caribbean. (a) & (b): Area 1 showing a local, complex wedge failure controlled by 3 discontinuity sets; (c) & (d): Area 2 showing stable slope with 2 discontinuity sets and random joints.

The open pit slopes (figure 3) are hosted in carbonaceous sediments comprising mudstones and sandstones, interbedded with various tuffs. The strata is generally sub-horizontal although it has been

Area 1 in the open pit mine is a failed slope (localized wedge), with a height of 10 m and a pre-failure slope angle of 56 degrees. Area 2 is a stable slope, 11 m high with a slope angle of 57 degrees. Mapping of geological structures using UAV photogrammetry models highlighted the presence of three main joint sets for Area 1 and two main joint sets (plus random joints) for Area 2 (figure 5 and Table 1). The parameters for estimating Q-slope (Table 1) were obtained from logging nearby boreholes. RQD was estimated to be 70% on average in both the slopes. This was confirmed with UAV photogrammetry focusing on open fractures in the slope.

Area 1 is characterized by a complex wedge failure where the joint sets (Set A and B, Table 1) are characterized by a smooth, undulating joint surfaces. The Set B has clayey infilling, while infill in Set A comprises sandy particles and rock fragments. Area 2 is stable and has similar joint characteristics to Set A in Area 1. O-factors have been described based on the orientation of the discontinuity sets relative to the slope.

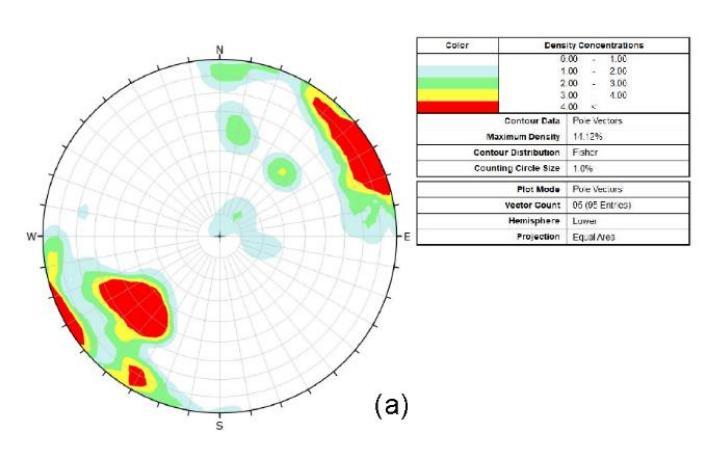
**Figure 4.** Stereonet representing the discontinuity sets in San Leo (note: bedding not shown for clarity).

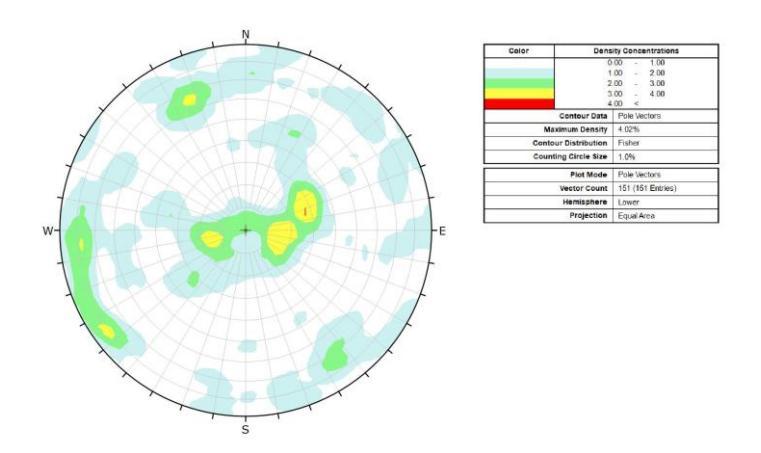
**Figure 5.** Stereonet representing the discontinuity sets in the open pit mine, inclusive of Area 1 and 2.

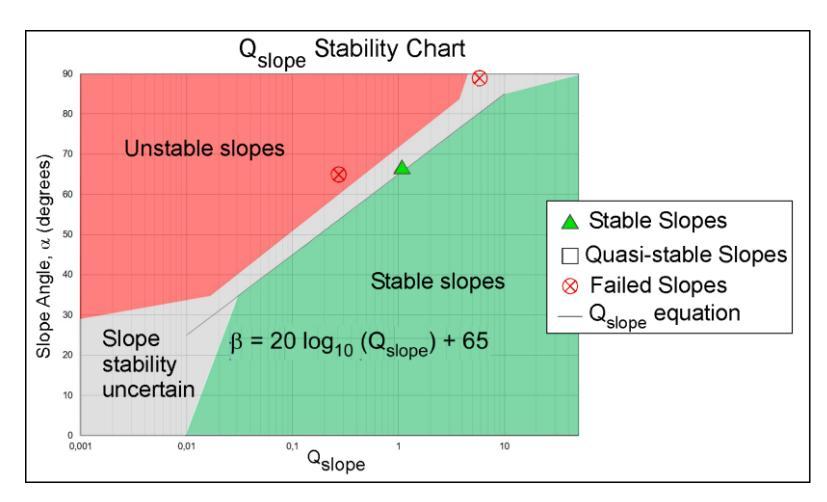
Figure 6. Q-slope stability chart with Italian and Caribbean case studies using UAV photogrammetry

UAV photogrammetry and Q-slope were applied to natural and engineered slopes for the case studies in hazardous areas in Italy and in the Caribbean. The results shown in figure 6 are in agreement with previous Q-slope assessments that were completed, on foot, in the field.
