Sand boil observations and geotechnical characterization of river embankments for the development of a backward erosion piping database

Observations de terrain et caractérisation géotechnique pour la mise en place d'une base de données des phénomènes d'érosion régressive

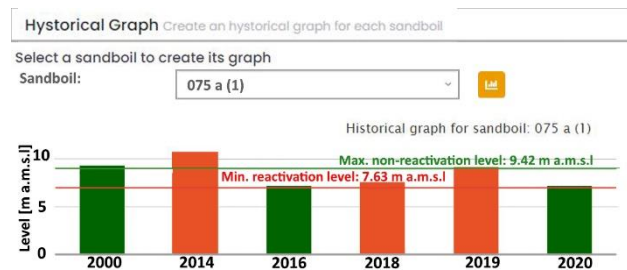
Figure 5. Example of data extraction in the form of “historical graph”, with reference to the sand boil No. 75 detected in Guarda Ferrarese.
