Effectiveness of FRM Reinforcement Applied to Masonry Walls Subject to Axial Force and Out-Of-Plane Loads Evaluated by Experimental and Numerical Studies

Bellini, A., Incerti, A., Bovo, M., Mazzotti, C. (2018). Effectiveness of FRM Reinforcement Applied to Masonry Walls Subject to Axial Force and Out-Of-Plane Loads Evaluated by Experimental and Numerical Studies. INTERNATIONAL JOURNAL OF ARCHITECTURAL HERITAGE, 12(3), 376-394 [10.1080/15583058.2017.1323246].

Effectiveness of FRCM reinforcement applied to masonry walls subject to axial force and out-of-plane loads evaluated by experimental and numerical studies

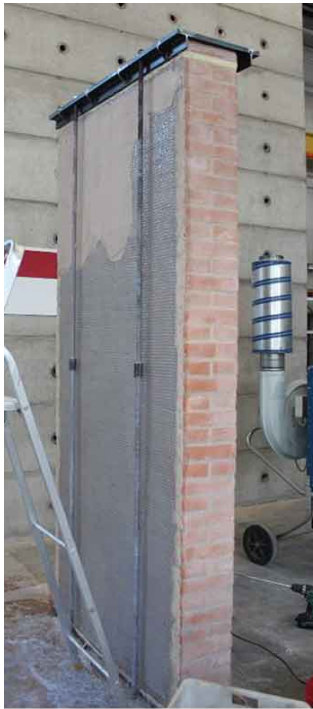
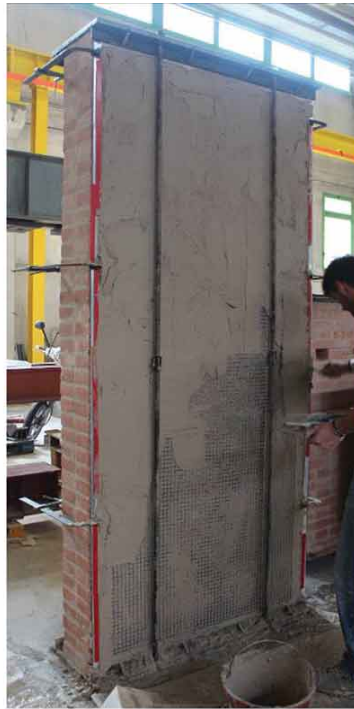
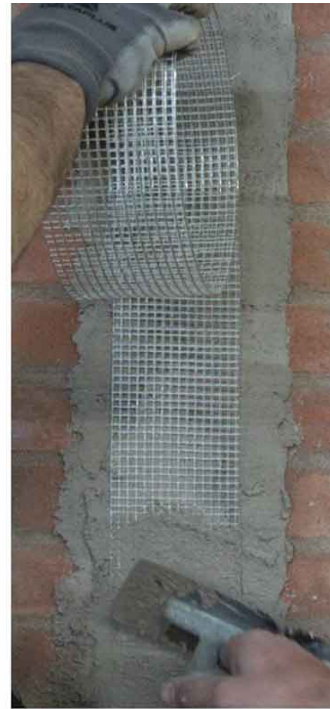
Figure 2. Application of the strengthening systems on the original masonry samples: (a) GFRCM_01; (b) GFRCM_02; (c) SRG_01.

The application of the strengthening system followed a standard procedure (Figure 2): application of the first mortar layer (about 3 mm thick) on the surface of the masonry wall, embedment of the composite reinforcement and finishing with a second layer of mortar (about 3 mm). Only for GFRCM_01 sample, the grid was impregnated with an adhesion promoter. During the reinforcement application, masons had also paid attention to not attach the FRCM composite on the whole masonry surface, adopting an offset of about 2 cm from top and bottom edges, in order to prevent buckling behaviour of reinforcement layer that could trigger early debonding phenomena during the pre-loading compression phase (Incerti et al., 2015). However, the adoption of the previously described tensioned steel bars, still present during reinforcement application and the choice of a constant axial stress of 0.2 MPa during the test (the same applied through the steel bars), allowed to avoid the transmission of potential compressive stresses to the FRCM reinforcement. The application of the composite reinforcement by using a predefined offset from left and right edges of the wall allowed also to analyze the behaviour of the small portions of unreinforced masonry and to locate strain and cracks in relation with masonry texture (bricks or mortar joints) by using DIC technique.

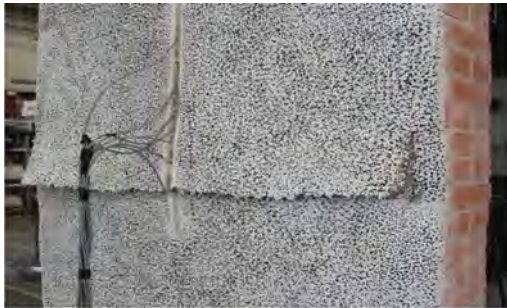
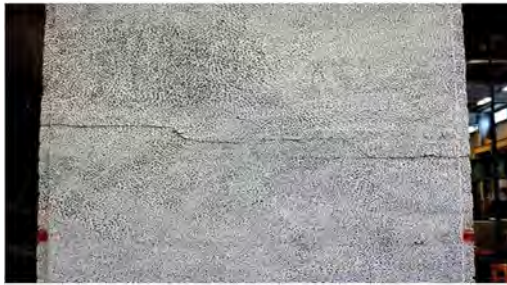
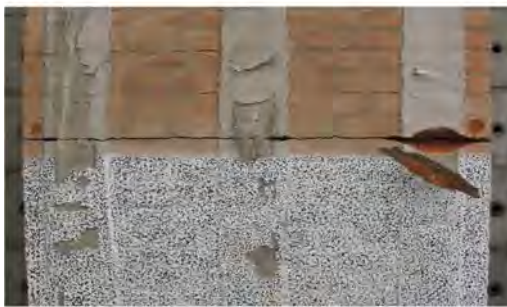
Figure 5. Failure modes of reinforced masonry walls: (a) GFRCM_01; (b) GFRCM_02; (c) SRG_01.

Figure-5 shows the typical flexural failure modes observed from the three tests carried out. All the tests were concluded by the tensile failure of the reinforcement in the central portion of the sample, where the bending moment was constant and maximum. In detail, failure occurred exactly at mid-height of the specimen (SRG_01) or just below (GFRCM_01) or above (GFRCM_02) the mid-height level. As expected, the critical cross-section (i.e. the section where final failure occurred) was always located at the level of a mortar joint, which was cracked. In particular, Figure 6 shows that failure of GFRCM_01 wall occurred within the reinforcement in correspondence of a crack previously opened at brick-mortar interface. The critical cross-section of GFRCM_02 and SRG_01 samples was located, instead, close to brick-mortar interface, but within the mortar layer.

Only in the case of discontinuous reinforcement (SRG_01), the failure of steel fibers was accompanied by the detachment of a triangular wedge of masonry (Figure 5c) due to the strong concentration of shear stresses occurring below the reinforcing strips.
