Calcium phosphate coatings for marble conservation: influence of ethanol and isopropanol addition to the precipitation medium on the coating microstructure and performance

Enrico Sassoni^{1,*}, Gabriela Graziani¹, Elisa Franzoni¹, George W. Scherer²

ABSTRACT

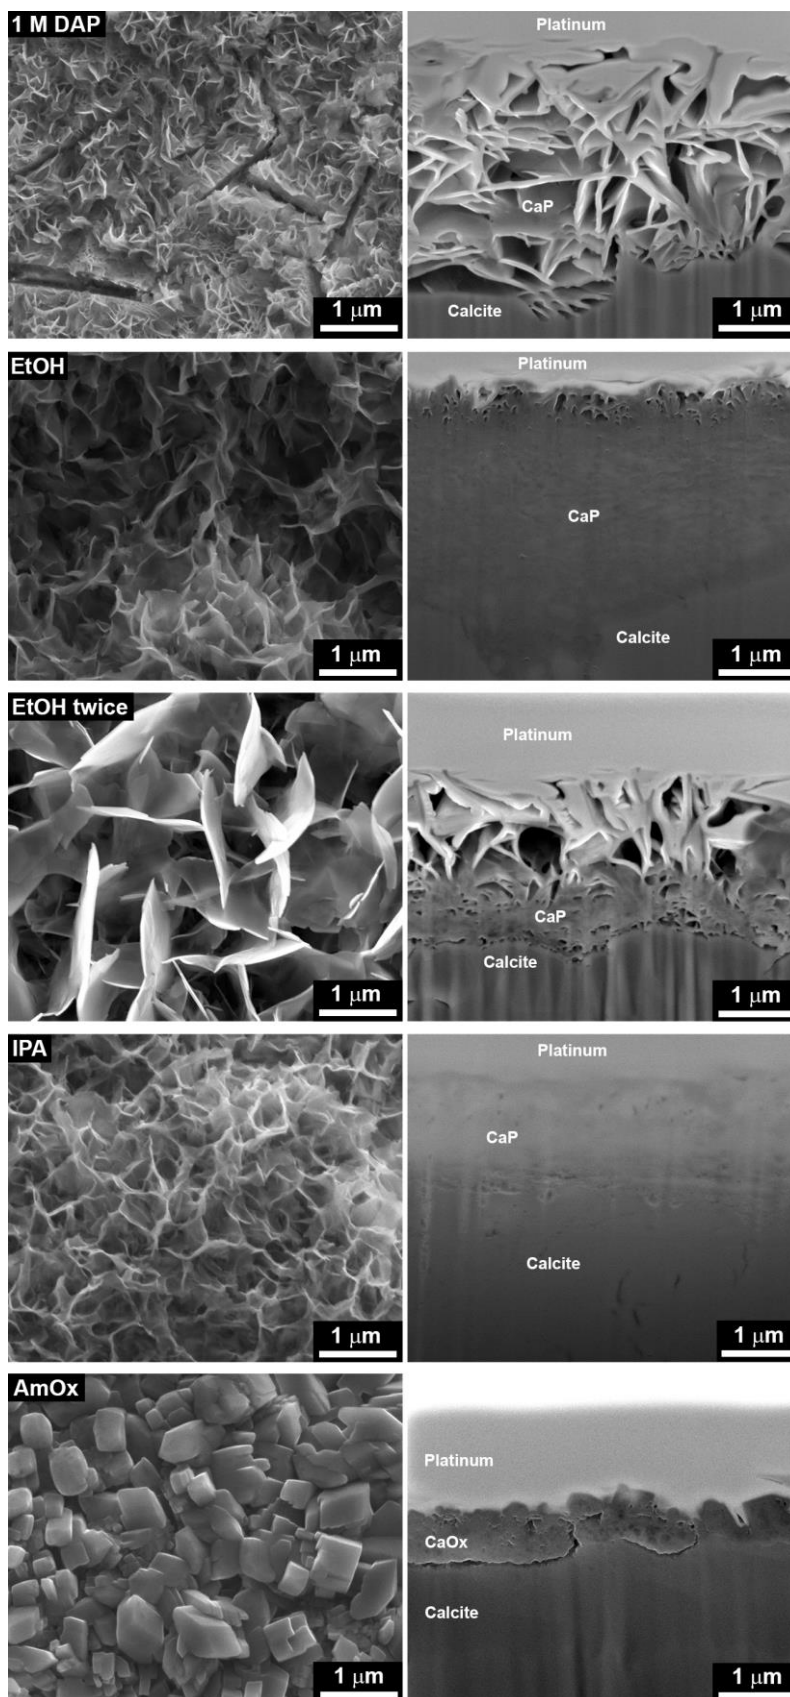
Figure 3. Surface morphology (left) and cross section (right) of marble samples subjected to different treatments.

Because repeated treatments had been found to significantly improve the surface coverage of marble particles by CaP coatings [22], the effect of repeating the “EtOH” treatment twice was investigated. As reported in Figure 3, this led to formation of huge CaP flakes on top of the coating, visible both from observation of the treated surface and in the FIB cross section (Figure 3). Even if the underlying layer exhibits a much denser microstructure than the superficial flakes, the adhesion at the coating-substrate interface seems worse compared to the single application, likely because the second treatment caused excessive growth and partial detachment of the coating from the substrate.

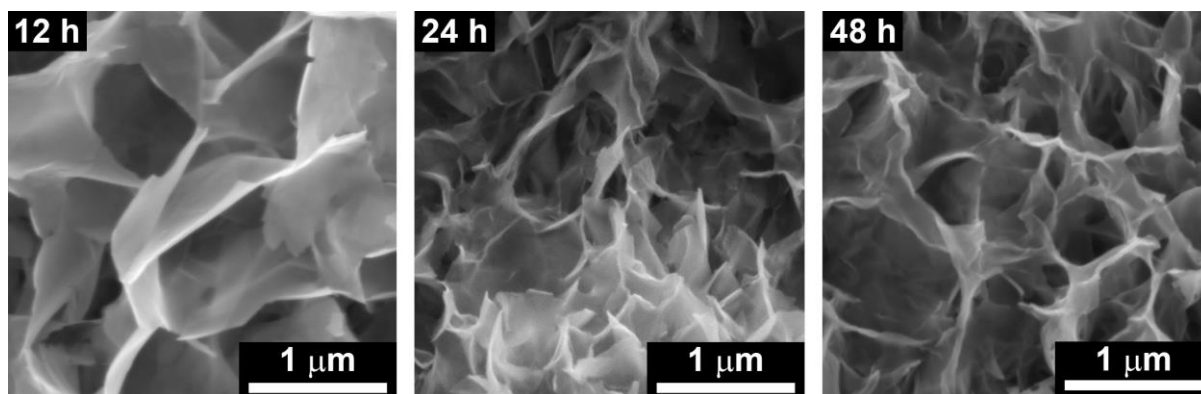
Figure 8. Morphology of CaP coatings formed after treatment for increasing time.

Considering that ethanol addition significantly favours formation of the new CaP coating, the effect of reducing the treatment duration from 24 to 12 hours was investigated. At the same time, because an evolution of the phase composition and microstructure has been reported in the literature passing from 24 to 48 hours (however in different conditions, especially without stirring of the DAP solution [43]), a longer reaction time was also considered. However, in the case of a solution containing 0.1 M DAP, 0.1 M CaCl_2 and 10 vol% ethanol, no remarkable difference in the coating morphology was noticeable for the different reaction times investigated (Figure 8), hence treatment for 24 hours (as recommended in [3]) was adopted for further comparisons.

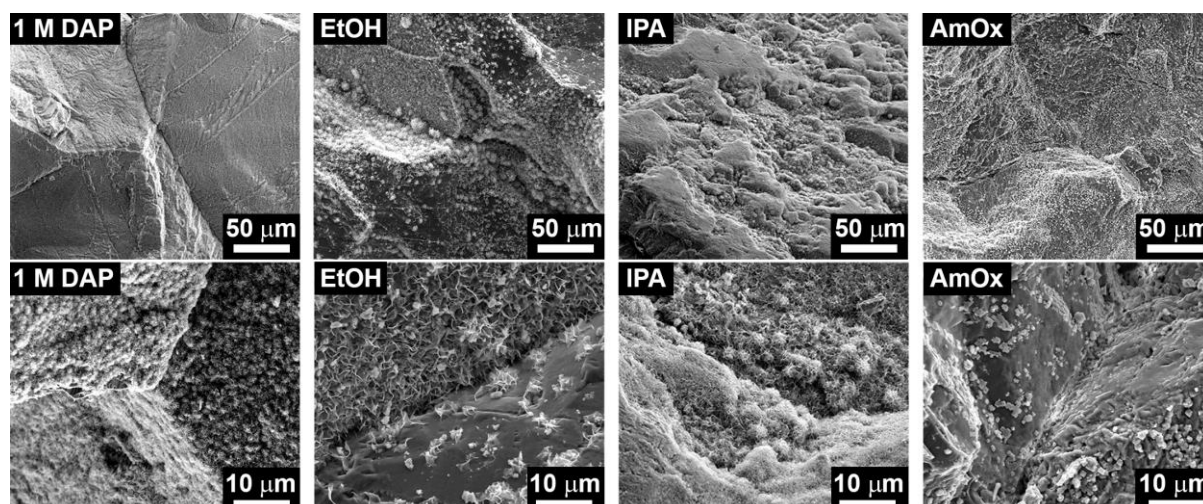
Figure 13. New phases formed inside microcracks between calcite grains after consolidation by different treatments.

After the E_d measurement, the formation of new phases in the microcracks among calcite grains was assessed by ESEM observation of fracture samples obtained by chisel from the tested specimens.
