# LIME AND CEMENT MORTAR CONSOLIDATION BY AMMONIUM PHOSPHATE

Enrico Sassoni\*, Elisa Franzoni

Department of Civil, Chemical, Environmental & Materials Engineering (DICAM)  
University of Bologna, Italy

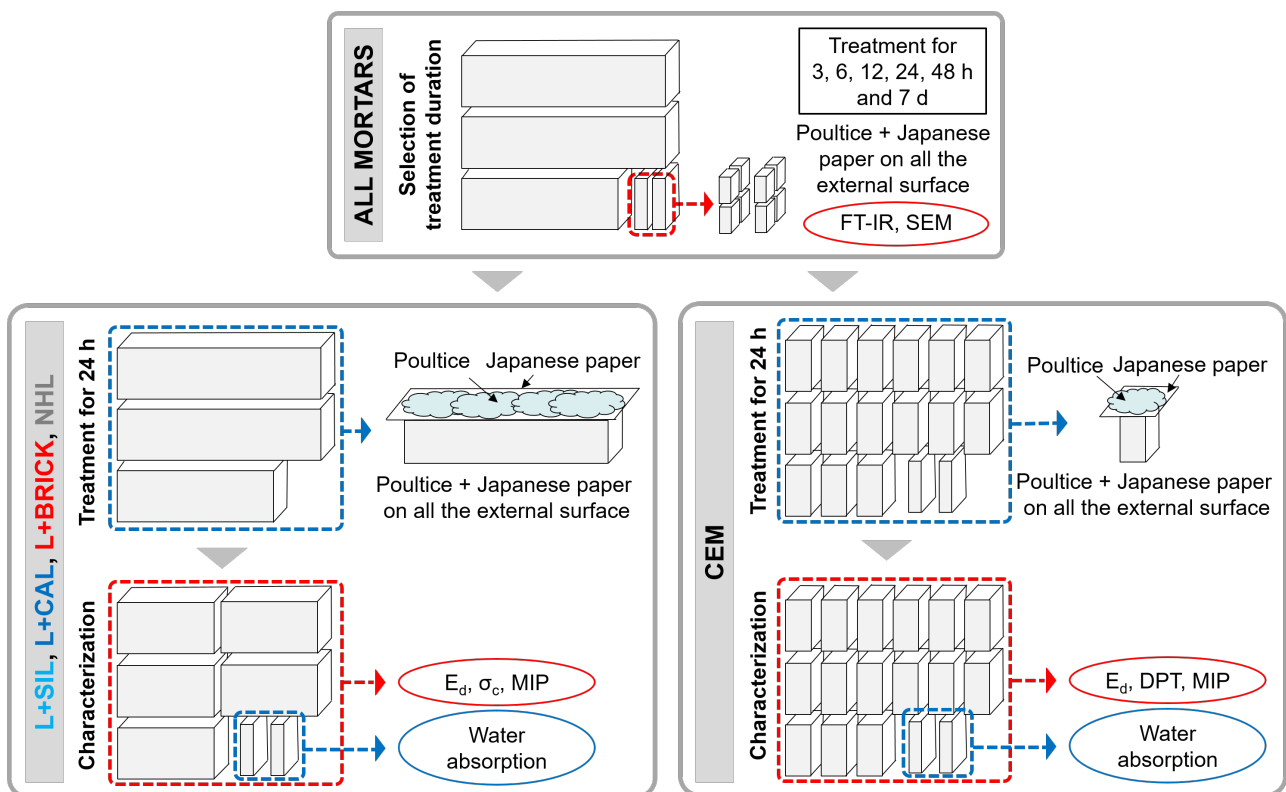
**Figure 1.** Scheme illustrating the rationale of the study, the sample production and testing.

As illustrated in Figure 1, for all mortar types small samples (about 2×2×1 cm<sup>3</sup>) were obtained from one standard prism by wet sawing. These small samples were used to identify the best treatment duration, by treatment for increasing time and analysis by FT-IR and SEM, as described in detail in § 2.3.

The treatment duration varied depending on the phase of the study. In the first phase, aimed at identifying the best treatment duration itself (Figure 1), the small samples ( $2 \times 2 \times 1 \text{ cm}^3$ ) were left to react for 3, 6, 12, 24, 48 hours and 7 days. For the development of the new CaP phases, the mortar mineralogical composition was regarded as the most important parameter, hence results obtained on “L+SIL\_1” and “L+CAL\_1” specimens were assumed as also representative for the “L+SIL\_0.75” and “L+CAL\_0.75” specimens, respectively.

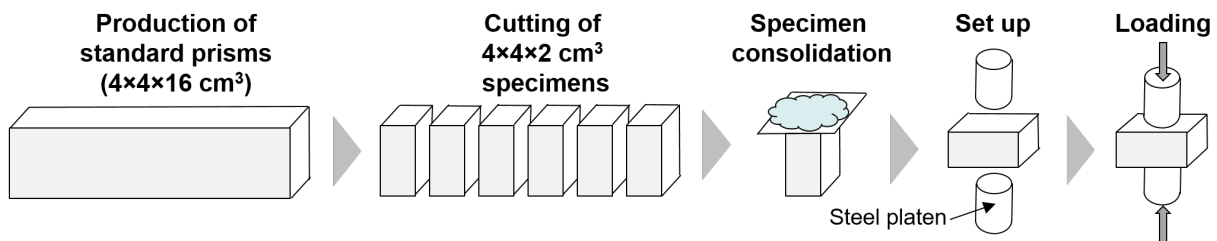
**Figure 2.** Scheme illustrating the procedure of the double punch test (DPT).

**Double punch test.** In the case of the “CEM” mortar, the compressive strength by double punch test ( $R_{c,DPT}$ ) was determined by subjecting the  $4 \times 4 \times 2 \text{ cm}^3$  specimens to double punch test (DPT) [33], following the procedure illustrated in Figure 2. The specimens were loaded onto the  $4 \times 4 \text{ cm}^2$  faces by means of two steel cylindrical platens (2 cm diameter) until failure. Compared to standard compressive test (leading to 2  $R_c$  values for each standard prism), the DPT has the advantage of providing a much higher number of results (up to 6  $R_{c,DPT}$  values for each standard prism). The 2 cm-thickness of the specimens for DPT was selected based on a previous study [34], which highlighted that testing samples with thickness (2 cm) similar to the diameter of the steel platens (2 cm) leads to  $R_{c,DPT}$  values in very good correlation with the standard  $R_c$  values. For each condition, at least 12 replicates were tested.

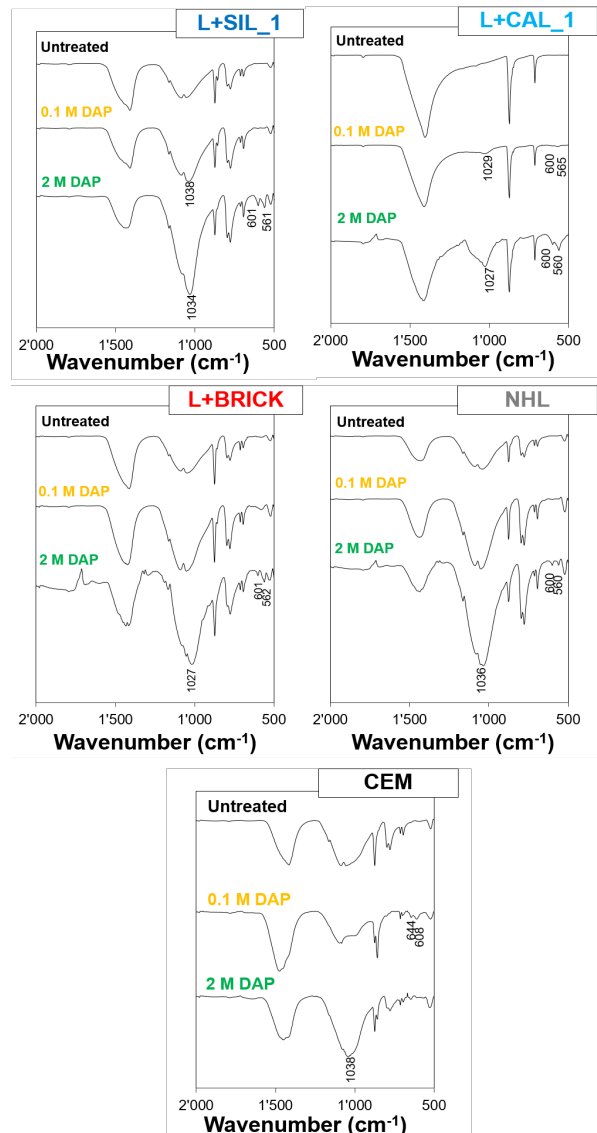
**Figure 3.** FT-IR spectra of the various mortar types after treatment for 24 hours. Bands owing to new CaP phases are indicated, while bands owing to the substrates are omitted.

The FT-IR spectra of the various mortar types, treated for increasing time, are reported in the Supplementary material (Figures S1-S5), while the spectra registered after treatment for 24 hours are summarized in Figure 3.

At all times, the “L+CAL\_1” mortar exhibited the most pronounced bands owing to new CaP formation. This is consistent with the fact that this mortar type, composed of calcium carbonate both in the binder and in the aggregates, can virtually totally react with the phosphate solution to form new CaP (although the binder, composed of finer crystals, is expected to be more reactive than the aggregates). In the “L+CAL\_1” sample, the position of the new bands (1027-1029, 600, 560-565  $\text{cm}^{-1}$ ) suggests formation of hydroxyapatite (HAP,  $\text{Ca}_{10}(\text{PO}_4)_6(\text{OH})_2$ , the most stable CaP at  $\text{pH}>4$ ), having bands at 1031, 604, 563  $\text{cm}^{-1}$  [37]. Similarly, also in the case of the “L+BRICK” mortar HAP seems to be the main new CaP phase, although the overlapping with the quartz bands (owing to the aggregate) make the identification less straightforward. In the case of the “L+SIL\_1”, “NHL” and “CEM” mortars, the new bands appearing after treatment seem more compatible with formation of octacalcium phosphate (OCP,  $\text{Ca}_8(\text{HPO}_4)_2(\text{PO}_4)_4 \cdot 5\text{H}_2\text{O}$ ), having bands at 1038, 602, 560  $\text{cm}^{-1}$  [37]. Although more soluble than HAP, OCP is significantly less soluble than calcite [9], hence its formation is expected to provide durable consolidating action, as assessed in previous studies [18]. The fact that all mortar types exhibited formation of new CaP after treatment, notwithstanding the lower amount of calcium ions that can dissolve from the substrate in the other mortars compared to the “L+CAL\_1” one, suggests that the addition of a calcium source directly into the DAP solution is sufficient to guarantee formation of new CaP phases. In all cases, bands owing to new CaP were more pronounced after the “2 M DAP” treatment, suggesting that the higher the DAP concentration, the more abundant the formation of new CaP. This was expected to some extent, even though addition of ethanol to the DAP solution was expected to substantially boost formation of new CaP, even for low DAP concentrations [16,18].

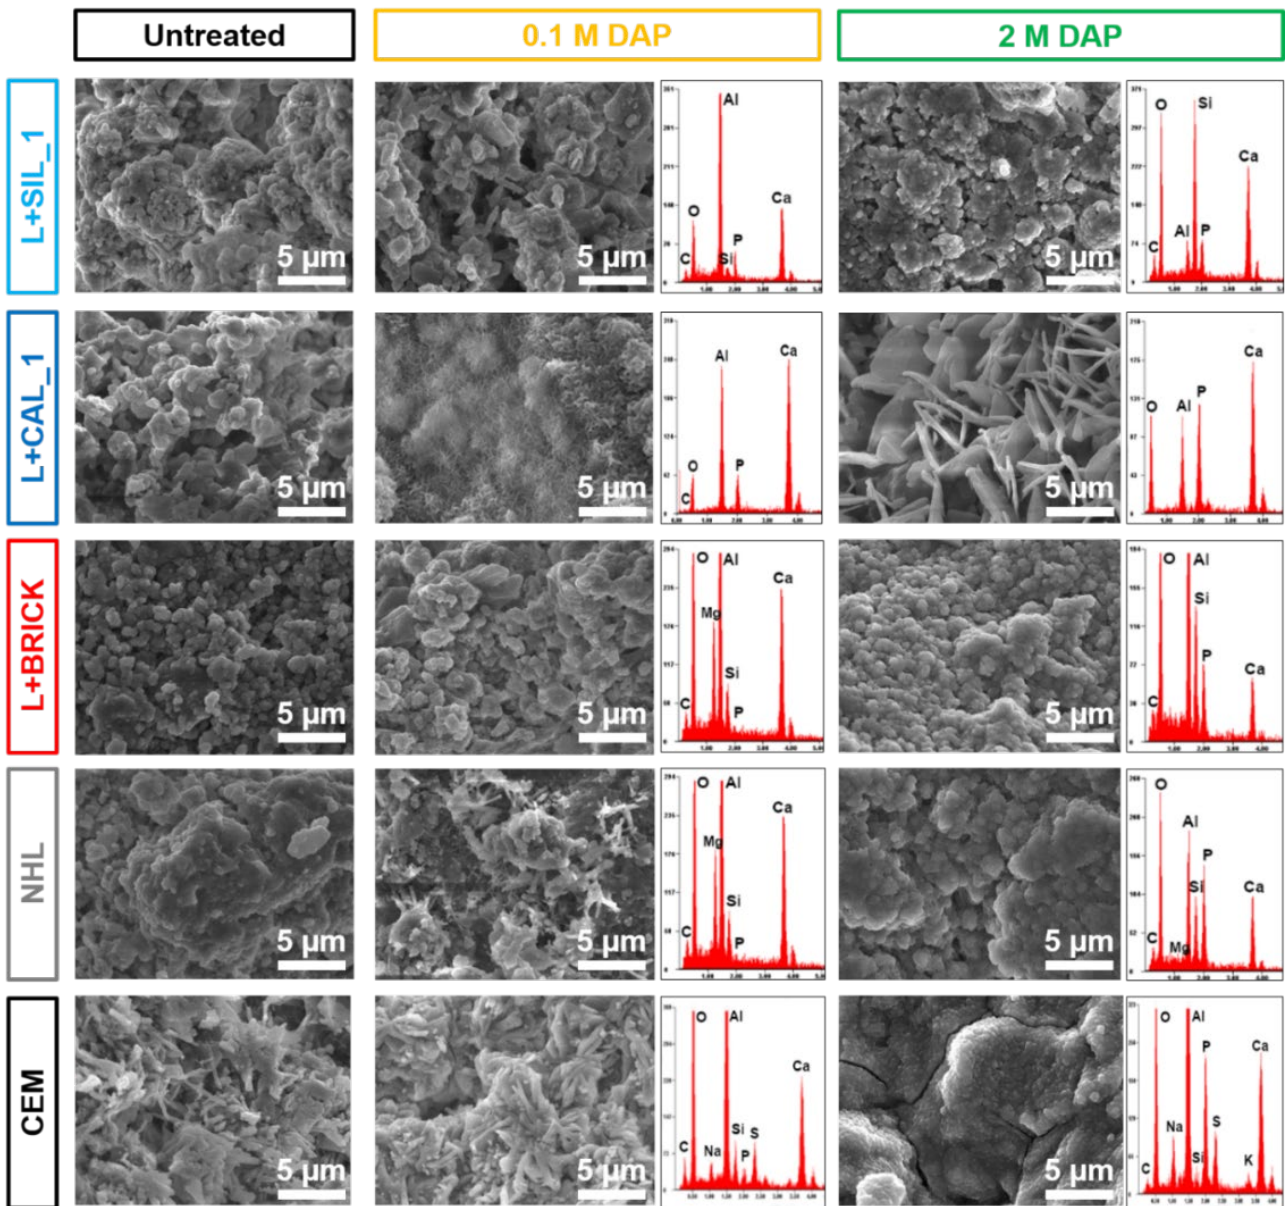
Figure 4. FT-IR spectra of the various mortar types after treatment for 24 hours.

Consistent with FT-IR results, SEM observation of samples treated for 24 hours (Figure 4) revealed evident formation of new CaP in the case of the “L+CAL\_1” mortar, where the typical flower-like morphology of CaP [9] was visible after treatment with both “0.1 M DAP” and, to a higher extent, “2 M DAP”. In the other mortar types, especially those based on slaked lime, recognition of the new CaP phases was less straightforward, because the morphology of the untreated mortars (characterized by the presence of many tiny particles) did not allow a clear distinction between the substrate and the new phases. Nonetheless, the presence of a phosphorus peak in the EDS spectra confirmed formation of new CaP phases in all mortar types. Consistently with the trend already assessed by FT-IR, the phosphorus peak was always more pronounced in the samples treated with the “2 M DAP” formulation, compared to the “0.1 M DAP” one. It is noteworthy that, in the

“CEM” samples, treatments led to formation of new CaP films at grain boundaries exhibiting cracking, especially in the case of the more concentrated solution (Figure 4).

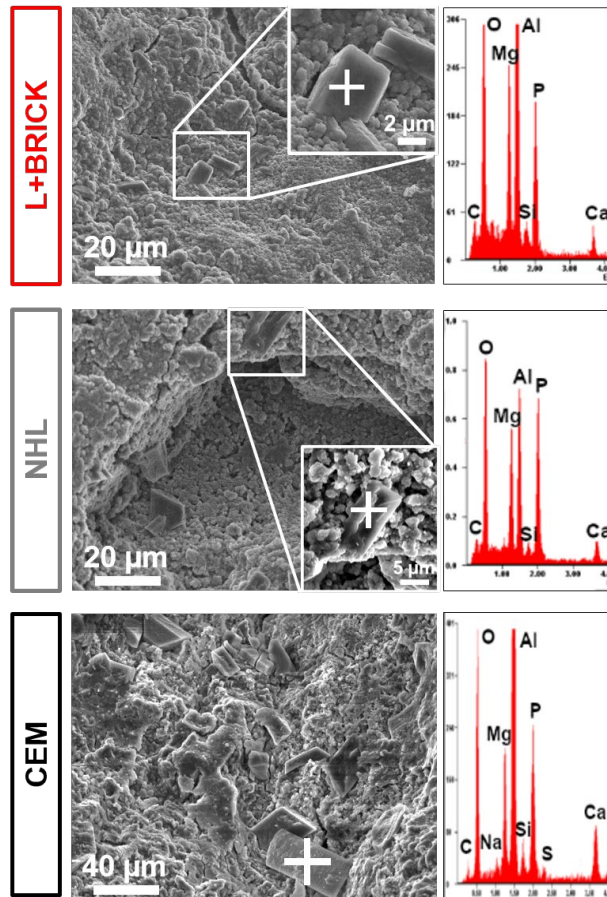
**Figure 5.** FT-IR spectra of the various mortar types after treatment for 24 hours.

SEM-EDS analysis also allowed to obtain some further important insight into formation of new phases. As reported in Figure 5, in several mortar types, when magnesium was present as an impurity, the phosphate treatment led to formation of some big isolated crystals, containing Mg and P (as indicated by EDS). Formation of magnesium phosphates (MgP) has been reported in the literature in studies where ammonium phosphate solutions were used to consolidate dolomite-rich natural stones [24] and also archaeological bones [38]. Because MgP grow as isolated crystals, they cannot provide any effective consolidating action, hence their formation is counterproductive. This should be taken into account and possibly prevented when substrates containing magnesium are treated.

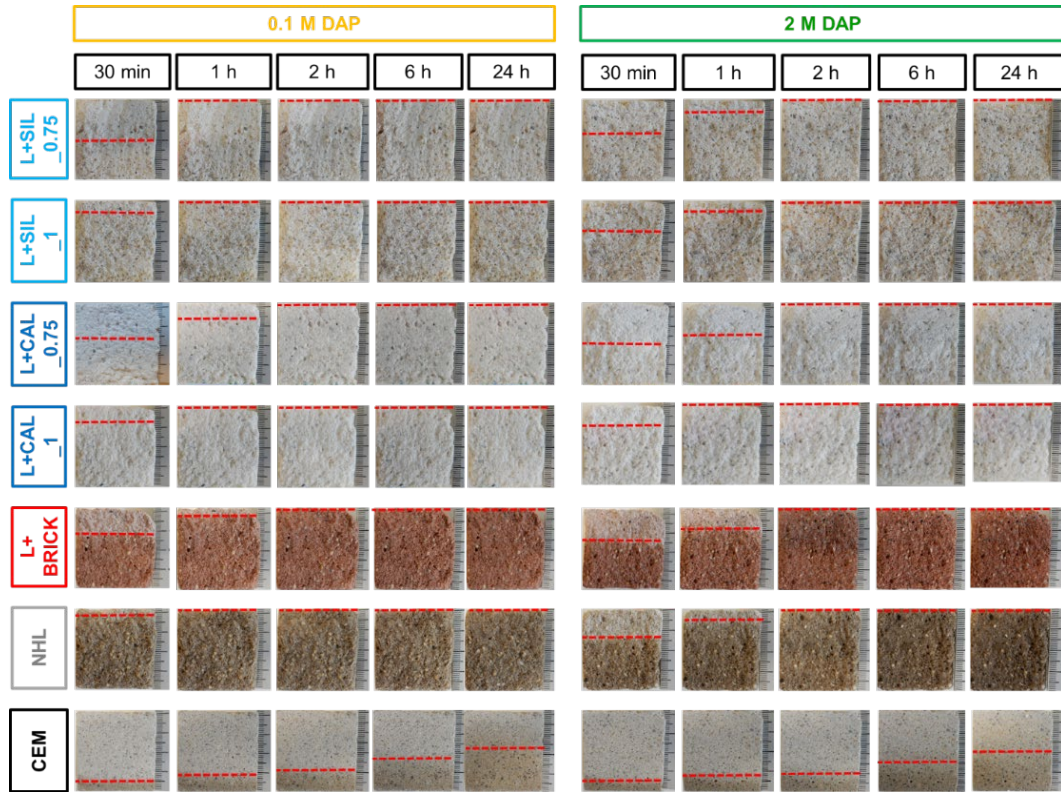
**Figure 6.** Penetration depth of the phosphate solutions into the various mortar types.

To evaluate the consolidating ability of the two phosphate solutions, their ability to penetrate into the various mortar types was first investigated. As illustrated in Figure 6, the “0.1 M DAP” solution was able to penetrate more quickly than the “2 M DAP” solution into all mortar types. This is thought to be due to the lower viscosity of the less concentrated solution (although viscosity was not experimentally determined in this study). For a given solution and a given mortar, the penetration depth was higher in the specimens with higher water/binder ratio (“\_1” compared to “\_0.75”), as expected. With the exception of the “CEM” mortars, after 24 hours both solutions were able to saturate completely all the lime- and NHL-based specimens, thus indicating that in these mortars the penetration depth after 24 hours was at least 40 mm. Such penetration depth can be regarded as fully satisfactory, compared to the penetration depth reported in the literature for alternative products for lime mortar consolidation: for nanolimes, 5 mm [39] to 8 mm [40]; for ethyl silicate, 16-30 mm (depending on the mortar porosity) [39]; for barium hydroxide solutions, 5-30 mm (depending on the mortar porosity) [39]. In the case of the “CEM” mortars, the penetration depth of the DAP solutions was lower than in the other mortars, as a consequence of the lower porosity and smaller pore size of this mortar type (cf. MIP results in the following). In the “CEM” mortars, the penetration depth was about 25 mm for the “0.1 M DAP” solution and about 20 mm for the “2 M DAP” solution, as a consequence of the higher viscosity of the latter solution. These values are in line with the penetration depth reported in the literature for ethyl silicate applied to cement mortars, for which a penetration depth of at least 20 mm was registered [41]. However, when comparing values of penetration depth reported in different studies, it should be borne in mind that mortars with the same type of binder may actually be quite different in terms of porosity, which depends on the water to binder ratio and which, in turn, influences the consolidant penetration depth.

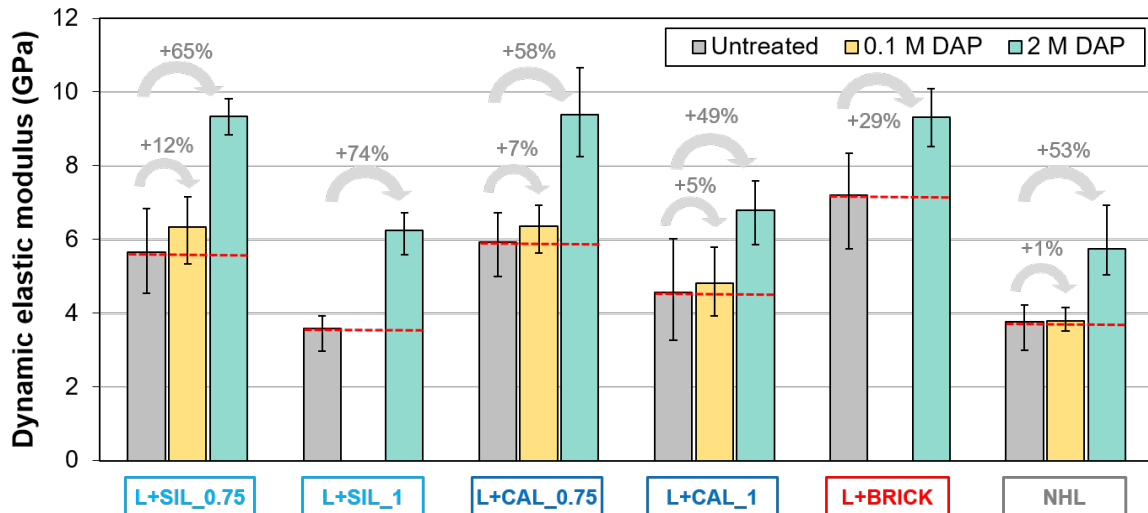
**Figure 7.** Dynamic elastic modulus ( $E_d$ ) of untreated and treated lime- and NHL-based specimens.

Thanks to the high penetration depth of the phosphate solutions and to the consequent formation of new CaP phases, the phosphate treatment was able to significantly improve mortar mechanical properties, as illustrated in Figure 7 and Figure 8 for lime- and NHL-based mortars and in Figure 9 for the cement mortar.

Before consolidation (gray bars in Figures 7 and 8), the lime-based specimens with higher water to binder ratio exhibited lower  $E_d$  and lower  $R_c$ , as expected. At given water to binder ratio, the addition of brick dust led to higher mechanical properties compared to mortars only containing slaked lime, as a consequence of C-S-H formation. The “NHL” specimens (produced using NHL 3.5 binder) exhibited low mechanical properties, which can be attributed to the high water to binder ratio (Table 1). In the case of the “CEM” specimens, notwithstanding the high water to binder ratio, the final compressive strength was close to the nominal one (samples were produced using CEM I 32.5).

After consolidation, the lime- and NHL-based mortars experienced limited increases in  $E_d$  (+1 to +16%) and  $R_c$  (0 to +16%) after treatment with the "0.1 M DAP" solution, while much higher improvements were obtained with the "2 M DAP" solution (+29 to +65% increase in  $E_d$ , +87 to +204% increase in  $R_c$ ). Such difference in consolidating ability between the two formulations is a consequence of the different amounts of new CaP phases formed in the two cases, as already assessed by FT-IR and SEM-EDS. The mechanical improvement was higher in the "L+SIL" and "L+CAL" mortars (where the binding fraction was made of calcium carbonate, highly reactive to form new CaP), compared to the "L+BRICK" and "NHL" mortars (where the binding fraction was mostly calcium silicate hydrates, less reactive than calcium carbonate, which in these specimens amounted to ~35 wt%). Nonetheless, some mechanical improvement was registered for all the mortar types, especially in the case of the more concentrated solution, even in cases where formation of new CaP was not very evident from FT-IR and SEM-EDS. This confirms that, thanks to the addition of a calcium source already in the DAP solution, significant consolidation can be achieved even on substrates that contain relatively low amounts of calcium-rich fractions. The beneficial effect of calcium ions supplied directly in the DAP solution, together with the predominant role of the binding fraction compared to

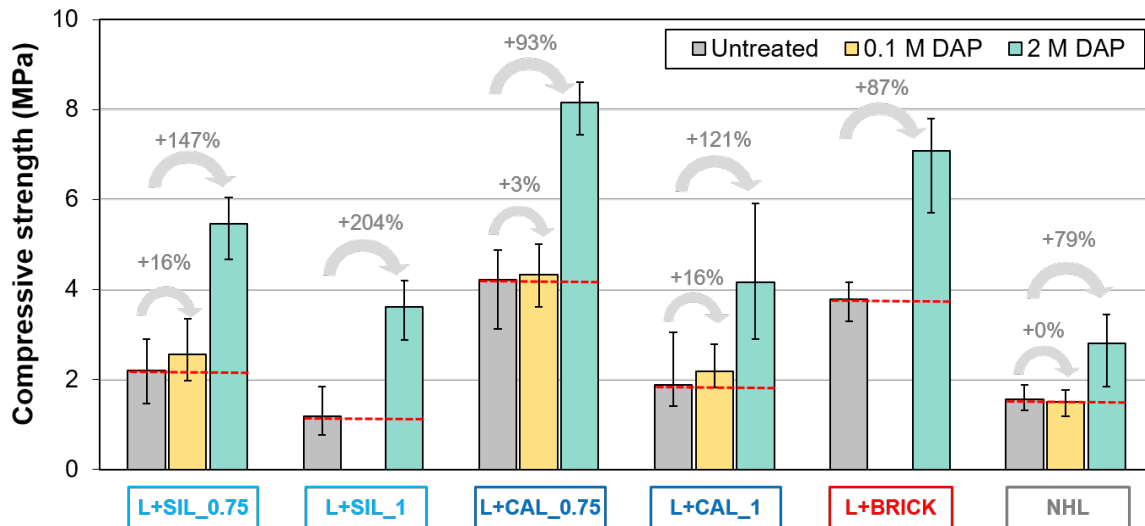
**Figure 8.** Compressive strength ( $R_c$ ) of untreated and treated lime- and NHL-based specimens.

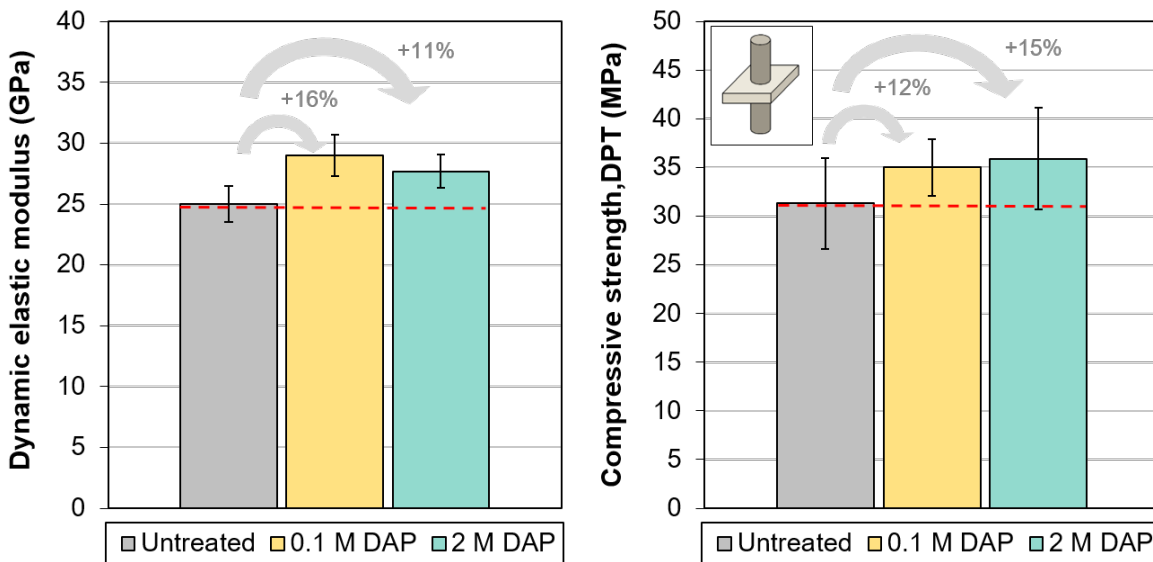
**Figure 9.** Dynamic elastic modulus ( $E_d$ ) and compressive strength determined by DPT ( $R_{c,DPT}$ ) of untreated and treated "CEM" specimens.

In the case of the “CEM” mortar (containing ~24 wt% calcium carbonate), substantially similar improvements in mechanical properties were achieved by either the “0.1 M DAP” or the “2 M DAP” solution ( $E_d$  increases of +16% and +11%, respectively, and  $R_{c,DPT}$  increases of +12 and +15%, respectively). The absence of significant differences between the two solutions in the case of the cement mortar, unlike the case of lime- and NHL-based mortars, is most likely a consequence of the fact that, notwithstanding the high water to binder ratio (Table 1), the specimens exhibited high mechanical properties and low porosity (Figure 9 and Figure 10, discussed in the following), so the starting material was not in a condition of severe loss of cohesion and consequent need of consolidation.

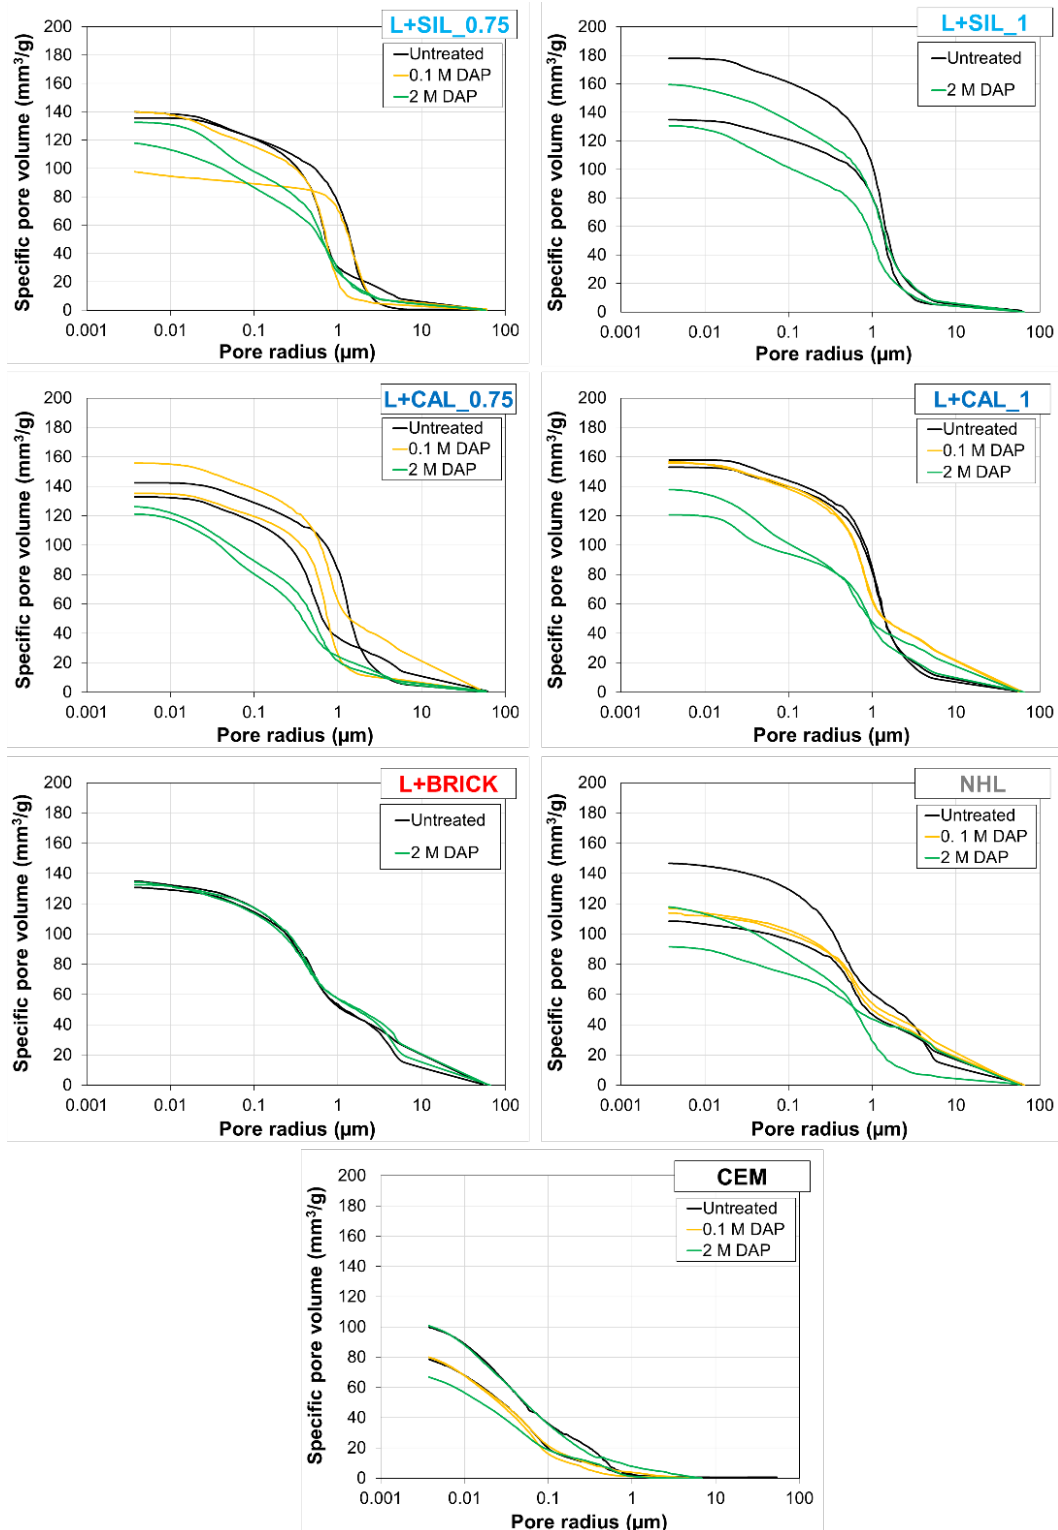
Figure 10. Pore size distribution of untreated and treated mortars.

The pore size distributions of untreated and treated mortars are illustrated in Figure 10. As expected, lime-based mortars with higher water to binder ratios exhibited higher open porosity (OP) than mortars with the same composition but a lower ratio: OP was 28.3% for “L+SIL\_1” and 24.7% for “L+SIL\_0.75”, while OP was 26.2% for “L+CAL\_1” and 24.8% for “L+CAL\_0.75”. As expected, the “CEM” specimens were the least porous ones (OP = 17.0%). In general, duplicate samples exhibited fair reproducibility, although in some cases some difference was found between the two samples tested for each condition (especially, in the “L+SIL\_1” and “NHL” mortars).

Formation of new CaP phases resulted in some reduction in the total open porosity and some alteration in pore size distribution, which were more pronounced after treatment with the “2 M DAP” solution, as a consequence of the higher amount of new CaP phases formed in this case. With this formulation, some shift of the pore size distribution towards smaller pores took place, but the final total open porosity was only slightly reduced compared to the untreated condition, the reduction often falling within the variability of the untreated references. Passing from the untreated to the “2 M DAP”-treated condition, OP changed from 24.7 to 24.9% for “L+SIL\_0.75”, from 28.3 to 26.0% for “L+SIL\_1”, from 24.8 to 22.3% for “L+CAL\_0.75”, from 26.2 to 24.8% for “L+CAL\_1”, from 25.1 to 23.6% for “L+BRICK”, from 21.6 to 20.5% for “NHL”, from 17.0 to 15.8% for “CEM”. The fact that in no case did significant pore occlusion take place can be regarded as a positive feature, because strong alterations in the pore system might lead to significant changes in water transport properties, with consequent durability issues [11,12]. Moreover, because no significant increase in the fraction of smallest pores occurred, the mortar resistance to freeze-thaw and salt crystallization cycles is not expected to be negatively affected, but specific tests are needed to confirm this. The lack of complete pore occlusion is common to other alternative products used for lime and cement mortar consolidation, such as nanolimes [4] and ethyl silicate [41].

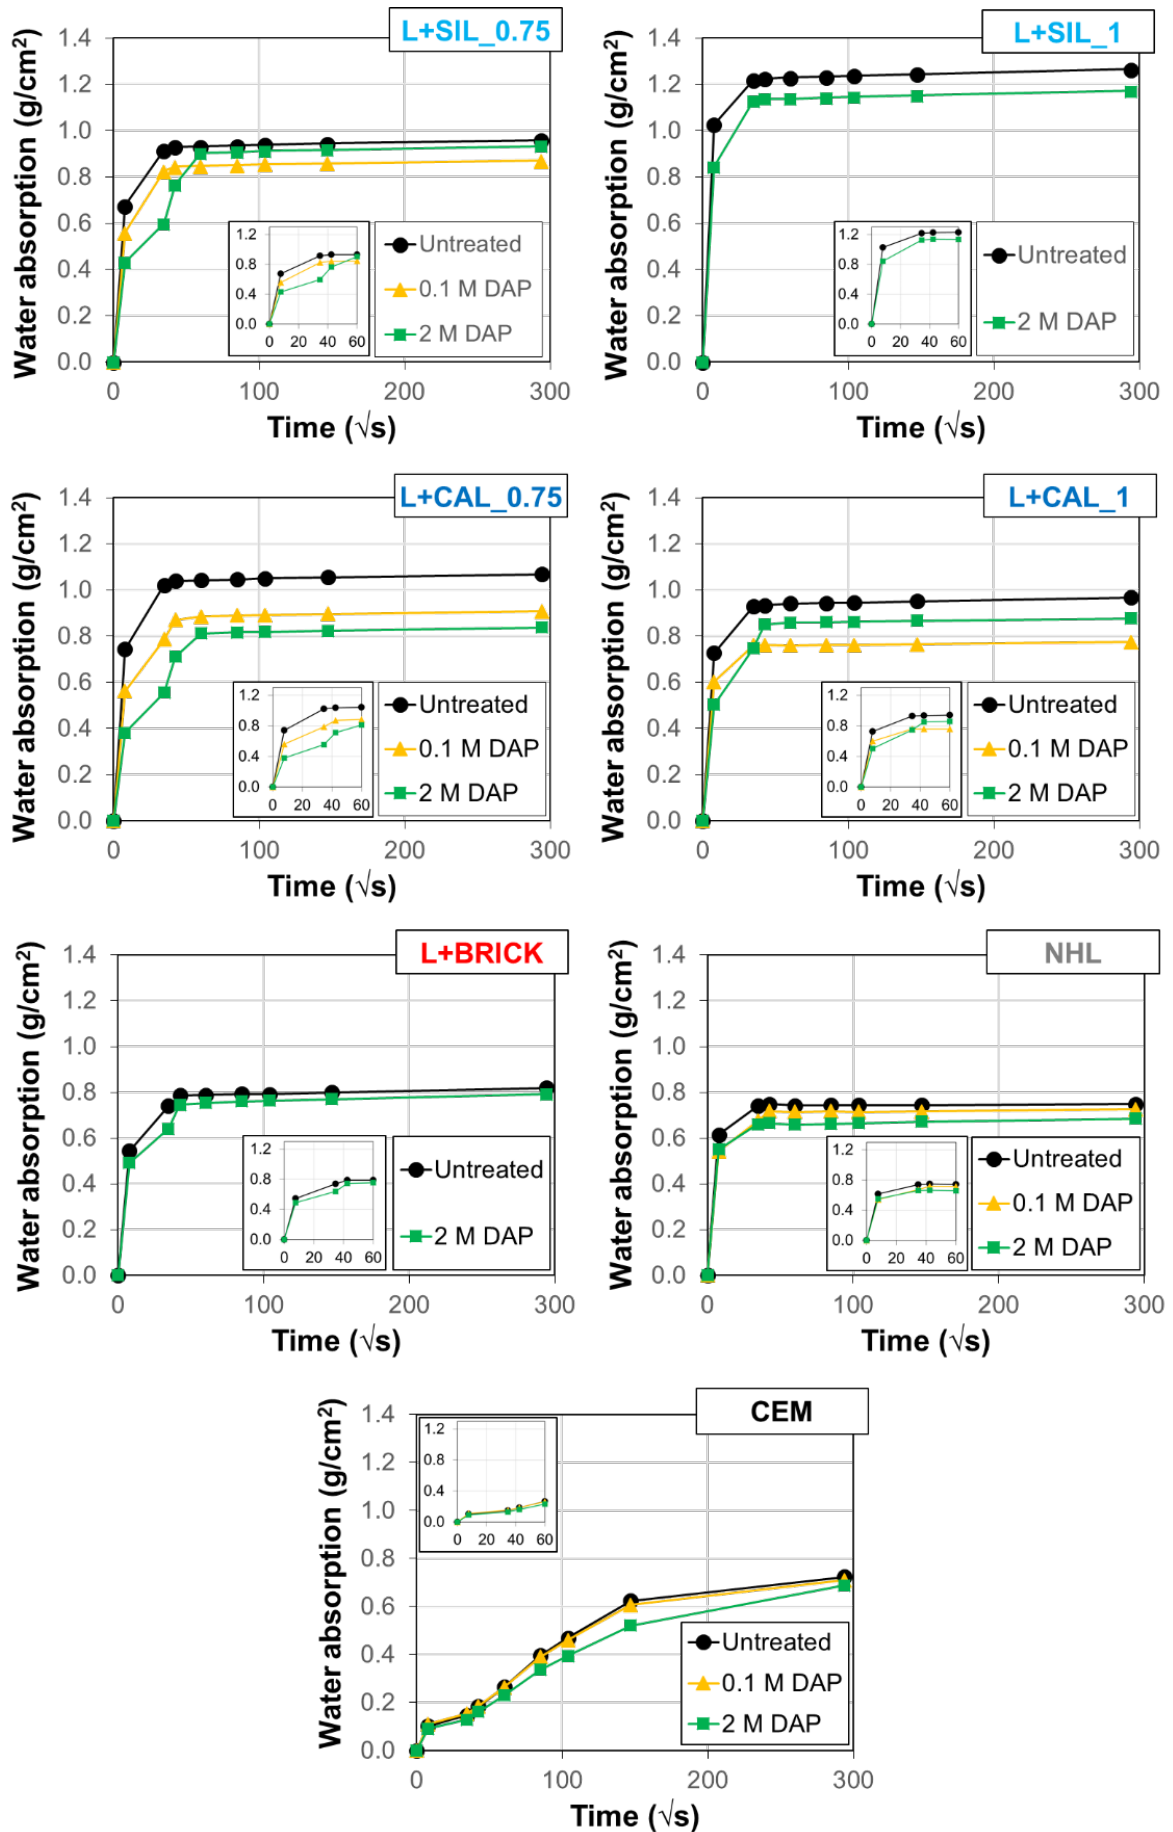
**Figure 11.** Water sorptivity of untreated and treated mortars (values are averages for 2 specimens).

As a consequence of the limited alterations in the pore system, also water transport properties were left basically unchanged after treatment with DAP solutions. As illustrated in Figure 11, minor reductions in water sorptivity and water absorption at the end of the test were registered, slightly more pronounced in the case of the “2 M DAP” solution. However, in no case was water absorption significantly inhibited after treatment.

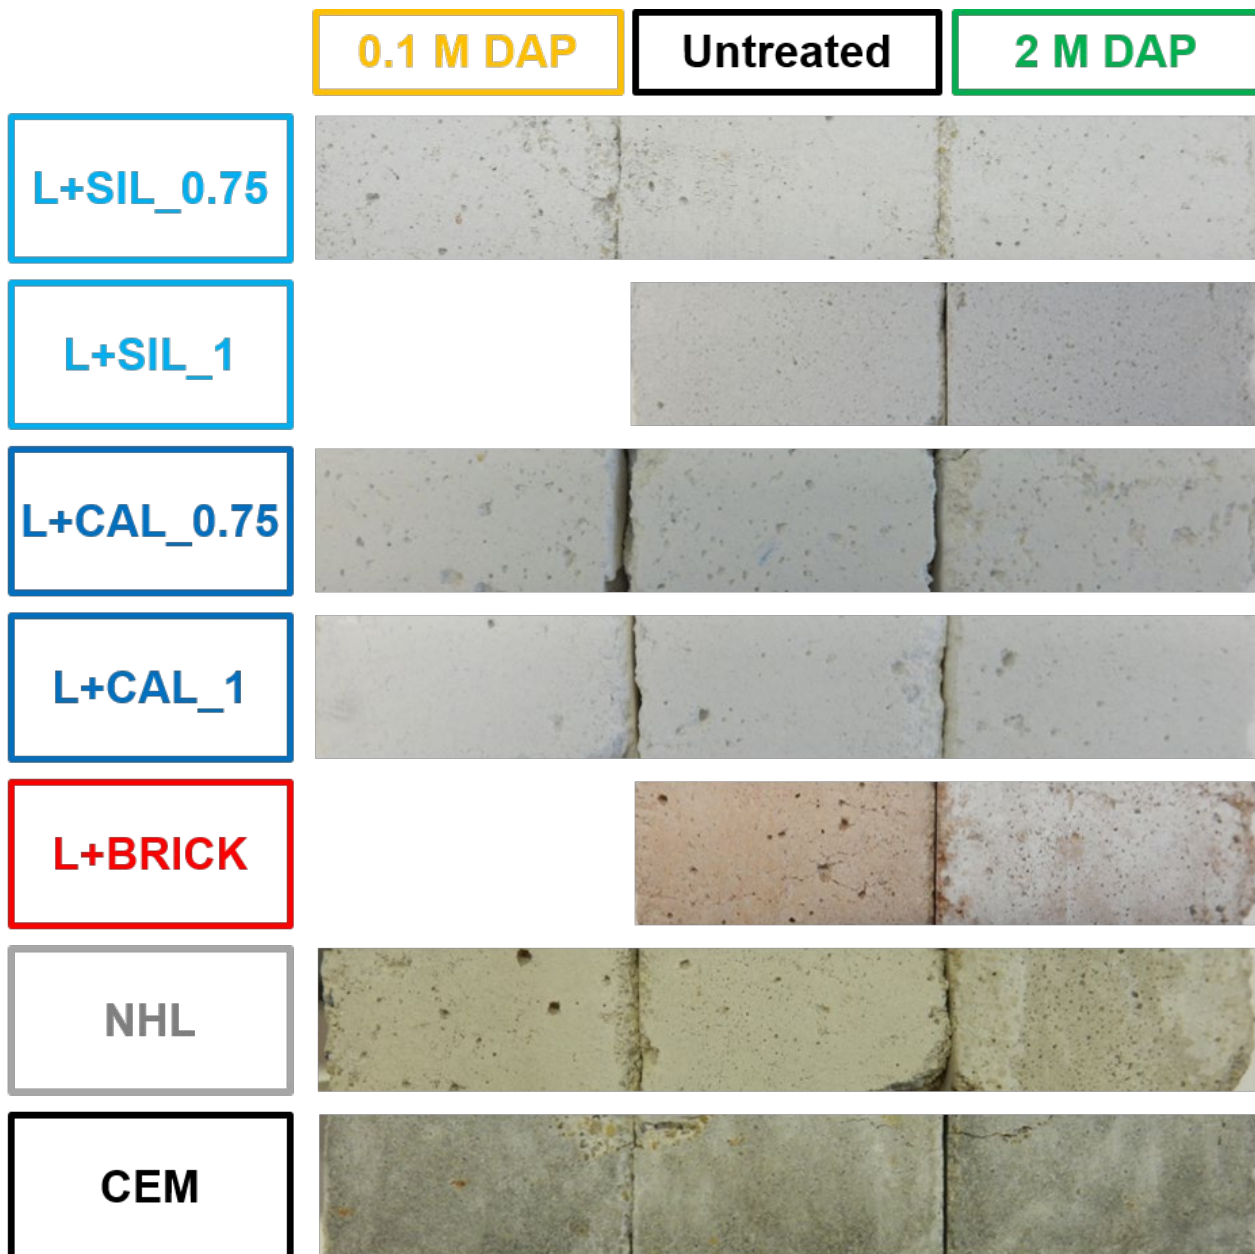
Figure 12. Visual appearance of untreated and treated mortars.

In terms of aesthetical compatibility, no visible color change occurred in the lime-based mortars, initially white, after consolidation with either formulation of the phosphate treatment (Figure 12). In the case of the other mortars (“L+BRICK” originally pink, “NHL” originally brownish, “CEM” originally gray), the “0.1 M DAP” solution caused no visible color change, but some whitening occurred after treatment with the “2 M DAP” formulation (Figure 12). This suggests that, while no particular issue is expected when white substrates are treated, in the case of colored substrates preliminary tests are recommended to ensure that no undesired aesthetic alteration takes place.

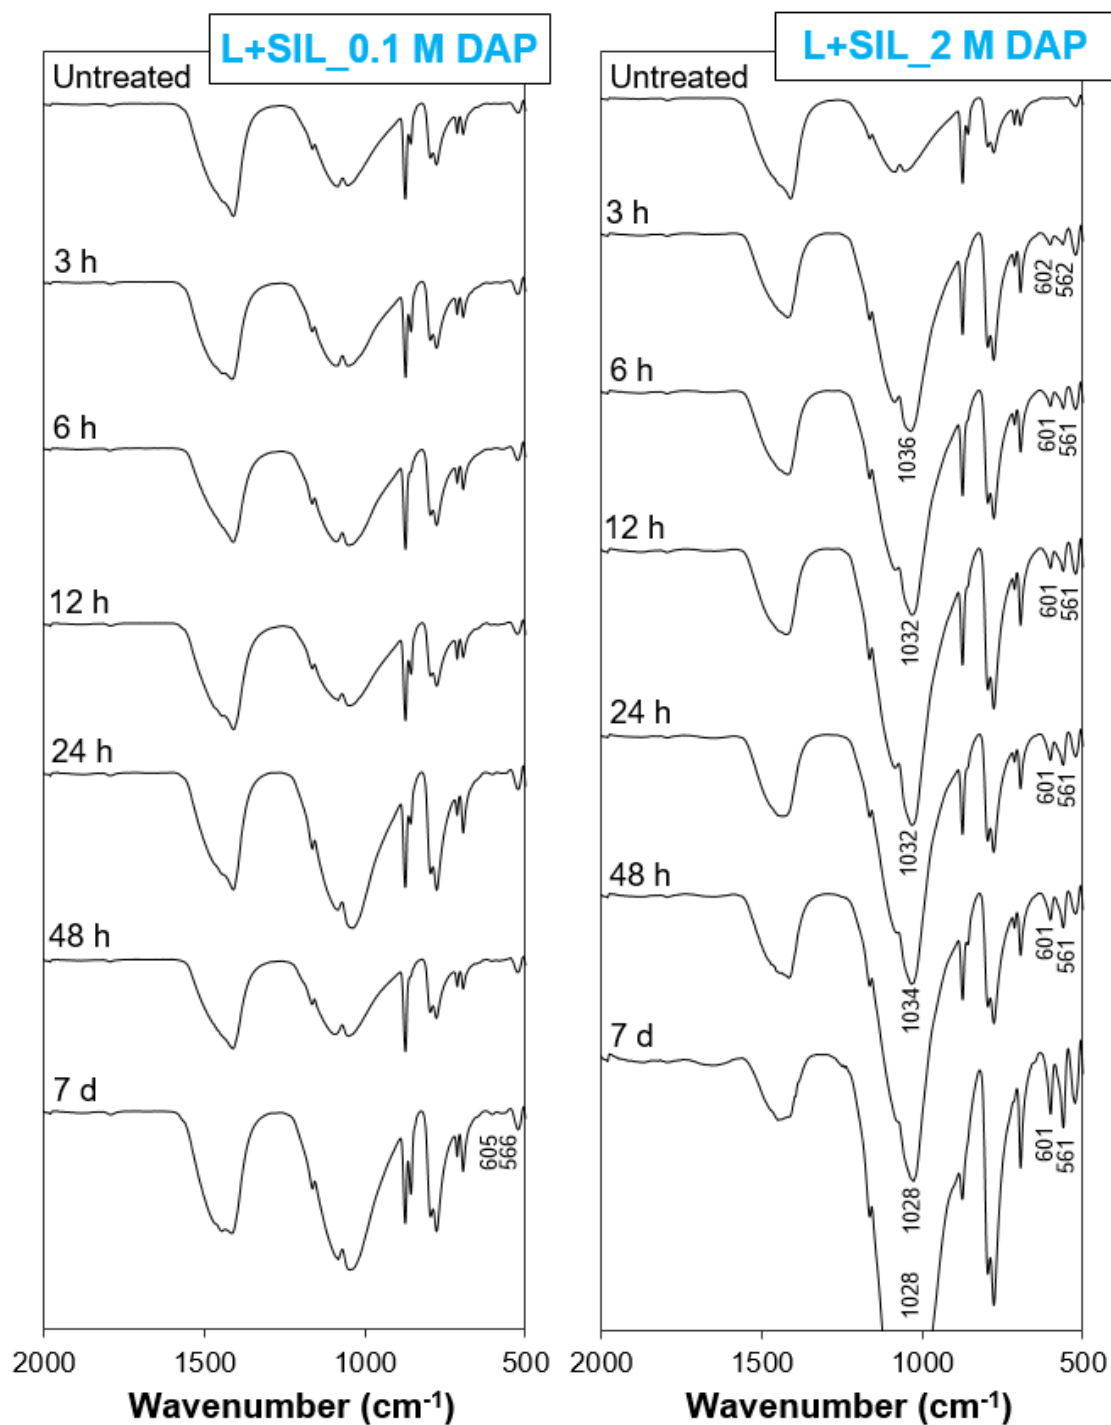
**Figure S1.** FT-IR spectra of “L+SIL” samples treated for increasing time.

Considering that, for all mortar types, no major increase in new phase formation was registered after treatment for 48 hours or 7 days (Figures S1-S5), treatment for 24 hours was selected as the reference treatment duration for the prosecution of the study. Such duration was selected also considering its feasibility in the onsite practice of architectural conservation, whereas longer durations might become challenging.

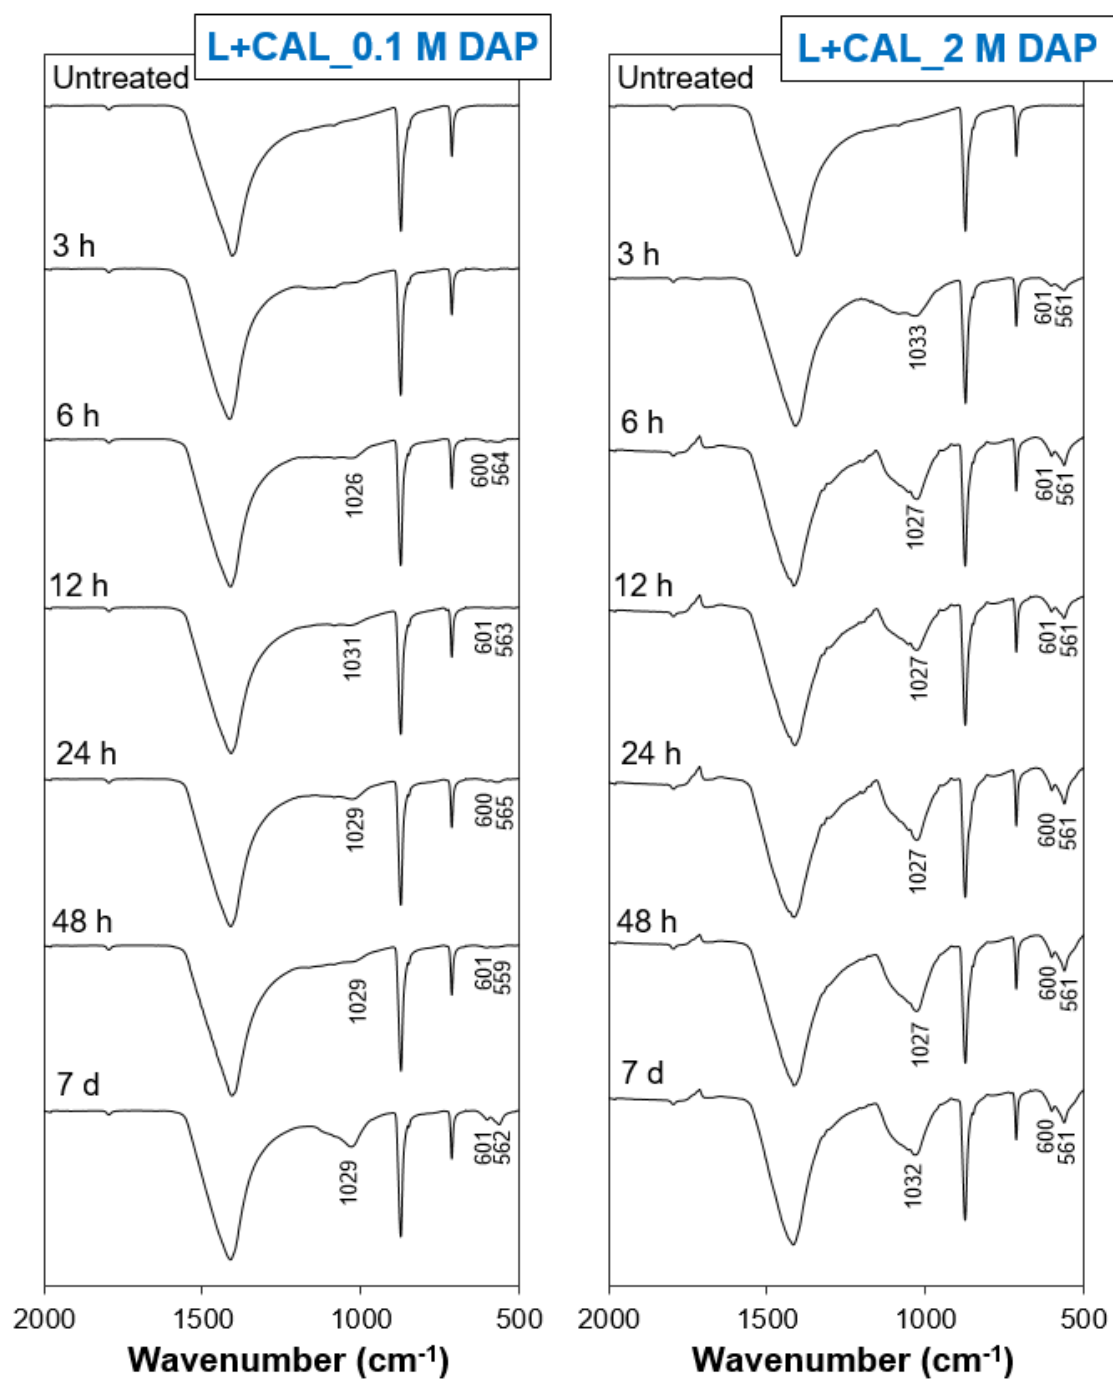
**Figure S2.** FT-IR spectra of "L+CAL" samples treated for increasing time.

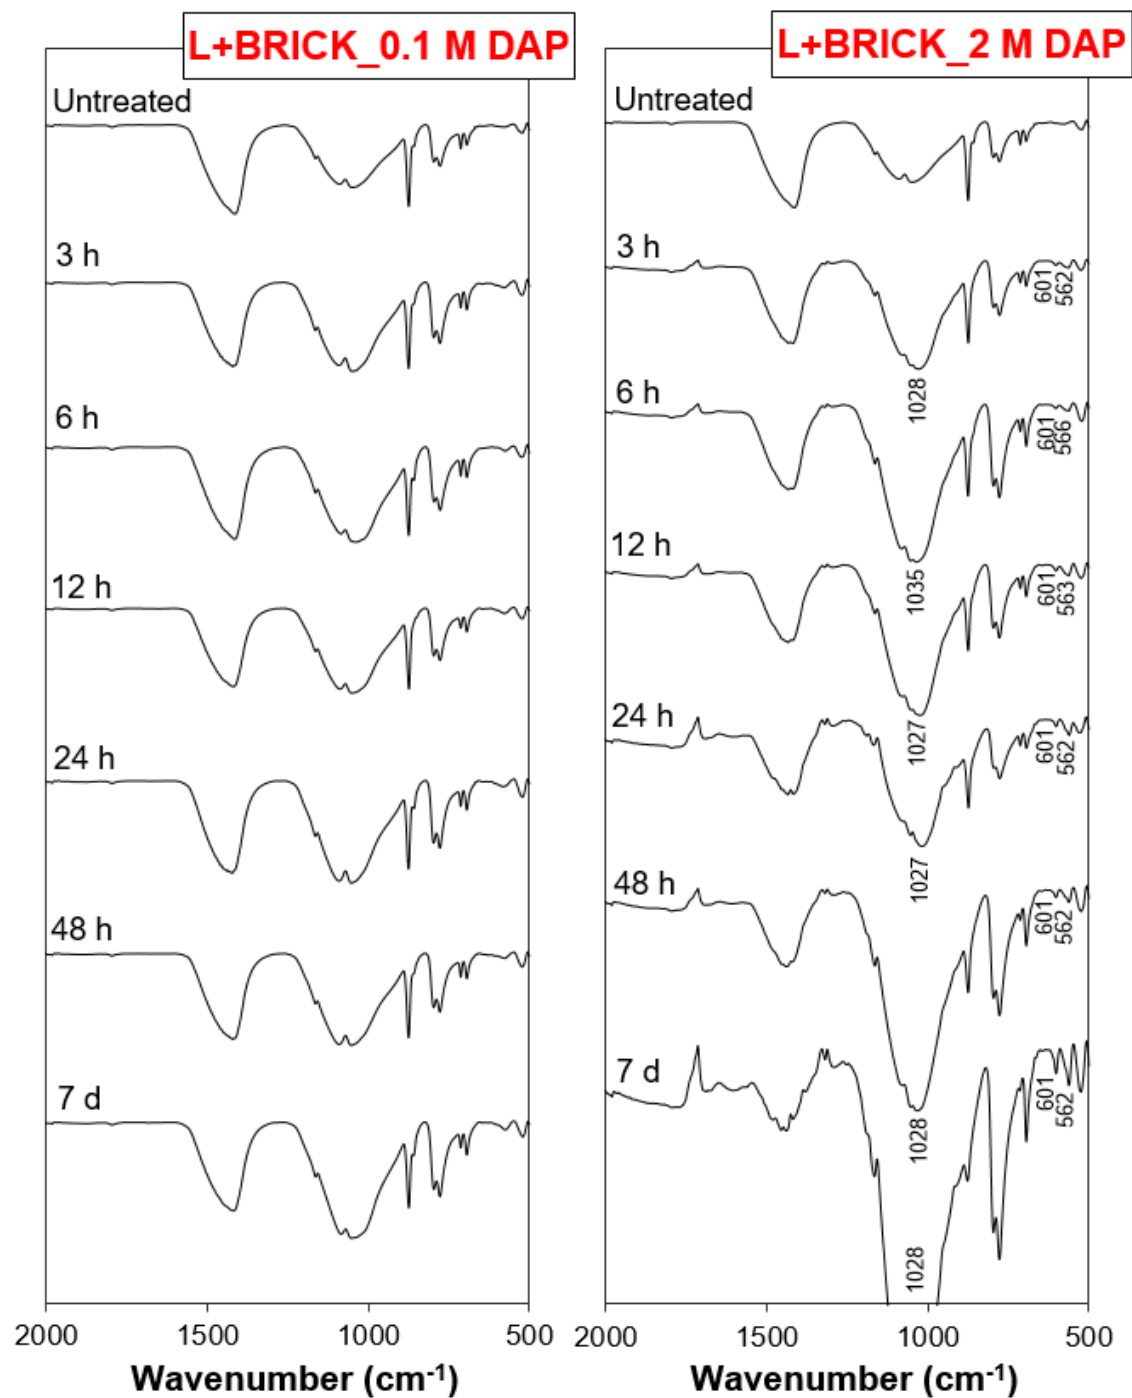
**Figure S3.** FT-IR spectra of “L+BRICK” samples treated for increasing time.
