# LIME AND CEMENT MORTAR CONSOLIDATION BY AMMONIUM PHOSPHATE

Enrico Sassoni\*, Elisa Franzoni

Department of Civil, Chemical, Environmental & Materials Engineering (DICAM)  
University of Bologna, Italy

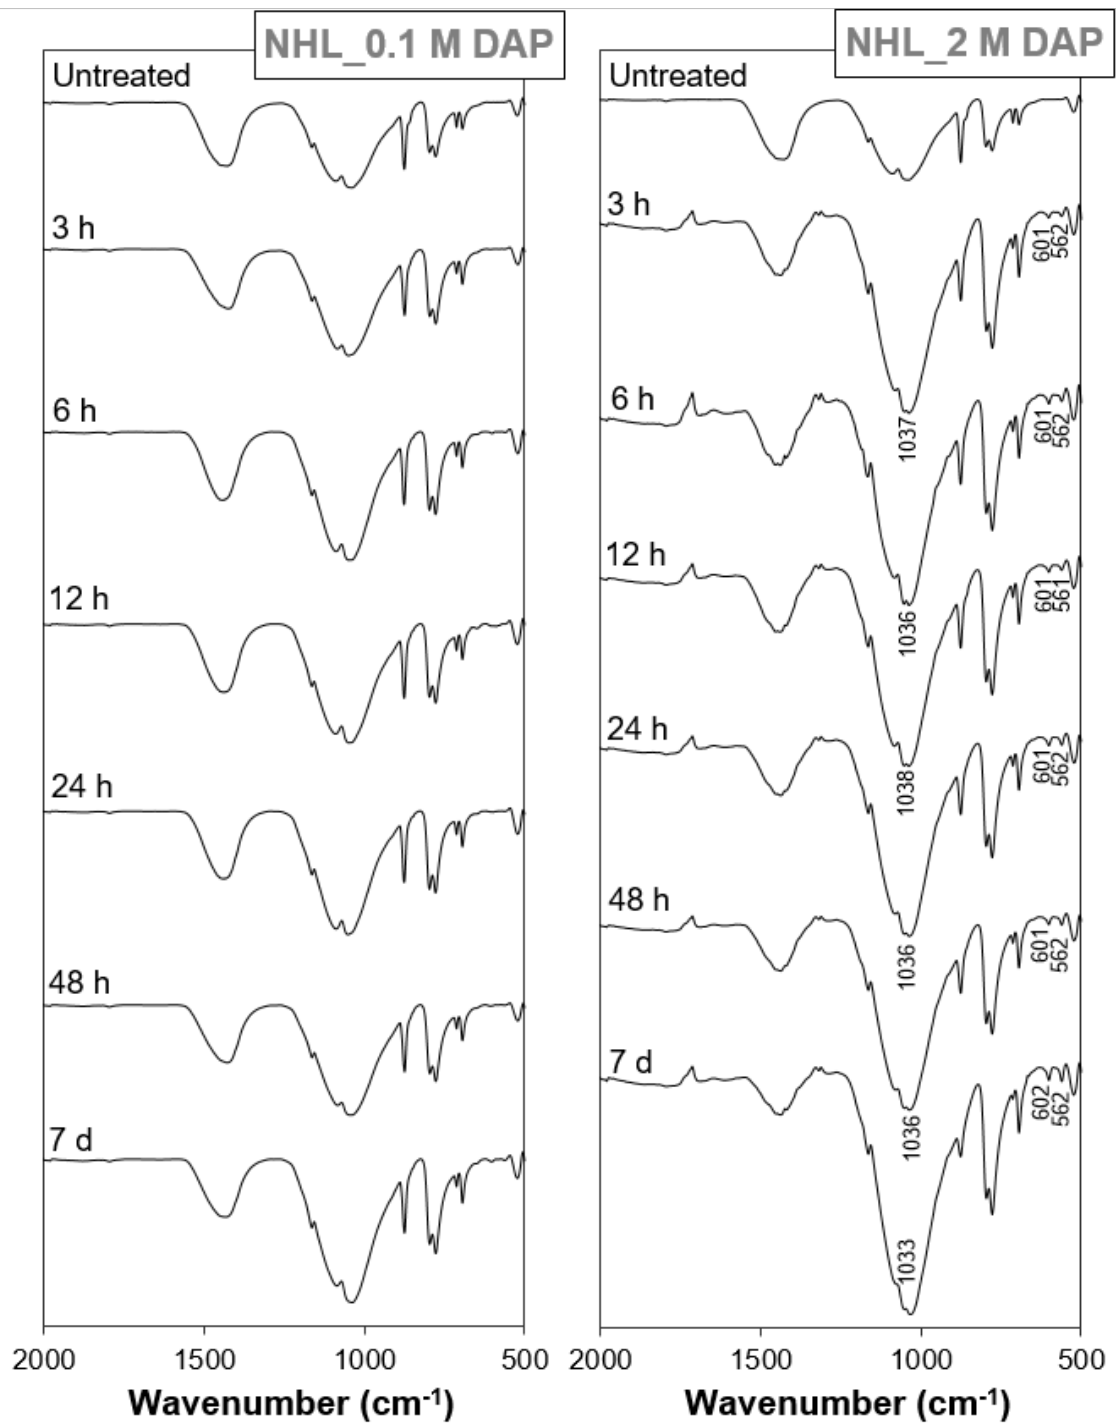
**Figure S4.** FT-IR spectra of “NHL” samples treated for increasing time.

Considering that, for all mortar types, no major increase in new phase formation was registered after treatment for 48 hours or 7 days (Figures S1-S5), treatment for 24 hours was selected as the reference treatment duration for the prosecution of the study. Such duration was selected also considering its feasibility in the onsite practice of architectural conservation, whereas longer durations might become challenging.
