Dry Grinding: A More Sustainable Manufacturing Process for the Production of Automotive Gears

# **DRY GRINDING: A MORE SUSTAINABLE MANUFACTURING PROCESS FOR THE PRODUCTION OF AUTOMOTIVE GEARS**

**Keywords:** Dry grinding; Gears; Sustainable technology; Surface Integrity

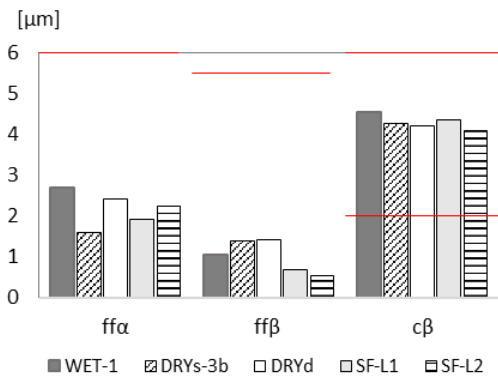
Figure 18: Dimensional tolerance (a) and roughness (b) comparison within optimised grinding conditions.

Klingelnberg measurements on dimensional tolerance show a substantial homogeneity between the processes, with no relevant differences between wet (conventional and superfinishing setups) and dry working conditions. Final values are much lower than commercial requirements in all cases (Figure 18a).
