Lime and cement mortar consolidation by ammonium phosphate

Sassoni E., Franzoni E. (2020). Lime and cement mortar consolidation by ammonium phosphate. CONSTRUCTION AND BUILDING MATERIALS, 245, 1-13 [10.1016/j.conbuildmat.2020.118409].

LIME AND CEMENT MORTAR CONSOLIDATION BY AMMONIUM PHOSPHATE

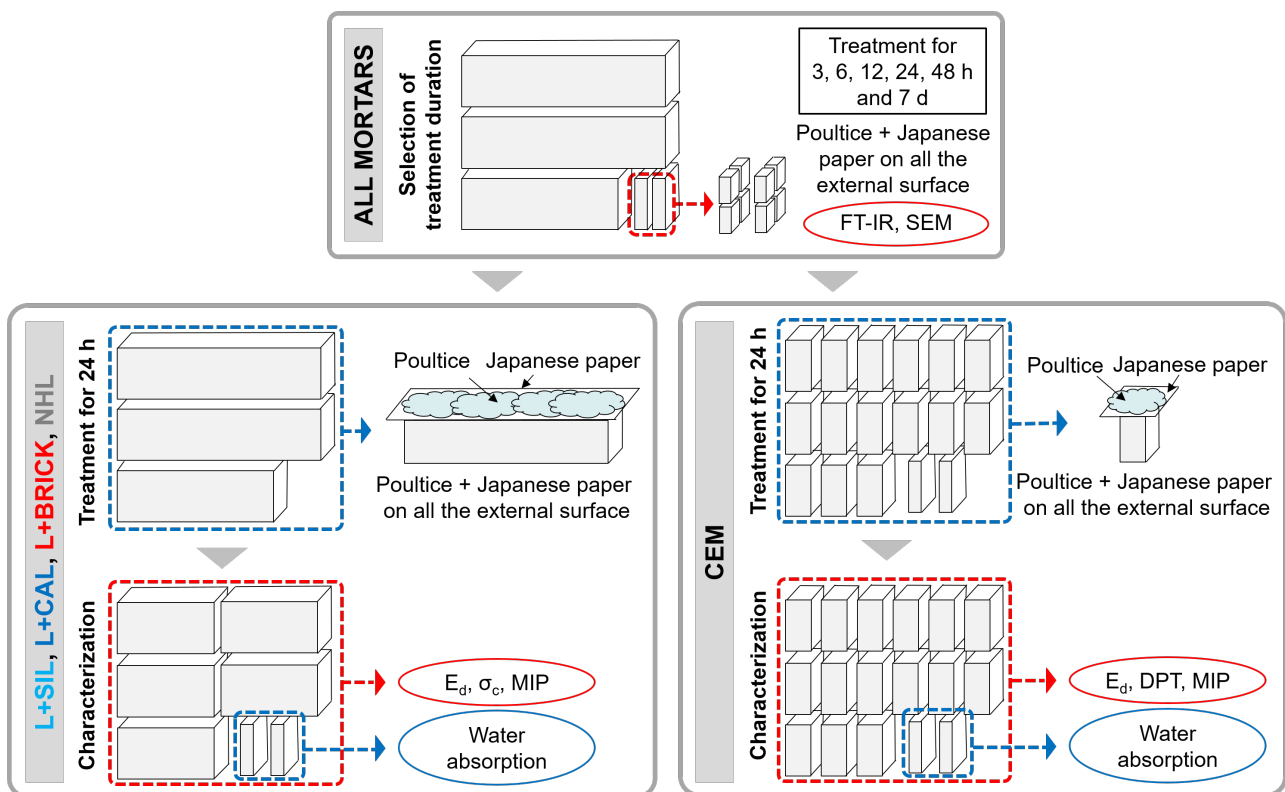
Figure 1. Scheme illustrating the rationale of the study, the sample production and testing.

As illustrated in Figure 1, for all mortar types small samples (about 2×2×1 cm³) were obtained from one standard prism by wet sawing. These small samples were used to identify the best treatment duration, by treatment for increasing time and analysis by FT-IR and SEM, as described in detail in § 2.3.

The treatment duration varied depending on the phase of the study. In the first phase, aimed at identifying the best treatment duration itself (Figure 1), the small samples ($2 \times 2 \times 1 \text{ cm}^3$) were left to react for 3, 6, 12, 24, 48 hours and 7 days. For the development of the new CaP phases, the mortar mineralogical composition was regarded as the most important parameter, hence results obtained on “L+SIL_1” and “L+CAL_1” specimens were assumed as also representative for the “L+SIL_0.75” and “L+CAL_0.75” specimens, respectively.

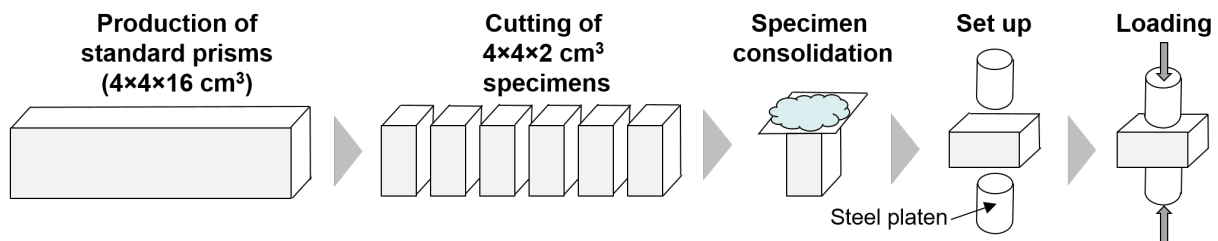
Figure 2. Scheme illustrating the procedure of the double punch test (DPT).

Double punch test. In the case of the “CEM” mortar, the compressive strength by double punch test ($R_{c,DPT}$) was determined by subjecting the $4 \times 4 \times 2 \text{ cm}^3$ specimens to double punch test (DPT) [33], following the procedure illustrated in Figure 2. The specimens were loaded onto the $4 \times 4 \text{ cm}^2$ faces by means of two steel cylindrical platens (2 cm diameter) until failure. Compared to standard compressive test (leading to 2 R_c values for each standard prism), the DPT has the advantage of providing a much higher number of results (up to 6 $R_{c,DPT}$ values for each standard prism). The 2 cm-thickness of the specimens for DPT was selected based on a previous study [34], which highlighted that testing samples with thickness (2 cm) similar to the diameter of the steel platens (2 cm) leads to $R_{c,DPT}$ values in very good correlation with the standard R_c values. For each condition, at least 12 replicates were tested.

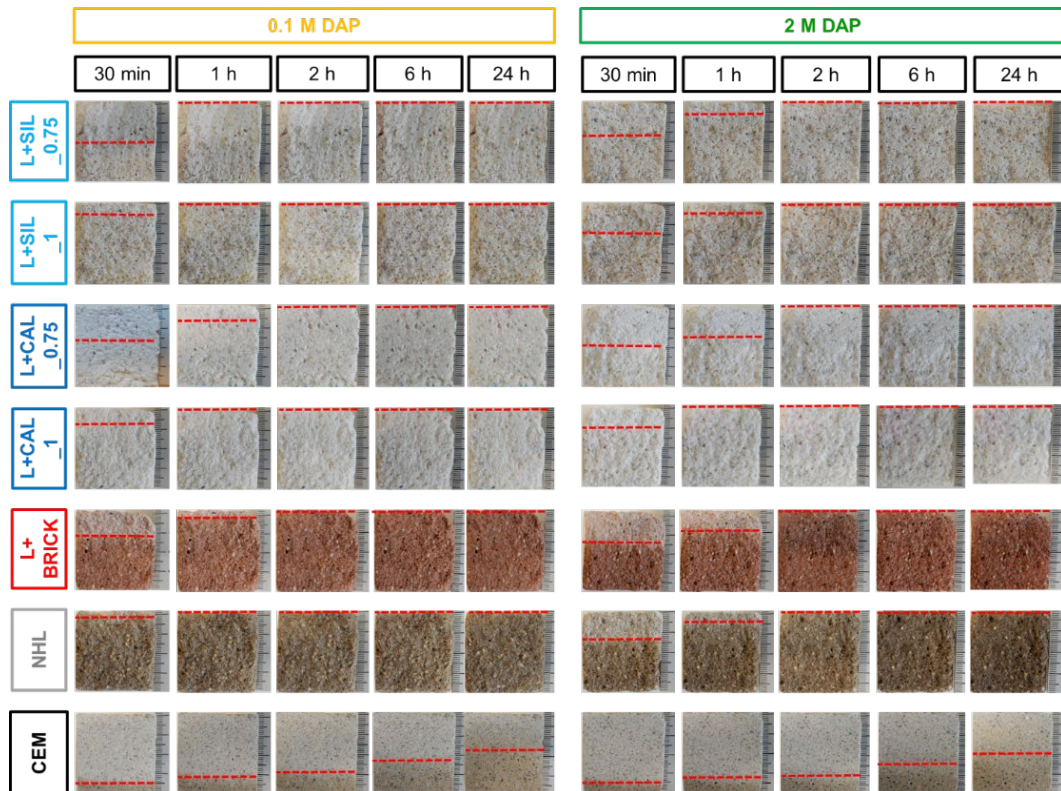
Figure 6. Penetration depth of the phosphate solutions into the various mortar types.

To evaluate the consolidating ability of the two phosphate solutions, their ability to penetrate into the various mortar types was first investigated. As illustrated in Figure 6, the “0.1 M DAP” solution was able to penetrate more quickly than the “2 M DAP” solution into all mortar types. This is thought to be due to the lower viscosity of the less concentrated solution (although viscosity was not experimentally determined in this study). For a given solution and a given mortar, the penetration depth was higher in the specimens with higher water/binder ratio (“_1” compared to “_0.75”), as expected. With the exception of the “CEM” mortars, after 24 hours both solutions were able to saturate completely all the lime- and NHL-based specimens, thus indicating that in these mortars the penetration depth after 24 hours was at least 40 mm. Such penetration depth can be regarded as fully satisfactory, compared to the penetration depth reported in the literature for alternative products for lime mortar consolidation: for nanolimes, 5 mm [39] to 8 mm [40]; for ethyl silicate, 16-30 mm (depending on the mortar porosity) [39]; for barium hydroxide solutions, 5-30 mm (depending on the mortar porosity) [39]. In the case of the “CEM” mortars, the penetration depth of the DAP solutions was lower than in the other mortars, as a consequence of the lower porosity and smaller pore size of this mortar type (cf. MIP results in the following). In the “CEM” mortars, the penetration depth was about 25 mm for the “0.1 M DAP” solution and about 20 mm for the “2 M DAP” solution, as a consequence of the higher viscosity of the latter solution. These values are in line with the penetration depth reported in the literature for ethyl silicate applied to cement mortars, for which a penetration depth of at least 20 mm was registered [41]. However, when comparing values of penetration depth reported in different studies, it should be borne in mind that mortars with the same type of binder may actually be quite different in terms of porosity, which depends on the water to binder ratio and which, in turn, influences the consolidant penetration depth.

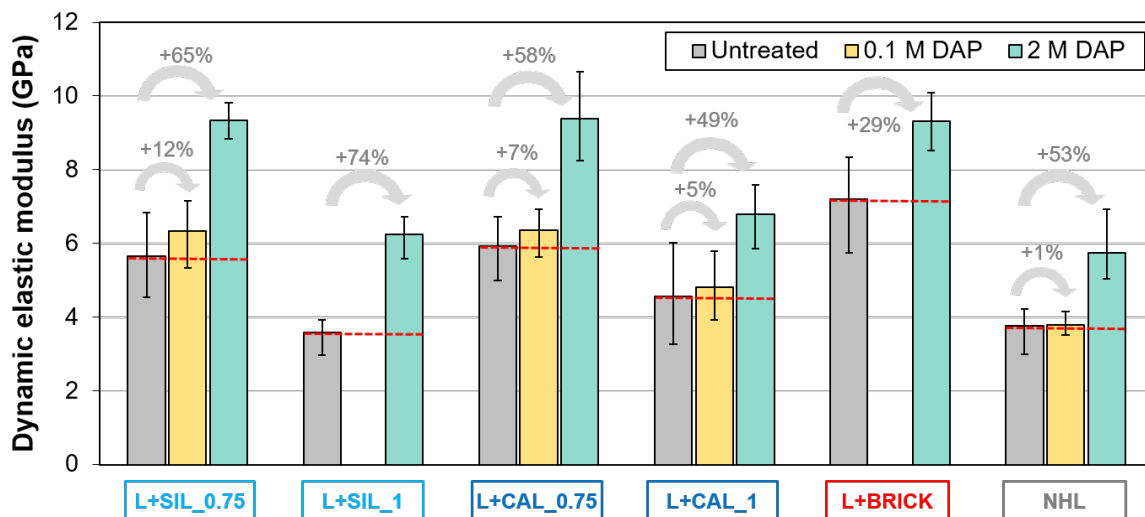
Figure 7. Dynamic elastic modulus (E_d) of untreated and treated lime- and NHL-based specimens.

Before consolidation (gray bars in Figures 7 and 8), the lime-based specimens with higher water to binder ratio exhibited lower E_d and lower R_c , as expected. At given water to binder ratio, the addition of brick dust led to higher mechanical properties compared to mortars only containing slaked lime, as a consequence of C-S-H formation. The “NHL” specimens (produced using NHL 3.5 binder) exhibited low mechanical properties, which can be attributed to the high water to binder ratio (Table 1). In the case of the “CEM” specimens, notwithstanding the high water to binder ratio, the final compressive strength was close to the nominal one (samples were produced using CEM I 32.5).

After consolidation, the lime- and NHL-based mortars experienced limited increases in E_d (+1 to +16%) and R_c (0 to +16%) after treatment with the "0.1 M DAP" solution, while much higher improvements were obtained with the "2 M DAP" solution (+29 to +65% increase in E_d , +87 to +204% increase in R_c). Such difference in consolidating ability between the two formulations is a consequence of the different amounts of new CaP phases formed in the two cases, as already assessed by FT-IR and SEM-EDS. The mechanical improvement was higher in the "L+SIL" and "L+CAL" mortars (where the binding fraction was made of calcium carbonate, highly reactive to form new CaP), compared to the "L+BRICK" and "NHL" mortars (where the binding fraction was mostly calcium silicate hydrates, less reactive than calcium carbonate, which in these specimens amounted to ~35 wt%). Nonetheless, some mechanical improvement was registered for all the mortar types, especially in the case of the more concentrated solution, even in cases where formation of new CaP was not very evident from FT-IR and SEM-EDS. This confirms that, thanks to the addition of a calcium source already in the DAP solution, significant consolidation can be achieved even on substrates that contain relatively low amounts of calcium-rich fractions. The beneficial effect of calcium ions supplied directly in the DAP solution, together with the predominant role of the binding fraction compared to

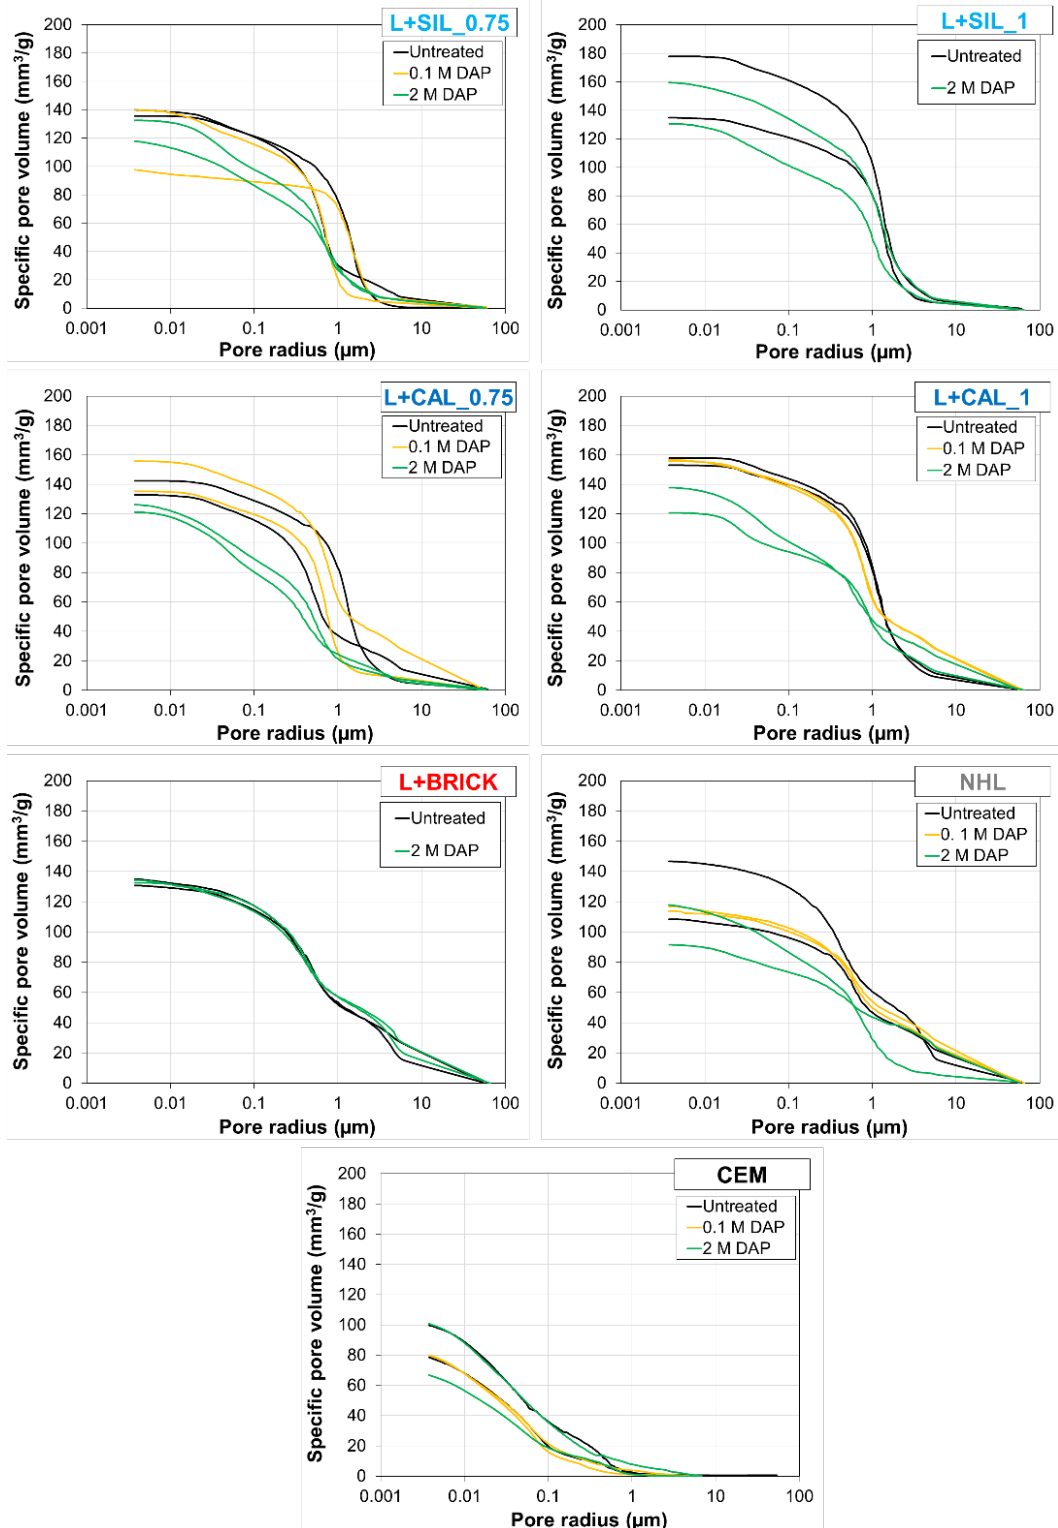
Figure 10. Pore size distribution of untreated and treated mortars.

The pore size distributions of untreated and treated mortars are illustrated in Figure 10. As expected, lime-based mortars with higher water to binder ratios exhibited higher open porosity (OP) than mortars with the same composition but a lower ratio: OP was 28.3% for “L+SIL_1” and 24.7% for “L+SIL_0.75”, while OP was 26.2% for “L+CAL_1” and 24.8% for “L+CAL_0.75”. As expected, the “CEM” specimens were the least porous ones (OP = 17.0%). In general, duplicate samples exhibited fair reproducibility, although in some cases some difference was found between the two samples tested for each condition (especially, in the “L+SIL_1” and “NHL” mortars).

Formation of new CaP phases resulted in some reduction in the total open porosity and some alteration in pore size distribution, which were more pronounced after treatment with the “2 M DAP” solution, as a consequence of the higher amount of new CaP phases formed in this case. With this formulation, some shift of the pore size distribution towards smaller pores took place, but the final total open porosity was only slightly reduced compared to the untreated condition, the reduction often falling within the variability of the untreated references. Passing from the untreated to the “2 M DAP”-treated condition, OP changed from 24.7 to 24.9% for “L+SIL_0.75”, from 28.3 to 26.0% for “L+SIL_1”, from 24.8 to 22.3% for “L+CAL_0.75”, from 26.2 to 24.8% for “L+CAL_1”, from 25.1 to 23.6% for “L+BRICK”, from 21.6 to 20.5% for “NHL”, from 17.0 to 15.8% for “CEM”. The fact that in no case did significant pore occlusion take place can be regarded as a positive feature, because strong alterations in the pore system might lead to significant changes in water transport properties, with consequent durability issues [11,12]. Moreover, because no significant increase in the fraction of smallest pores occurred, the mortar resistance to freeze-thaw and salt crystallization cycles is not expected to be negatively affected, but specific tests are needed to confirm this. The lack of complete pore occlusion is common to other alternative products used for lime and cement mortar consolidation, such as nanolimes [4] and ethyl silicate [41].

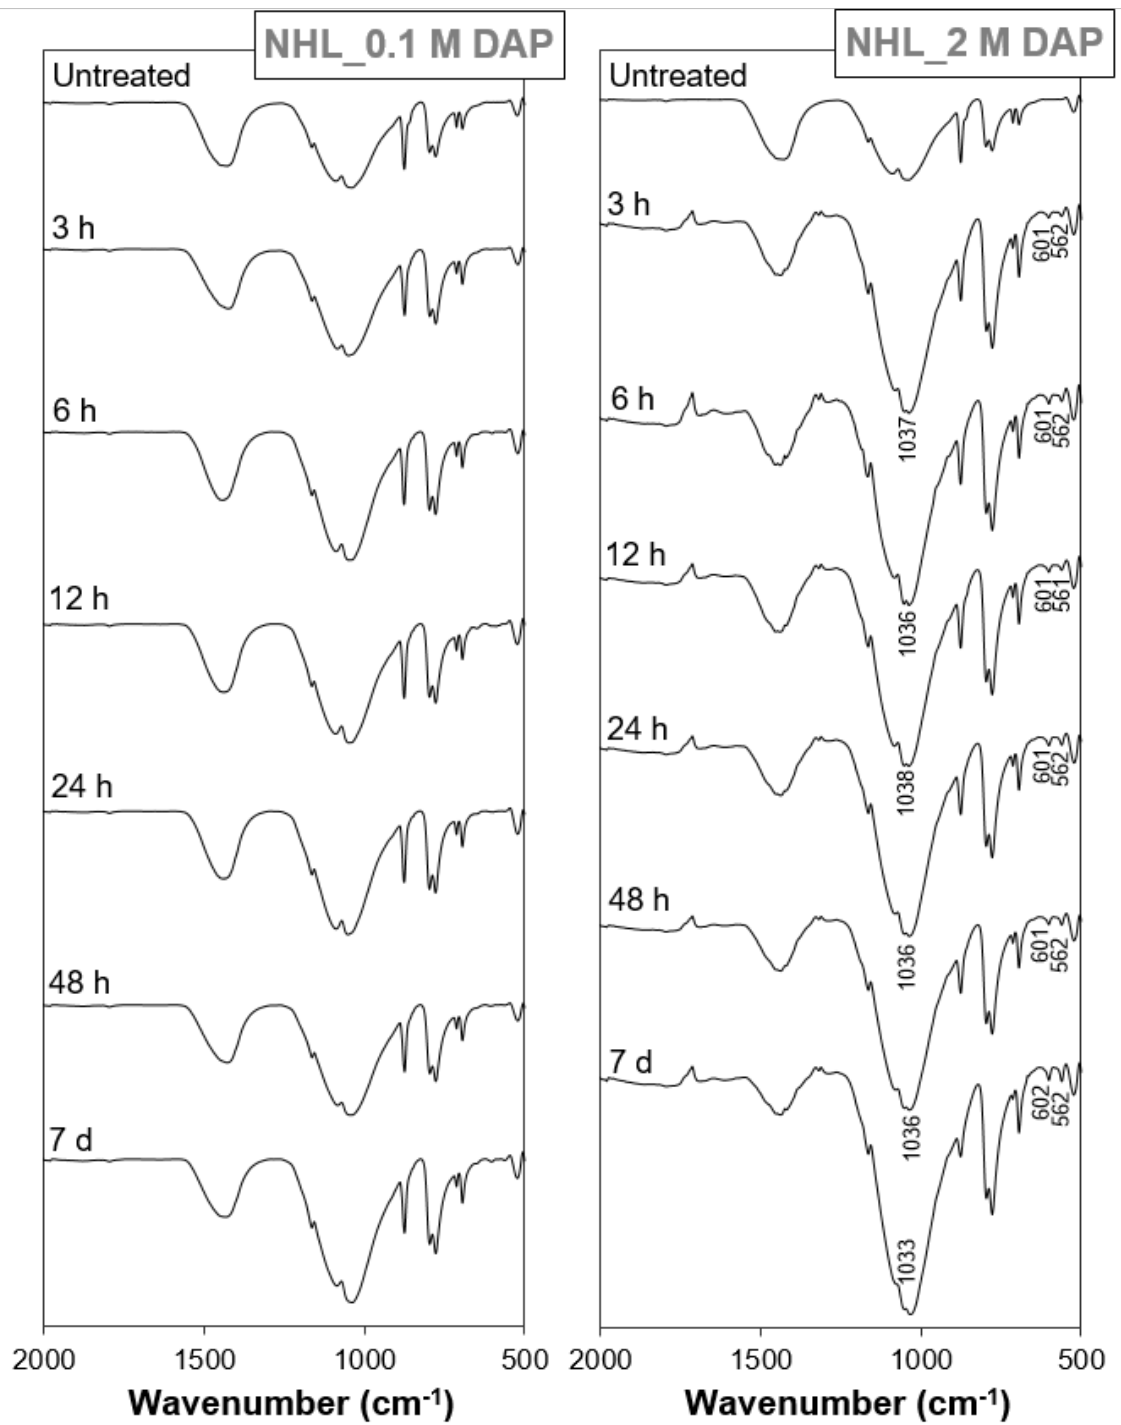
Figure S4. FT-IR spectra of “NHL” samples treated for increasing time.

Considering that, for all mortar types, no major increase in new phase formation was registered after treatment for 48 hours or 7 days (Figures S1-S5), treatment for 24 hours was selected as the reference treatment duration for the prosecution of the study. Such duration was selected also considering its feasibility in the onsite practice of architectural conservation, whereas longer durations might become challenging.
