## Osteogenesis and Morphology of the Peri-Implant Bone Facing Dental Implants

This study investigated the influence of different implant surfaces on peri-implant osteogenesis and implant face morphology of peri-implant tissues during the early (2 weeks) and complete healing period (3 months).

Thirty endosseous titanium implants (conic screws) with differently treated surfaces (smooth titanium = SS, titanium plasma sprayed = TPS, sand-blasted zirconium oxide = Zr-SLA) were implanted in femur and tibiae diaphyses of two mongrel sheep.

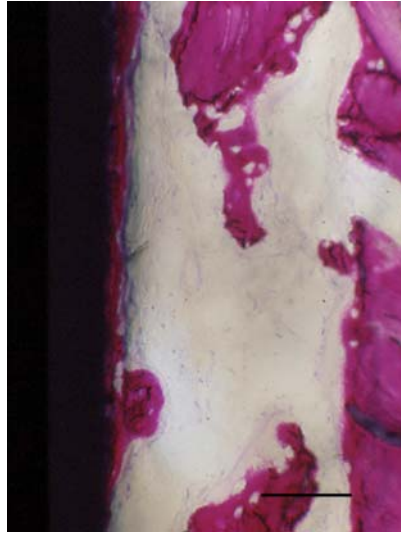
**FIGURE 3.** LM image of Zr-SLA screw 2 weeks after surgery. Newly formed bone trabeculae develop both from host bone (on the right) and directly on the metal surface. Many osteoblasts are lined on these bone trabeculae, which contain rounded osteoblasts/osteocytes in wide lacunae. Bar = 100  $\mu$ m.

A gap similar to that observed in the other samples was present in areas between two adjacent threads of Zr-SLA screws. In those regions, a network of many newly formed bone trabeculae developed both from host bone and directly on the metal surface. These thin bone trabeculae often ran parallel and on the

metal surface; they were rich in rounded osteoblasts/osteocytes in wide lacunae and sometimes included host bone chips (35–220  $\mu$ m) (Fig. 3).
