# External gap progression after cyclic fatigue of adhesive overlays and crowns made with high translucency zirconia or lithium silicate

**Objectives:** To evaluate three-dimensional external gap progression after chewing simulation of high translucency zirconia (HTZ) and zirconia-reinforced lithium silicate (ZLS) applied on endodontically treated teeth with different preparation designs.

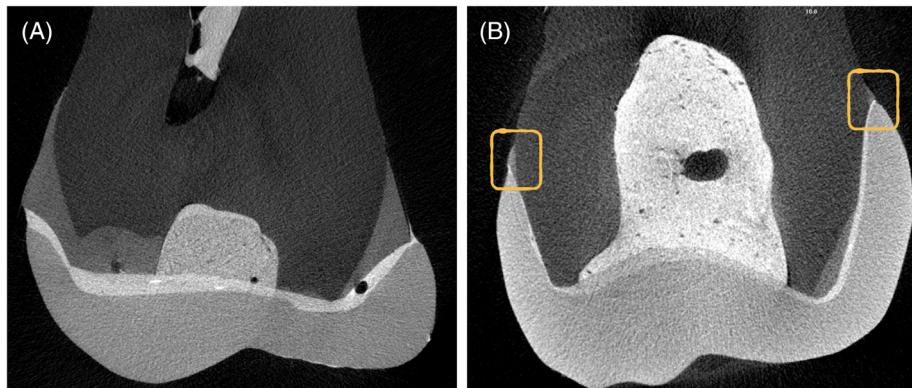
**FIGURE 1** Random samples transversal sections of a low-retentive design (Fig. 1A) and high-retentive design (Fig. 1B). Both the restorations were performed above the CEJ level, as highlighted in Fig. 1B

An exemplificative image reporting transversal sections of a low-retentive and high-retentive designs is reported in Figure 1.

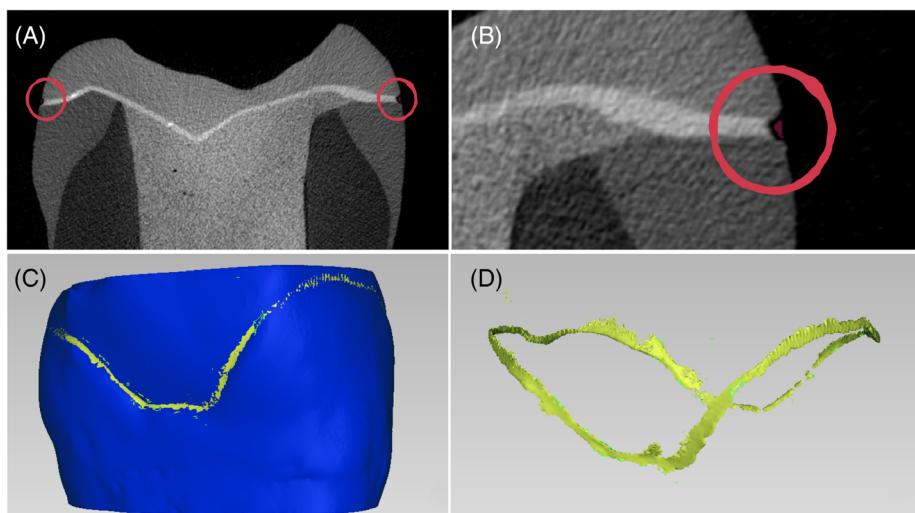
**FIGURE 2** Random sample external gap analysis (ADH, ZLS) in stages A–D. Figure A presents a random cross-section with external gaps highlighted. Figure B is a magnification of Figure A, showing in red the pixels corresponding to the external gap used in the analysis. Figure C shows a 3D rendering (Geomagic Studio 12, 3D Systems) of the tooth-restoration complex (in blue) and the analyzed gap (in yellow). Figure D presents the analyzed gap in yellow

Specimens which survived to chewing simulation were submitted to a second micro-CT scan, with the same parameters as the baseline, to maintain data consistency and evaluate the effect of fatigue on external gap progression. The obtained DICOM data were imported into a segmentation software (Mimics Medical 20.0, Materialise). A standardized workflow consisting of thresholding, region growing, and Boolean and morphological operations was used to specifically analyze the external interfacial gap. Segmented masks were converted into optimal quality STL files and imported into the analysis software (Geomagic Studio 12, 3D Systems) for noise removal and volume calculation (mm<sup>3</sup>). Figure 2A–D presents a schematic representation of the protocol steps for clarification.

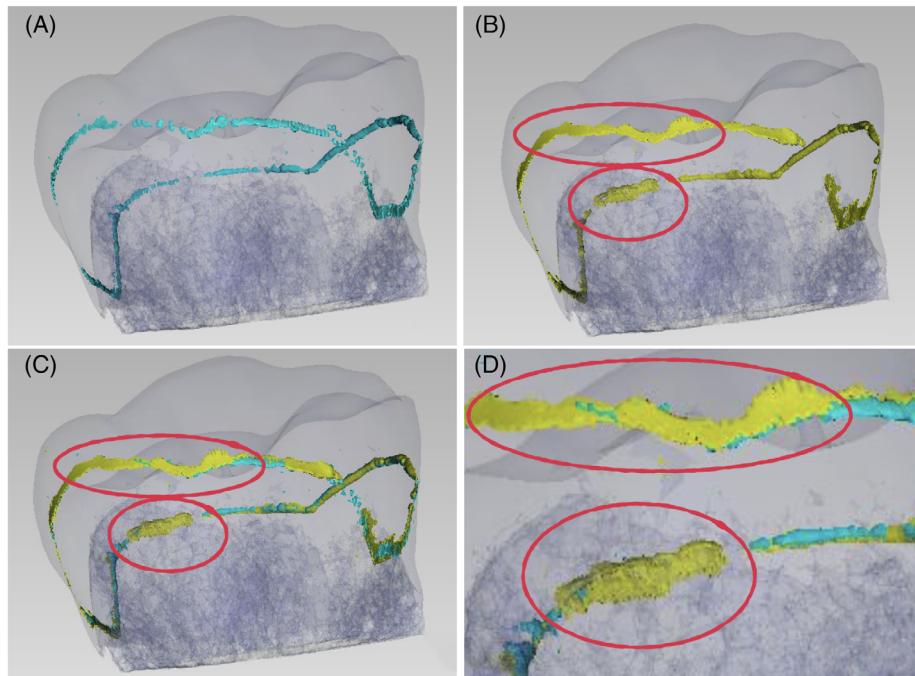
**FIGURE 3** Random sample (ADH, HTZ) external gap progression analysis. Figure A presents the baseline gap in light blue aligned with the transparent blue tooth-restoration complex. It is worth mentioning that even if a gap is reported throughout the whole interface, it is extremely thin, making its total volume almost irrelevant. Figure (B) presents the same sample gap after fatigue simulation in yellow, with red circles indicating some of the area that showed a significant gap progression. Figure (C) presents the superimposition of the baseline (light blue) on the final gap (yellow), with the same highlights presented in Figure B. Figure (D) presents a detailed view of Figure C for better understanding

To have significant data to discuss and to highlight the interfacial gap progression caused by cyclic fatigue, a subtraction was made between the final gap volume and the baseline gap volume. Figure 3 presents a random sample gap analysis, before and after the chewing simulation, with the external gap progression highlighted.
