Calcium phosphate coatings for marble conservation: influence of ethanol and isopropanol addition to the precipitation medium on the coating microstructure and performance

Enrico Sassoni^{1,*}, Gabriela Graziani¹, Elisa Franzoni¹, George W. Scherer²

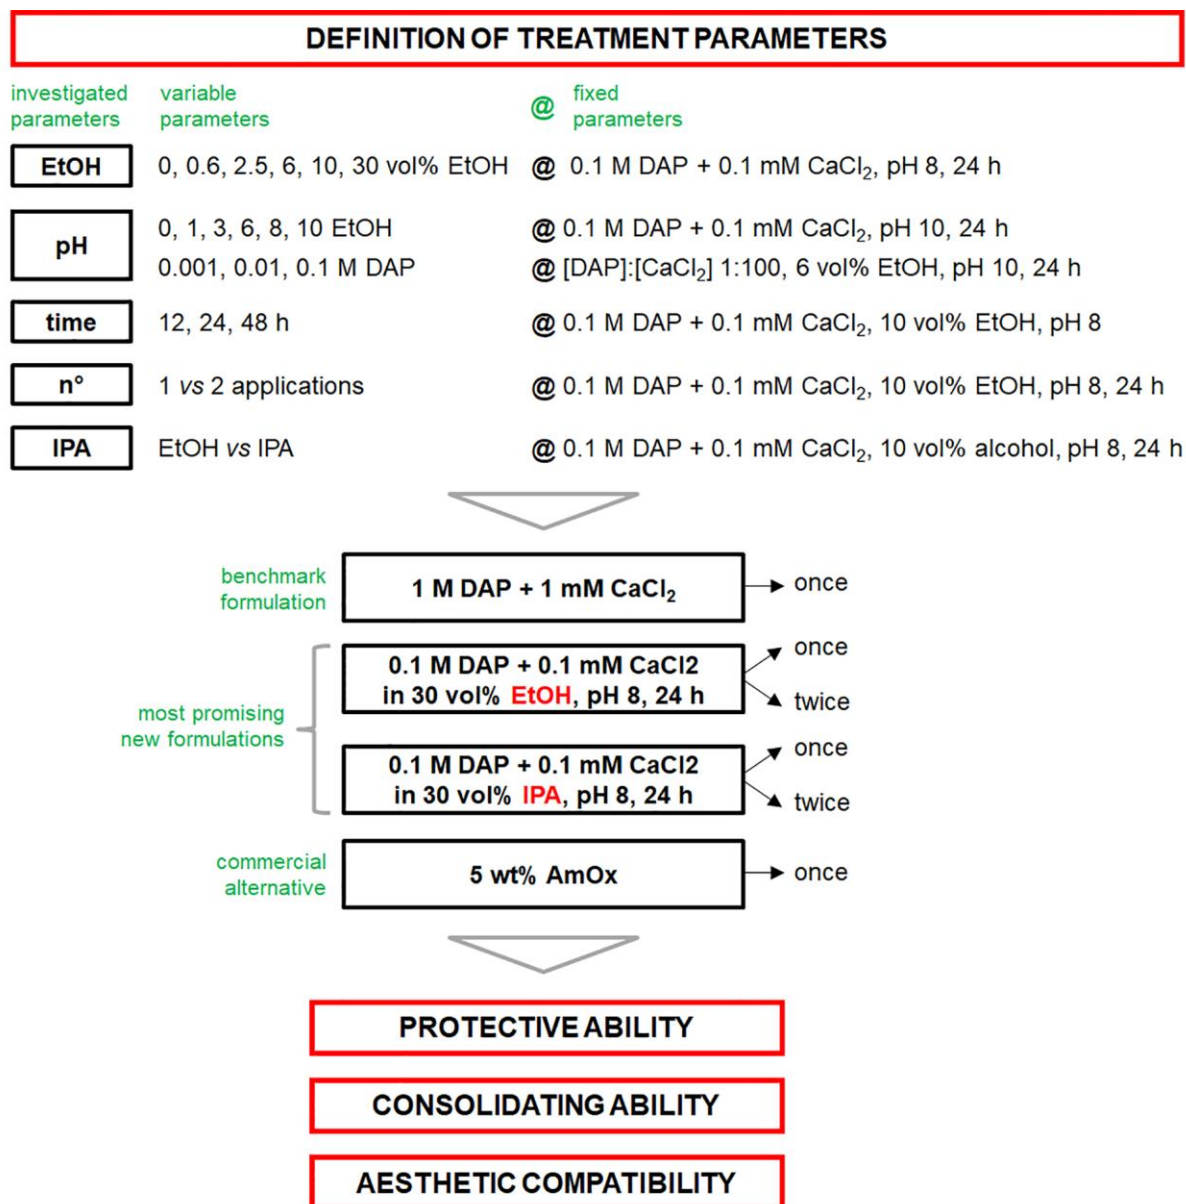
Figure 1. Scheme illustrating the investigated parameters and the whole rationale of the study.

The possible improvement of this formulation, in terms of surface coverage and microstructure, was investigated by exploring the influence of the parameters described in § 2.2.1 - § 2.2.5. A summary of the investigated parameters is reported in Figure 1. Treatment by a 5 wt% aqueous solution of ammonium oxalate (labelled as “AmOx”) was also taken as a commercial benchmark. All treatments were performed by immersing a cubic specimen in a plastic container with 200 ml of solution and then rotating the containers to ensure stirring of the solutions during treatment. The treatment duration was 24 hours, unless otherwise specified. At the end of the treatment, the specimens were taken out of the solutions, rinsed with deionized water and then dried at room temperature. The features of the different coatings were determined as described in § 2.2.6.

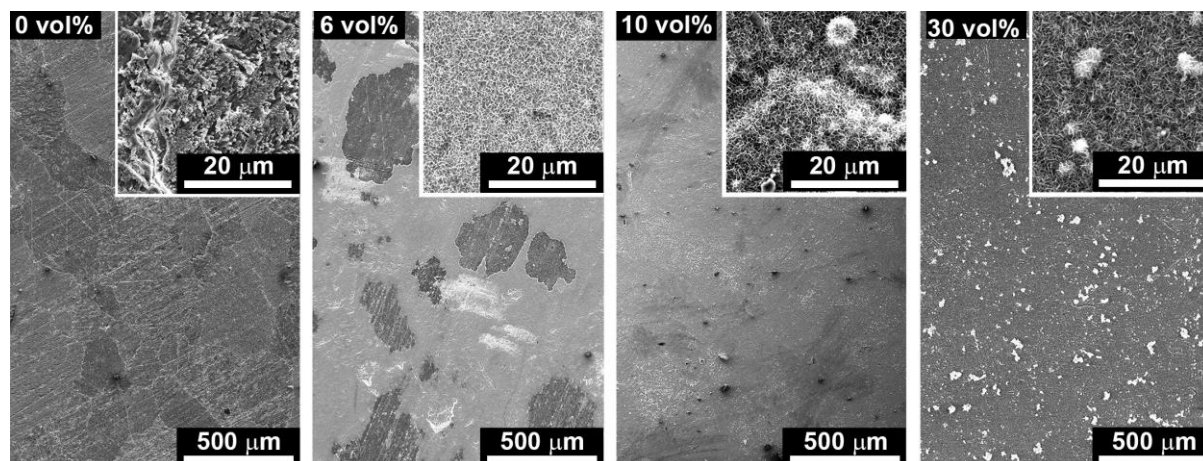
Figure 2. Coverage of marble surface by CaP coatings formed by reaction with a 0.1 M DAP and 0.1 mM CaCl_2 solution containing increasing amounts of ethanol.

When the DAP concentration was reduced and ethanol was added to the solution, cracking was prevented and a much denser microstructure was achieved (Figure 2), which allowed a significant improvement in the protecting ability (“EtOH” sample in Figure 2). The time required for pH increase from 4.75 to 5.75 was more than doubled (from 3.9 h to 8.3 h, Table 2), and the “EtOH” curve remained below the untreated reference “UT” for the whole duration of the test (Figure 9). When observed after the acid attack test (Figure 10), the coating exhibited no diffused detachment (unlike the “1 M DAP” sample), but still some cracking, which allowed the acid to reach the substrate and cause the increase in pH registered after some time.

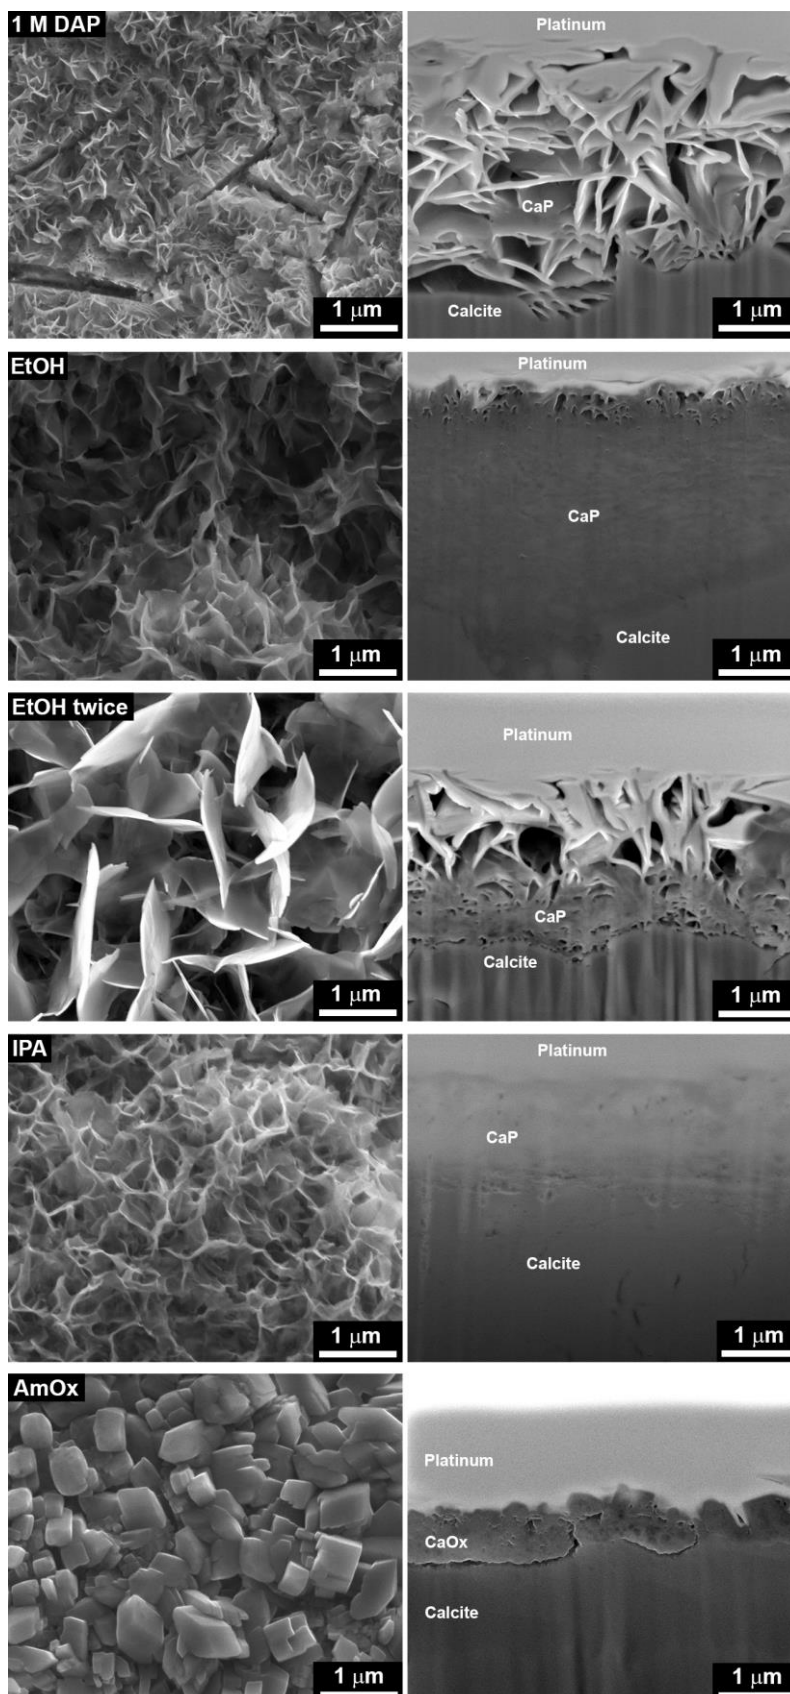
Figure 3. Surface morphology (left) and cross section (right) of marble samples subjected to different treatments.

Because repeated treatments had been found to significantly improve the surface coverage of marble particles by CaP coatings [22], the effect of repeating the “EtOH” treatment twice was investigated. As reported in Figure 3, this led to formation of huge CaP flakes on top of the coating, visible both from observation of the treated surface and in the FIB cross section (Figure 3). Even if the underlying layer exhibits a much denser microstructure than the superficial flakes, the adhesion at the coating-substrate interface seems worse compared to the single application, likely because the second treatment caused excessive growth and partial detachment of the coating from the substrate.

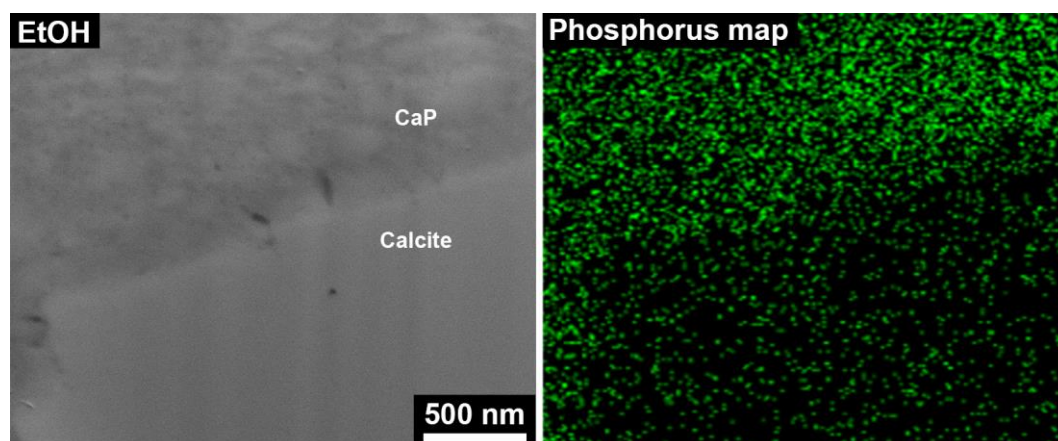
Figure 4. Interface between the calcite substrate and the CaP coating (left) and corresponding phosphorus map (right).

In addition to the increased surface coverage, ethanol addition also had a significant effect on the coating microstructure and tendency to crack. If one compares a specimen treated with a solution containing 0.1 M DAP, 0.1 mM CaCl_2 and 10 vol% ethanol (“EtOH” sample) with a specimen treated with a 1 M DAP and 1 mM CaCl_2 solution (“1 M DAP”), the following observations can be made. In both cases complete coverage of the marble surface is achieved. However, the “1 M DAP” specimen is affected by some cracking, likely developed during drying, while the “EtOH” specimen exhibits no visible cracks (Figure 3). In terms of porosity of the coating, FIB-SEM revealed that numerous large pores are present in the “1 M DAP” specimen (Figure 3), which are expected to negatively affect the acid resistance (cf. § 3.1.6). On the contrary, the “EtOH” specimen exhibits a much denser microstructure and no visible pores (Figure 3), apart from the top of the coating (right after the platinum layer), where the typical flower-like morphology of CaP is present. Notably, at the interface between the calcite substrate and the CaP coating (about 2–4 μm thick), good adhesion seems present (Figure 4).

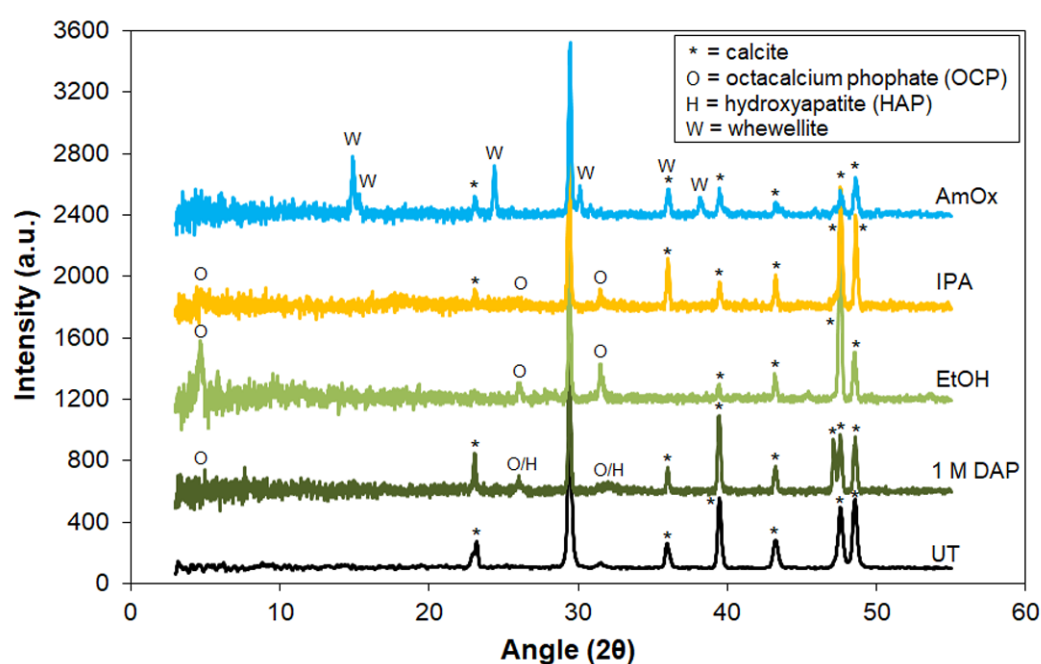
Figure 5. Mineralogical composition of untreated and treated specimens.

Consistently with the theoretical expectations, the amount of PO₄³⁻ ions in solution when 10 vol% IPA was added was found to be much higher than when the same amount of ethanol was added (0.71 mg/l vs 0.32 mg/l, respectively), basically corresponding to a 30 vol% ethanol addition (0.76 mg/l) (Table 3). Accordingly, the microstructure of the CaP coating formed with IPA addition was even denser than in the case of ethanol, the interface between the calcite substrate and the coating being hardly distinguishable (Figure 3). In terms of composition, the coating consisted of OCP, as in the case of ethanol addition (Figure 5).

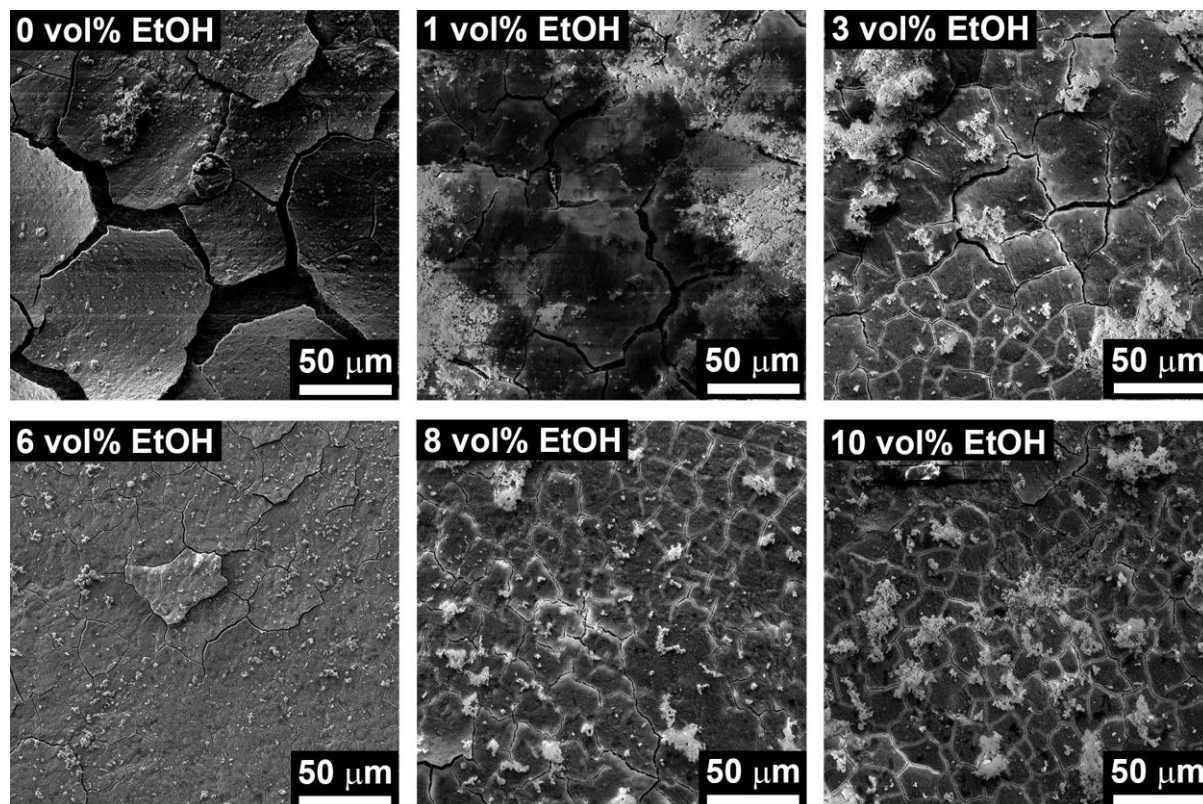
Figure 6. Morphology of CaP coatings formed at pH 10 for increasing amount of ethanol addition to the DAP solution.

Increasing the pH of the DAP solution to 10 using NH_4OH had a huge effect on the CaP coating development, as illustrated in Figure 6. Even with no ethanol addition, at pH 10 abundant formation of new phases occurred when marble was treated with a 0.1 M DAP and 0.1 mM CaCl_2 solution, while no formation took place at pH 8 (Figure 2). This is a consequence of the higher amount of PO_4^{3-} ions originating from DAP dissociation at high pH [19]. However, because of excessive growth, the CaP coating is extensively cracked (Figure 6), which prevents effective acid protection. To try to avoid cracking, two routes were tested. First, increasing ethanol additions to the DAP solution were tested, to develop a more adherent coating with more refined

microstructure. As illustrated in Figure 6, a reduction in cracking and flake detachment was achieved, but cracks were not completely eliminated. Moreover, the combination of high pH and high ethanol additions led to an excessive PO_4^{3-} amount, which resulted in abundant precipitation of CaP particles over the coating (Figure 6). Therefore, considering that at higher pH a lower concentration of DAP could be enough to achieve complete surface coverage, a progressive reduction in DAP concentration from 0.1 M to 0.01 M and 0.001 M was tested (the CaCl_2 :DAP concentration always being 1:1000). As illustrated in Figure 7, a DAP concentration of 0.01 M at pH 10 was enough to obtain complete coating of the surface. However, the coating exhibited some cracking (Figure 7). A further reduction of the DAP concentration by 10 times led to no coating formation (Figure 7), because the PO_4^{3-} content became too low. Since the boosting effect of high pH was always linked to cracking in the tested conditions, only treatments at pH 8 were considered for the prosecution of the study.

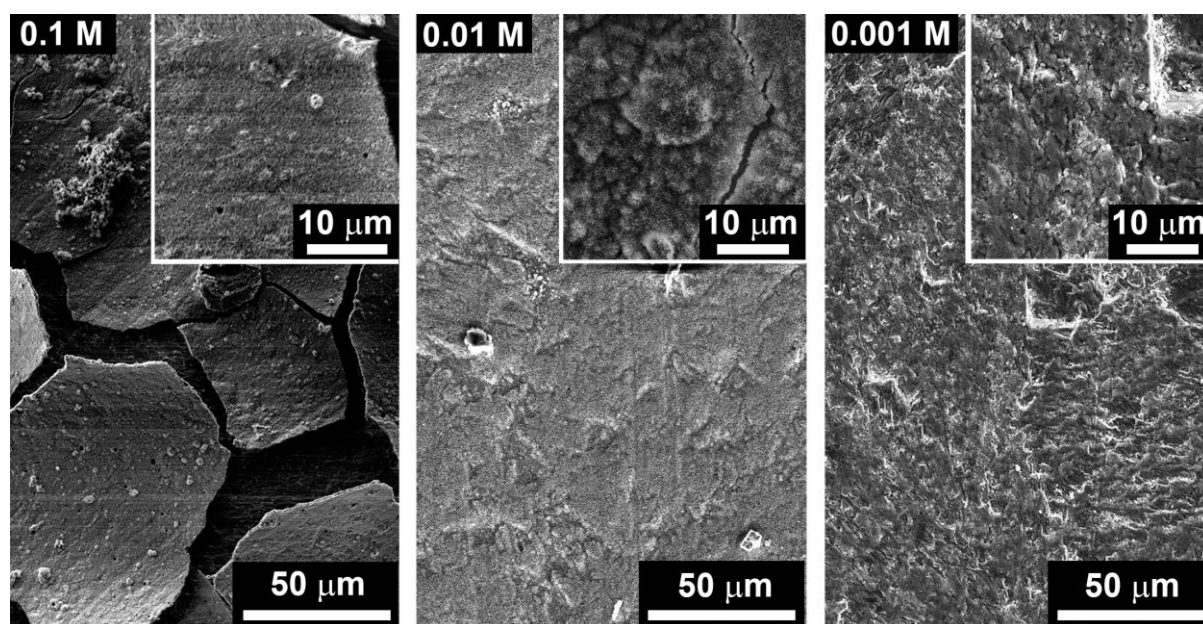
Figure 7. Morphology of CaP coatings formed at pH 10 for decreased DAP concentration and no ethanol addition to the DAP solution.

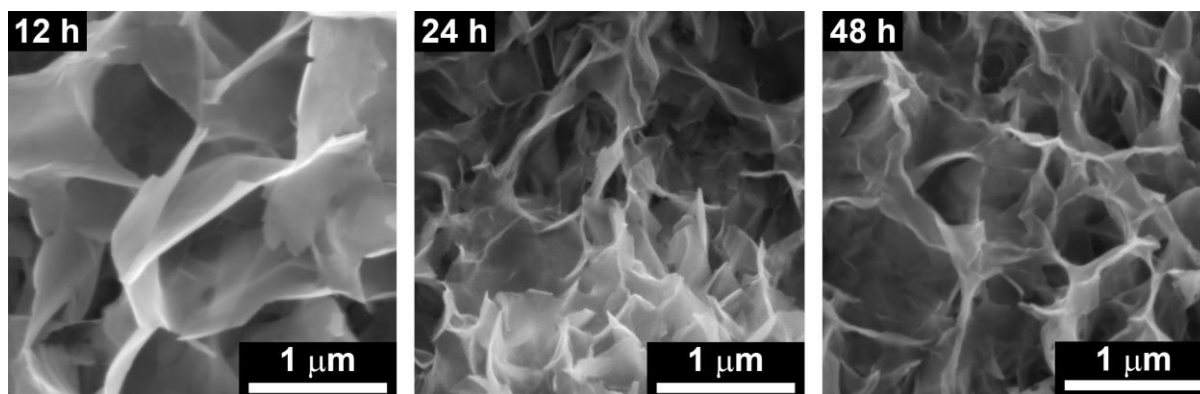
Figure 8. Morphology of CaP coatings formed after treatment for increasing time.

Considering that ethanol addition significantly favours formation of the new CaP coating, the effect of reducing the treatment duration from 24 to 12 hours was investigated. At the same time, because an evolution of the phase composition and microstructure has been reported in the literature passing from 24 to 48 hours (however in different conditions, especially without stirring of the DAP solution [43]), a longer reaction time was also considered. However, in the case of a solution containing 0.1 M DAP, 0.1 M CaCl_2 and 10 vol% ethanol, no remarkable difference in the coating morphology was noticeable for the different reaction times investigated (Figure 8), hence treatment for 24 hours (as recommended in [3]) was adopted for further comparisons.

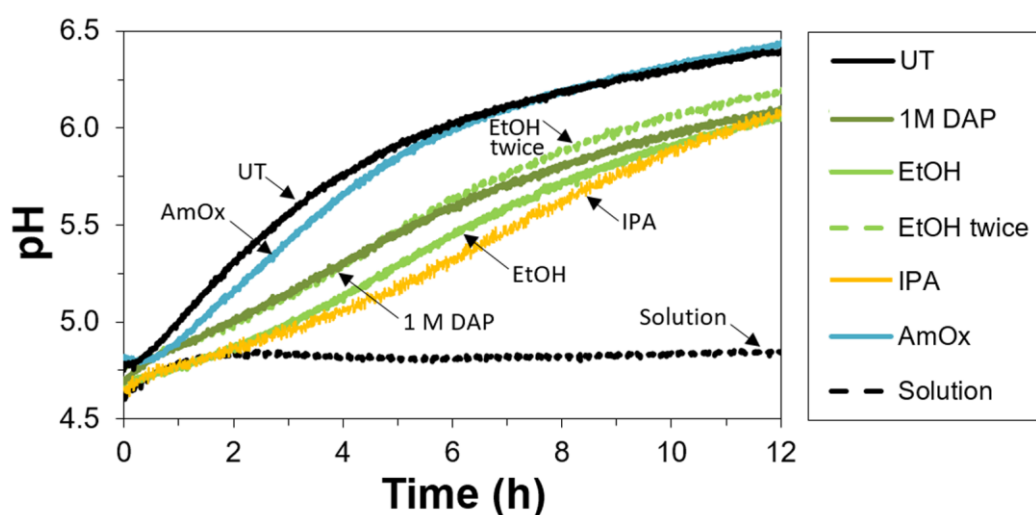
Figure 9. Acid resistance (in terms of pH increase over time) of untreated and treated specimens (the curves are averages for two specimens, one tested on the rougher surface and one tested on the smoother surface). The curve of the acid solution alone (with no sample) is illustrated as well.

First, the stability of the solution pH when no sample was immersed was checked and no pH increase was in fact recorded. The “UT” sample caused a quick increase of pH during the test (Figure 9). This increase is due to H⁺ ions in the solution being consumed as Ca²⁺ ions are released from calcite [1]. Since the Ca²⁺ concentration increases as the test proceeds, the rate of dissolution decreases, because the dissolved Ca²⁺ ions remain in the solution [1]. At the end of the test, the marble surface is significantly etched, so that single grains and grains boundaries become apparent (Figure 10).

The “1 M DAP” treatment was able to provide some protection against dissolution, as denoted by the fact that the respective curve lies well below the untreated reference (Figure 9). For instance, if one compares the time required for the solution pH to increase by 1 unit (from 4.75 to 5.75), the “1 M DAP” treatment allowed an increase from 3.9 h (“UT”) to 7.3 h (“1 M DAP”) (Table 2). However, at the end of the acid attack test, the coating exhibited several areas where it had been detached and removed (Figure 9). This is a consequence of the presence of cracks and pores

When repeated twice, the EtOH treatment performed a little worse, the curve basically overlapping with that of the “1 M DAP” sample (Figure 9) and the time for pH shift decreasing to 6.8 h (Table 2). Accordingly, diffused cracking was noticed when the sample was analysed after the acid attack test (Figure 10). The worsening of the treatment performance when repeated twice is in agreement with the less dense microstructure observed in the “EtOH twice” specimen (Figure 2), likely related to the excessive growth of the film during the second application.

The acid resistance of the “IPA” sample resulted improved with respect to the “EtOH” sample, especially at the beginning of the test (Figure 9), the time required for pH increase to 5.75 being the longest (8.7 h against 8.3 h for the “EtOH” sample and 3.9 h for the “UT” reference, Table 2). The ESEM observation of the coating after the acid attack test revealed that no diffuse detachment occurred, even if cracks are visible (similarly to the case of the “EtOH” sample) (Figure 10).

It is important to point out that, even if initially they exhibited sensibly different behaviours, the curves of the different phosphate treatments converge as the test proceeds, so that after 12 h only minor differences are present (Figure 9). This is a consequence of the fact that, even if the coating exhibits complete coverage and no cracks, still some sporadic defects can be noticed. As illustrated in Figure 11, when impurities are present over the marble surface, the formation of the coating is interrupted. The remaining bare areas are weak points, from where the attack on the marble surface can start and propagate to the adjacent areas, where the coverage was originally good. Moreover, it was observed that the continuity of the coating is sometimes abruptly interrupted at the boundary between two grains, so that one calcite grain has perfect coverage and the adjacent one remains almost bare (Figure 11). This is thought to be a consequence of the different orientation of calcite grains, which might be more or less favourable for the development of the CaP coating. In fact, epitaxial growth of HAP over calcite has been reported in the literature, but only along privileged crystallographic directions of the calcite and HAP crystals [48]. Along these directions, the distance between the phosphate groups in the HAP crystal closely matches the distance between carbonate groups in the calcite crystal, so that epitaxial growth can occur [48]. However, in marble where calcite grains have random orientation, this is generally not the case. Epitaxial growth might occur over those grains that have a particularly favourable orientation (over these grains, HAP nucleation is also favoured by the reduction in supersaturation needed for nucleation [48]) and from these grains the coating can spread to the adjacent ones with different orientation. However, when the coating development reaches grains with a particularly unfavourable orientation, formation over these grains may be impeded. Possible routes to overcome the influence of the underlying calcite crystals orientation on the development of the phosphate coating are currently being investigated.

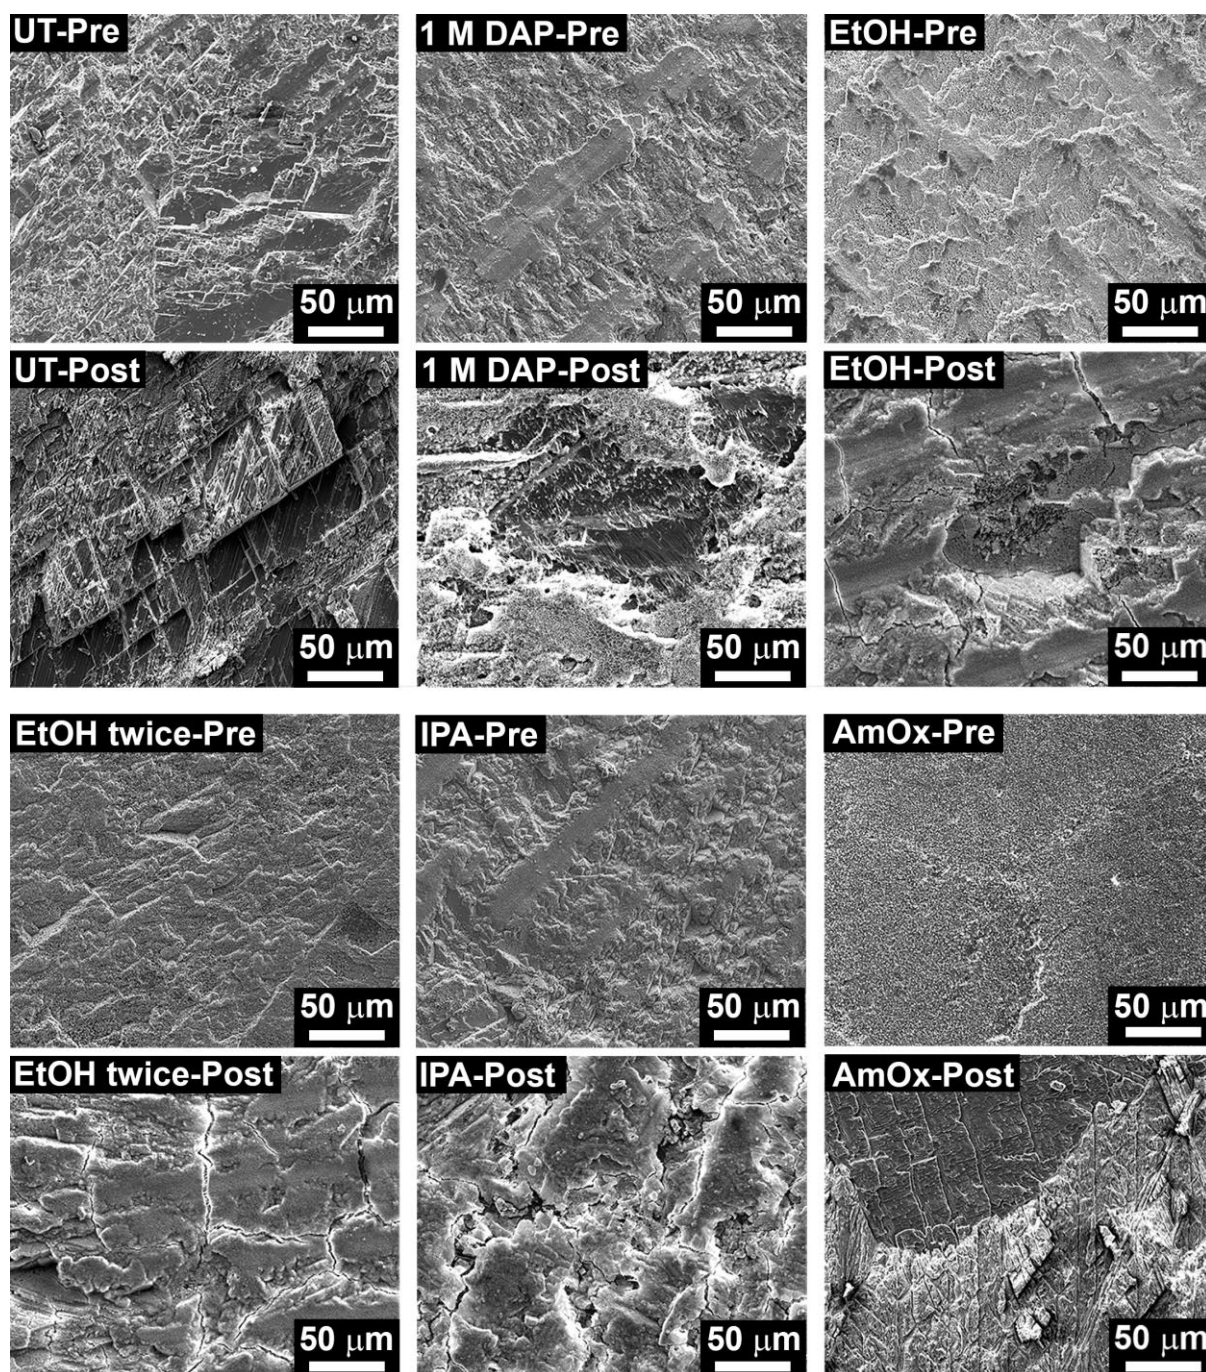
Figure 10. Surface morphology of untreated and treated specimens, before (“-Pre”) and after (“-Post”) the acid attack test.

For the most promising formulations of the phosphate treatments (namely, “EtOH”, “EtOH twice”, “IPA” and the reference “1 M DAP”, Table 2), as well as the reference conditions “UT” and “AmOx”, the results of the acid attack test are illustrated in Figure 9. Results are expressed in terms of pH increase over time of the acid solution simulating rain, in which the samples had been immersed. The appearance of the coating before and after the acid attack test is illustrated in Figure 10.

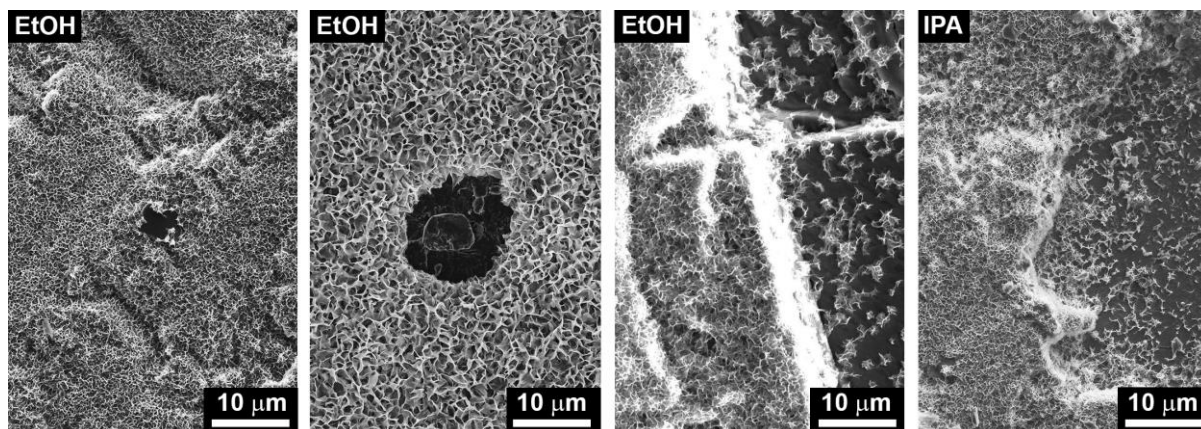
Figure 11. Interruptions in the CaP coating due to the presence of impurities (left two images) and due to the different crystallographic orientation of calcite grains (right two images).

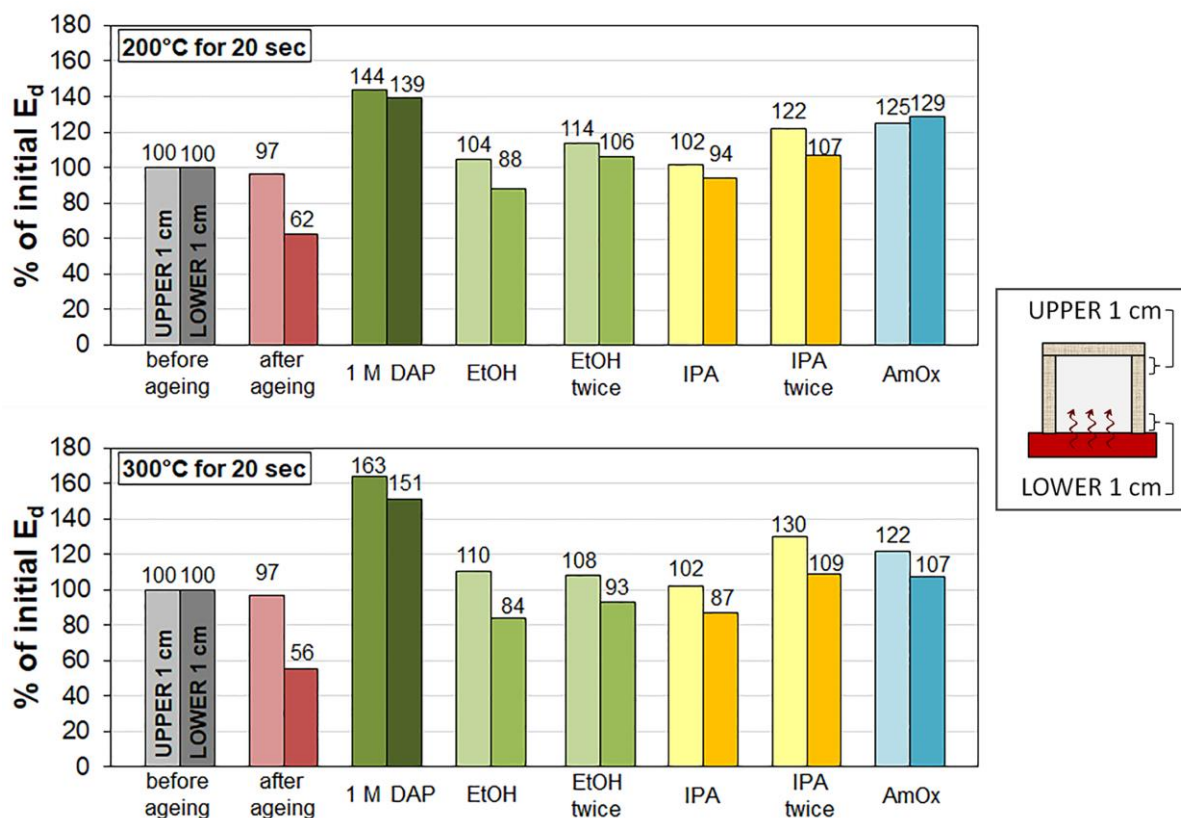
Figure 12. Variations in dynamic elastic modulus (E_d), with respect to the initial value, after accelerated ageing and after consolidation by different treatments. Values refer to the lower and upper 1 cm of the specimens, which had been subjected to accelerated ageing as illustrated in the inset: one face of the specimens was put in contact with the hot plate (in red), while the sides and the top were wrapped with a high temperature resistant insulator (in grey), to ensure the uni-directional heat flux.

After accelerated ageing by contact with a hot plate for 20 seconds, in the first 1 cm from the heated surface the specimens exhibited a 38% E_d decrease after heating at 200 °C and a 44% E_d decrease after heating at 300 °C (Figure 12). These values are in very good agreement with those predicted by the mathematical model (35% and 42%, respectively) [28], which was used to calculate the heating temperature and time required to produce damage similar to that experienced in the field by naturally weathered marble [27-29]. At the same time, the upper 1 cm of the sample underwent no substantial E_d decrease (Figure 12), as expected.

Consolidation by the “1 M DAP” treatment proved to be the most effective among all the investigated treatments, being able to increase E_d in the weathered part up to 139% (samples heated at 200 °C) and 151% (samples heated at 300 °C) of the initial value. The higher consolidating efficacy in samples with higher initial damage is consistent with previous results obtained on limestone [21]. The fact that the “1 M DAP” treatment was able to increase mechanical properties the most, in spite of the presence of cracks and pores in the formed CaP layer, derives from the following fact. Whereas in the case of *protection* it is essential that the formed coating continuously cover the surface and be crack- and pore-free, in order to prevent acid from reaching the substrate, this is not as important in the case of *consolidation*. In this latter case, the main requirement is that the newly formed material be able to seal the tip of the cracks among grains [50]. If the crack tip is effectively sealed, then the continuity of the coating and the presence of cracks and pores are not as detrimental as in the case of acid protection (however, cracks in the coating might propagate to the crack between grains, so uncracked coatings are nevertheless preferable). A potentially negative aspect of the high consolidating effectiveness of the “1 M DAP” treatment is that not only the initially deteriorated part (lower 1 cm), but also the initially sound part (upper 1 cm) underwent a significant mechanical improvement (Figure 12). This is undesired, because over-strengthening of the sound part might lead to mechanical incompatibility between the treated part and the substrate, potentially leading to its detachment [51,52]. Therefore, treatments able to restore mechanical properties of the weathered part, without causing excessive strengthening of the sound part are recommended [51,53].

Specimens consolidated by “AmOx” exhibited remarkable mechanical improvement, second only to the “1 M DAP” specimens (Figure 12). In fact, the initial modulus in the weathered part was completely restored and even enhanced after a single application (E_d up to 129% and 107% in specimens heated at 200 and 300 °C, respectively), with considerable strengthening also of the sound part (E_d up to 122–125%). Such mechanical improvement is notable, considering that in a previous study we found the consolidating ability of the ammonium oxalate treatment to be very modest [29]. The poor consolidating behaviour of ammonium oxalate was ascribed to the reduced depth of formation of whewellite [29], owing to the very rapid reaction between the ammonium oxalate solution and calcite [54]. In addition to the different thickness of samples to be consolidated (1 cm in the present case, 2 cm in the previous case [29], a possible explanation for the better results obtained in this study may be the different application technique. While in the previous study the ammonium oxalate solution had been applied by brushing [29], in the present study it was applied by vacuum impregnation, which likely allowed to achieve a deeper and quicker penetration of the consolidating solution into marble microcracks, leading to higher strengthening. However, it should be noted that, given the low resistance of the newly formed whewellite to dissolution in acid, it is not unlikely that most of the mechanical improvement induced by the “AmOx” treatment could be lost after prolonged exposure to rain.

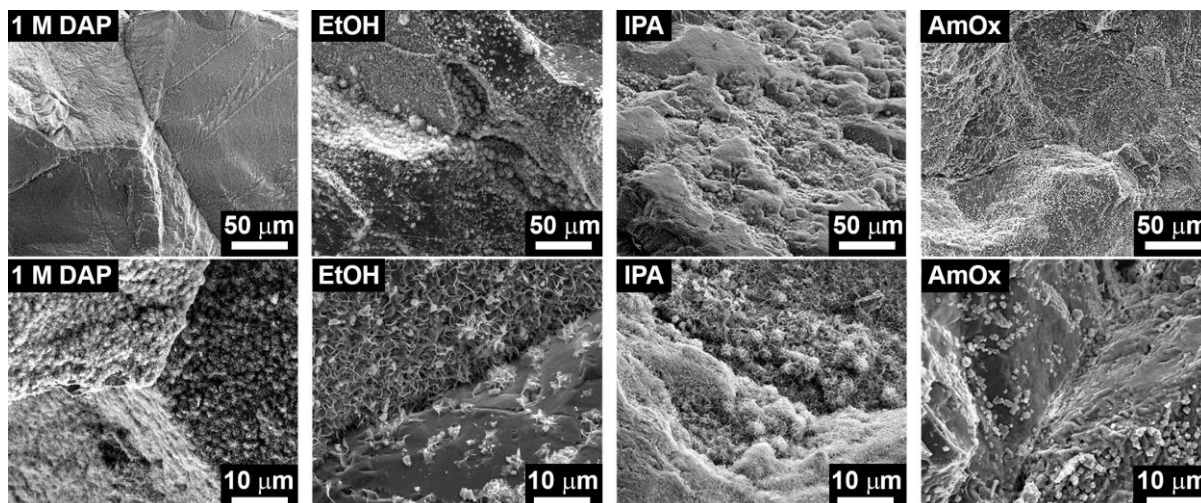
Figure 13. New phases formed inside microcracks between calcite grains after consolidation by different treatments.

After the E_d measurement, the formation of new phases in the microcracks among calcite grains was assessed by ESEM observation of fracture samples obtained by chisel from the tested specimens.
