Transcatheter Mitral Valve-in-Valve Dislocation: A Rescue Strategy

Alessandro Leone, Jacopo Alfonsi, Emanuele Pilato, Luigi Lovato, Luca Di Marco, Giacomo Murana, Francesco Saia, Davide Pacini, Roberto Di Bartolomeo, Transcatheter Mitral Valve-in-Valve Dislocation: A Rescue Strategy, *The Annals of Thoracic Surgery*, 2018; 106: e137-e139

Transcatheter Mitral Valve-In-Valve Dislocation: A Rescue Strategy

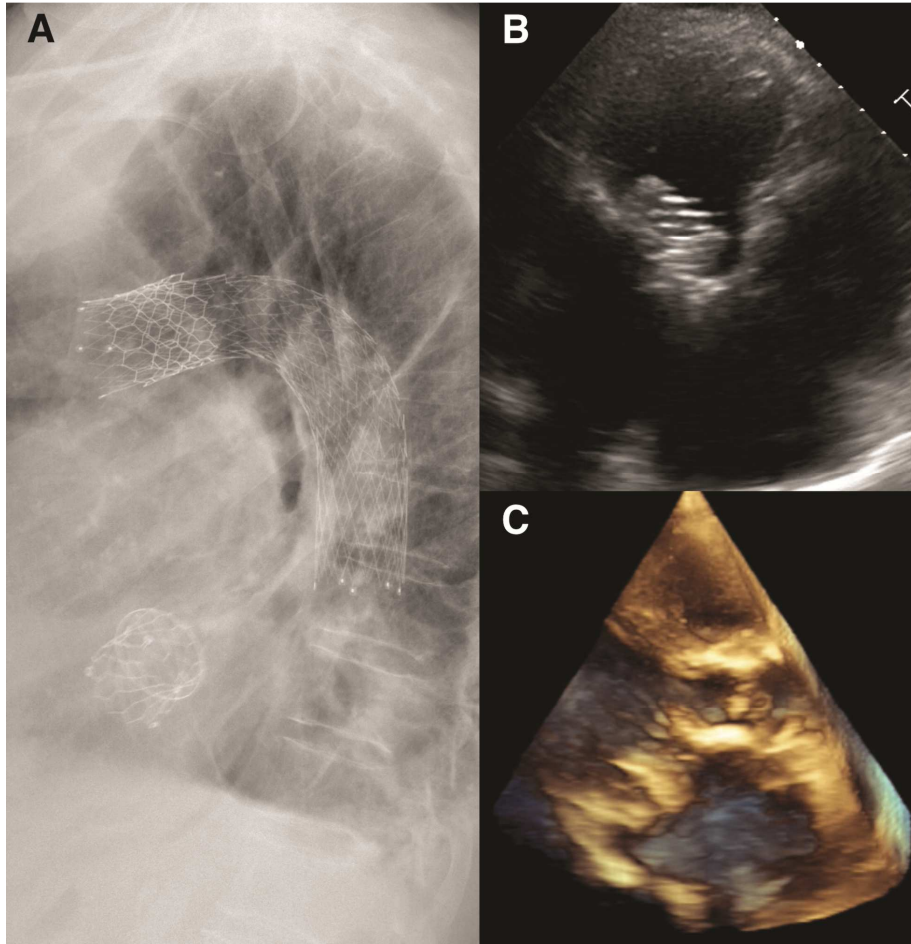
Figure 2. (A) Post-operative fluoroscopic image showing the right positioning of the prosthesis (B) Three-dimensional transthoracic echocardiography and (C) Bi-dimensional transthoracic echocardiography showing the 29-mm Edwards SAPIEN prosthesis (Edwards Lifesciences LLC, Irvine, CA) successfully placed inside the degenerated 31-mm Hancock bioprosthesis.

immediately implanted in the degenerated bioprosthesis using the same approach under fluoroscopy and echocardiography guidance, during rapid ventricular pacing (figure 1B). Fortunately the position of the dislocated mitral prosthesis, perfectly aligned in the arch, did not interfere with the catheters passage. Considering this, the dislocated prosthesis was then successfully stabilized in the aortic arch introducing through the right femoral artery a bare aortic stent (E-xl 36-32, JOTEC), allowing also an adequate perfusion of epiaortic vessels (figure 1C). The patient was extubated 14 hours after the procedure, no complications occurred, the post-operative chest X-ray showed the right positioning of the prosthesis (figure 2A) and he was discharged from hospital 8 days after valve implantation with warfarin therapy. The pre-discharge echocardiogram showed no mitral regurgitation and any paravalvular leakage, mitral valve area was 2.8 cm² with a mean gradient of 7 mmHg, LV ejection fraction was 43% (figure 2B, 2C).
