First water safety plan approach applied to a Dental Clinic complex: identification of new risk factors associated with *Legionella* and *P. aeruginosa* contamination, using a novel sampling, maintenance and management program

RESEARCH ARTICLE

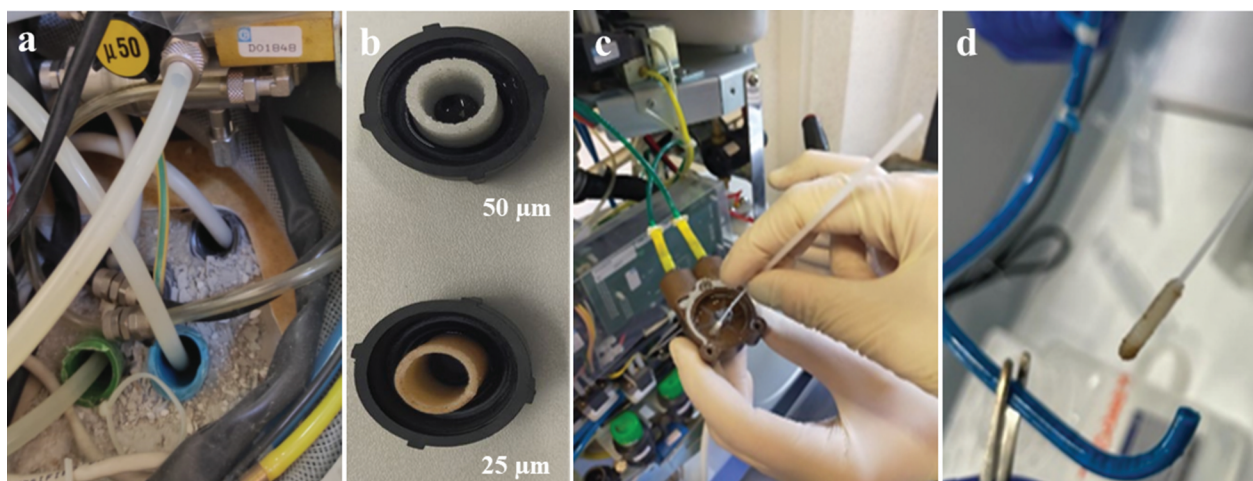
Figure 1. DUWLs components analyzed: a) filter pressure reducers located in the dental chair; b) details of two filter pressure reducers; c) flow sensors and d) FLOQSwabs® minitip samples on part of water pipelines.

- all the DUWLs were suspended and the contaminated DUWLs were also disconnected from the municipal water connection;
- replacement of two in-line filter pressure reducers (50 and $25 \mu\text{m}$), located after the input of the main municipal water, were carried out (Fig. 1a,b);
- all the damaged pieces or anything else that could over time cause water stagnation, flow reduction and biofilm formation, such as the flow sensor (Fig. 1c) or the small pipelines that connect the main water to dental handpieces, cup filler and the spittoon, were replaced (Fig. 1d);
- in accordance with manufacturer's staff instructions, a new cycle of sanitification was performed. The applied protocol was changed from the previous one, in terms of the number of rinses (two times after each treatment), use of sterile water and increase in disinfectant concentration,

Blue-green colonies, which produced a characteristic bright green color on the medium and showed fluorescence under a Wood's lamp (ultraviolet light at 365 nm), were identified as presumptive *P. aeruginosa*. The colonies were biochemically identified by indole, oxidase reaction tests and Remel RapID NF Plus system (Thermo Fisher Scientific, Diagnostic, Ltd., Basingstoke, UK), according to the manufacturer's instructions. The results were also confirmed by MALDI Biotyper System (Bruker Daltonics, Germany) according to the manufacturer. Moreover, further analysis was carried out on all changed or removed components of DUWLs by using FLOQSwabs® minitip (Copan, Brescia, Italy). In detail, swab samples were collected on the filter pressure reducers, on the flow sensor and on the changed connecting pipelines, as well as on the handpieces (Figure 1c,d).

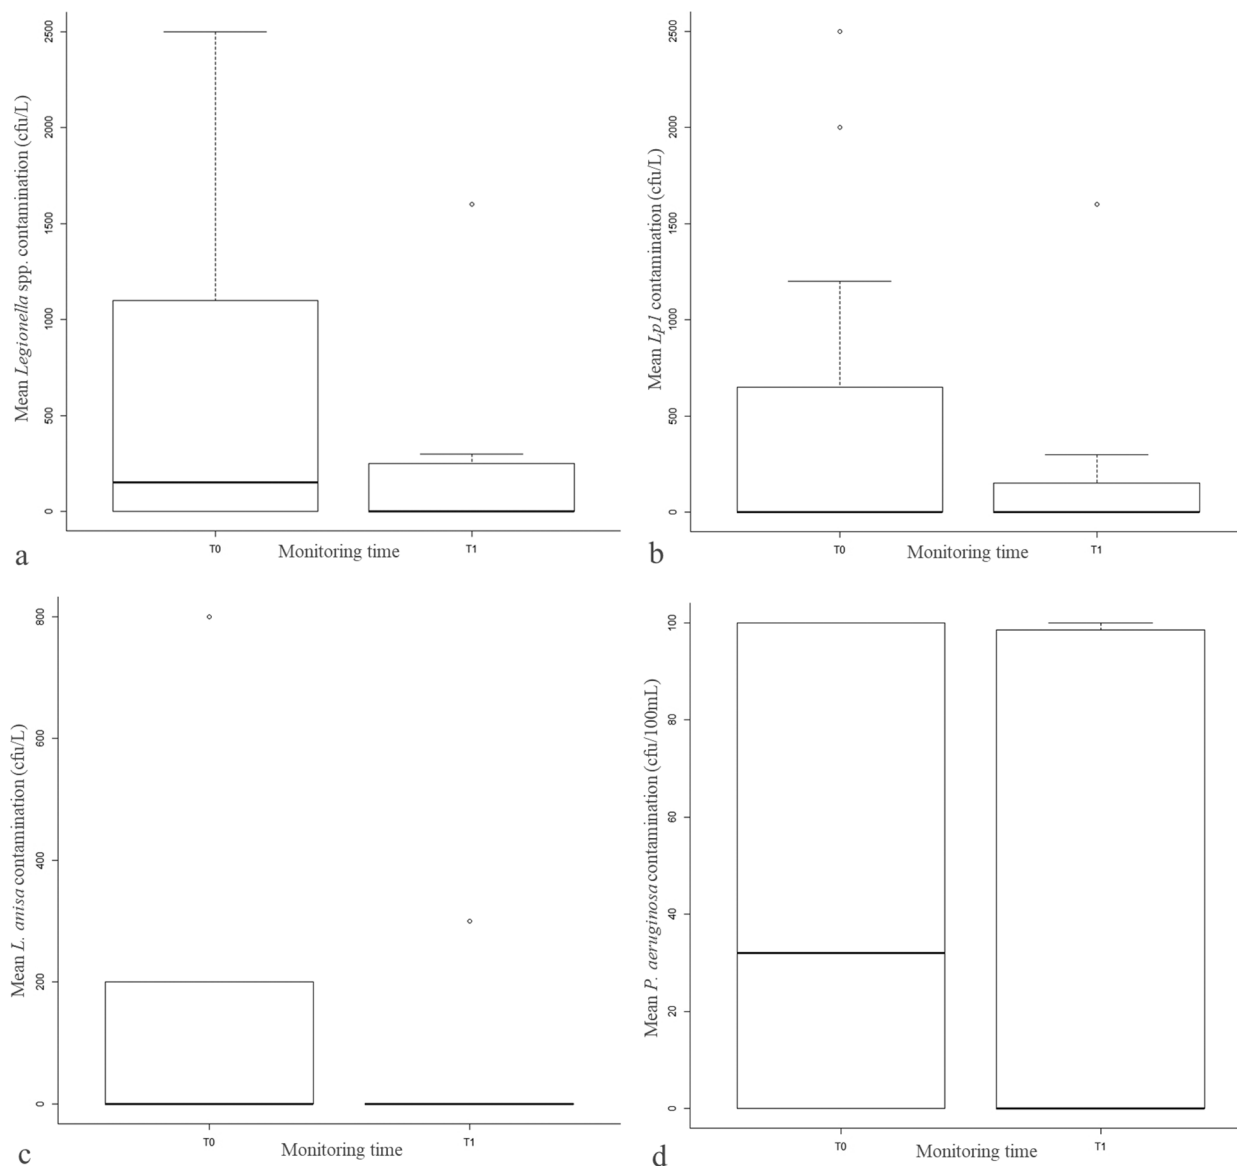
Figure 2. Type B DUWLs cup filler mean contamination: a) *Legionella* spp., b) *Lp1*, c) *L. anisa* and d) *P. aeruginosa*. Contamination comparison between T0 and T1 on 12 Type B DUWLs remained positive. No significant differences were obtained. Detection limits were 100 ufc/L for *Legionella* and 0 cfu/100mL for *P. aeruginosa*.

A total of 36 samples were collected 24 h after the activity was undertaken, following the same methodology (cup filler, handpieces and water bottle). Moreover, 1 L of water input was again sampled as a control. The results obtained after the ordinary sanification protocol conducted during monitoring time T1, and the comparison with the previous results (T0) are shown in Figure 2.

As shown in Figure 2, after the sanification procedures, a general decrease in *Legionella* and *P. aeruginosa* mean contamination was observed in cup filler. In particular, the following reductions were observed: *Legionella* spp. -59.54% (*Lp1* -42.53% , *L. anisa* -90.63%) and *P. aeruginosa* -43.29% . These results do not show statistically significant differences. However, in the dental handpieces, the contamination disappeared, and the absence of contamination in the water bottles and water input was reconfirmed.

Results show that, despite the fact that the ordinary sanification protocol led to a contamination decrease, the

cup filler, remained contaminated and over the regulation limit.
